River Maigue Catchment Riparian Habitat Study

RIVER MAIGUE RIPARIAN HABITAT SURVEYS

FINAL REPORT

Prepared by Wetland Surveys

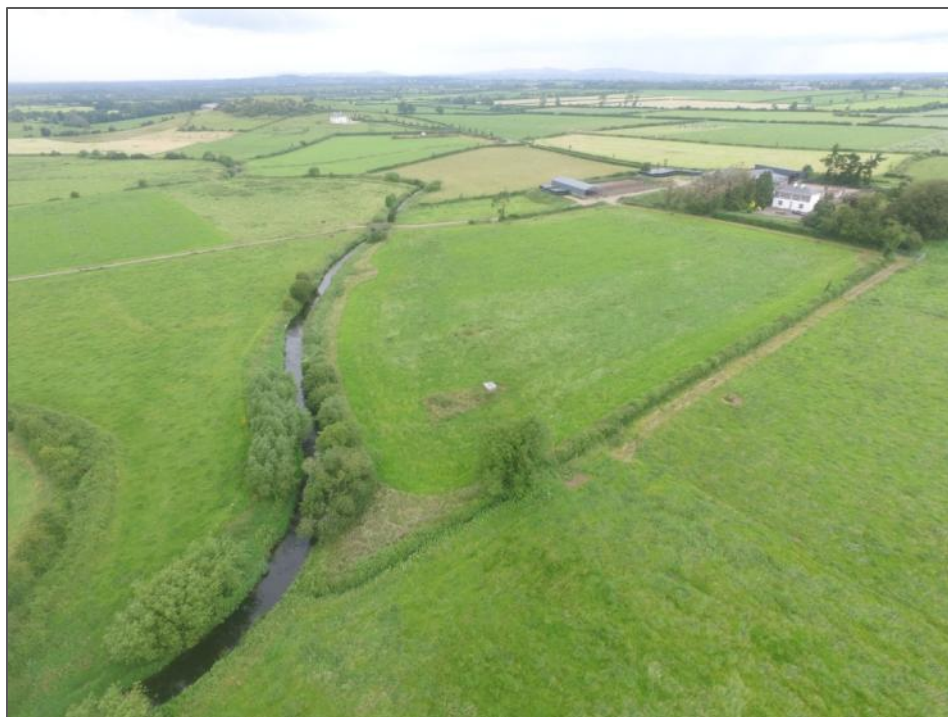
In general there was an absence of vegetation layers (generally shrub and or tree layer were missing) on one or both river banks throughout much of the catchment (Plate 5). All wooded areas recorded along the river banks are highly modified, generally comprising conifer plantation, estate / demesne planted areas, treelines, and hedgerows (Plate 6). Site MRS003 that was targeted for field survey comprised a good example of mature woodland in the catchment area, with a diverse range of tree species present. See Appendix I for more details.

Plate 5: The absence of riparian vegetation along the river channel within improved agricultural areas was a feature of much of the catchment, as seen on the Loobagh.

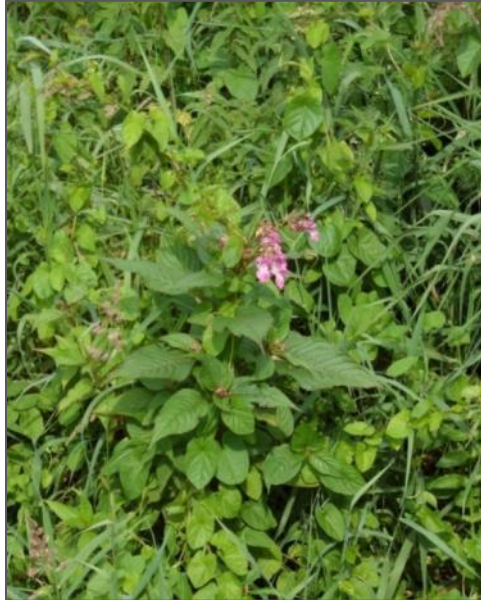
A small number of Himalayan balsam plants were recorded from a bridging point (MS03) on the Morningstar (Plate 15). There did not appear to be any other plants present immediately upstream or downstream of this location, and the plants found may be recent garden escapes. Given the potential for this species to outcompete native species along water courses, it is recommended that these plants be removed as soon as possible. The seed pods of Himalayan Balsam explode open spreading seeds up to 7m from the parent plant, making it likely that this plant will spread downstream unless it is

Plate 15: Himalayan Balsam on the banks of the Morningstar River (at sit MS03).

eradicated. Eradication is recommended to be carried out between mid-May and June (before the plant develops seed pods). As the seeds remain viable for two years it will be important to revisit this site for two years after the initial removal, to ensure that no new growth has occurred.

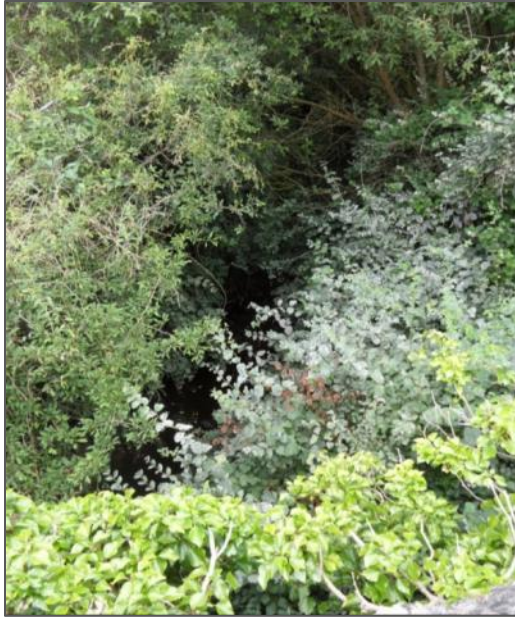
Snow Berry (*Symphoricarpos albus*), which an Amber listed invasive species according to Invasive Species Ireland, was also commonly recorded within the catchment area (Plate 16). Amber listed species are recognised as potentially representing a significant threat to native species or habitats, or potentially impacting either / or Natura 2000 sites or the goals of the WFD. Overall these species do not have a high risk rating, however, their presence still results in a loss of native biodiversity.

Plate 16: Snowberry is common in the catchment area, especially in hedgerow and scrub vegetation.

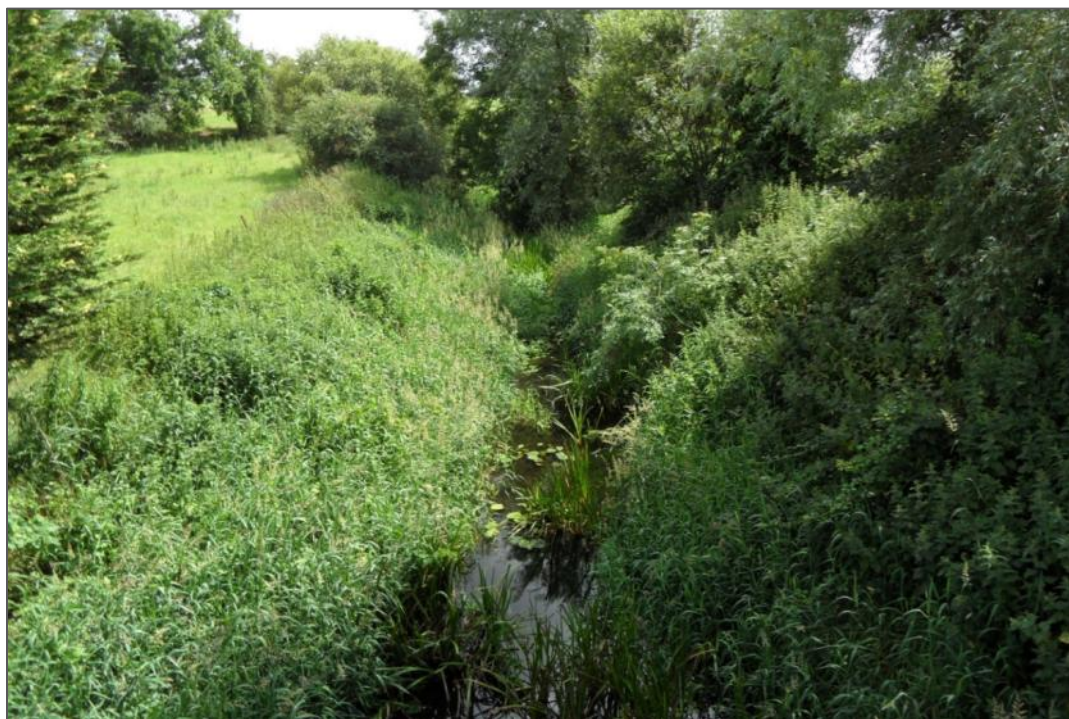
The Camoge river rises just to the south of Emly, runs through Knocklong, Knockainy, and Meanus before joining the Maigue to the south of Croom. The majority of land adjoining the river is comprised of improved agricultural grassland, with some areas of wet grassland. A number of areas that would previously have consisted of wet grassland were found to be comprised of improved agricultural grassland during the field survey. A number of highly modified wooded areas occur along the river, comprising conifer plantation and mixed broadleaved woodland. Overall there is a lack of continuous treelines and hedgerows along the river, and an absence of canopy layers as would be expected in an unaltered riparian zone.

Plate 19: Camoge River with narrow riparian zone dominated by Reed Canary Grass (*Phalaris arundinacea*) (Site Code: CM07).

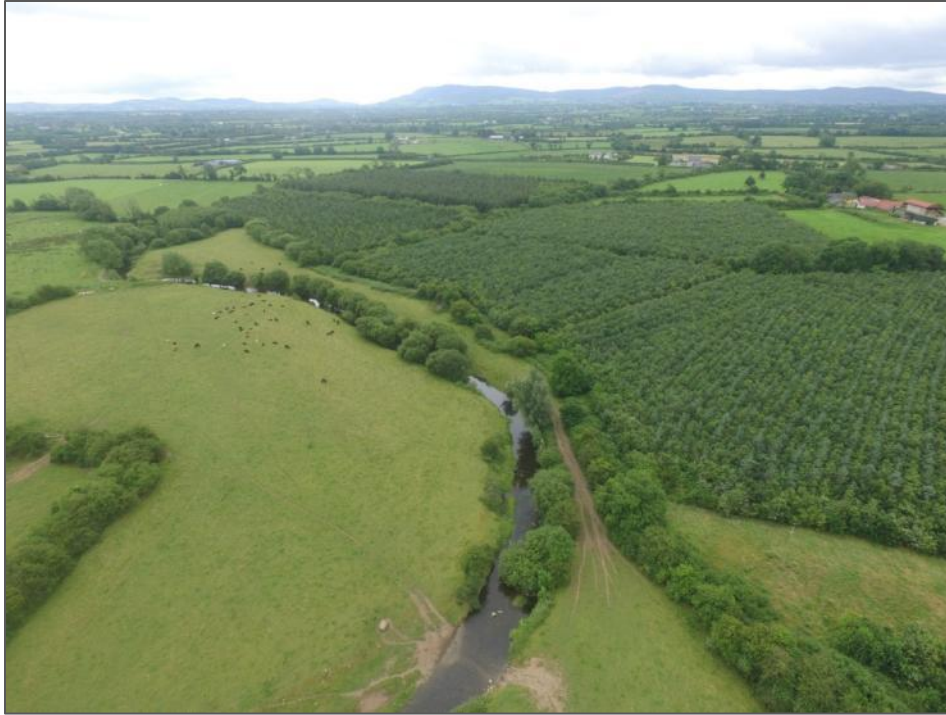
Plate 24: Conifer plantation in proximity to the Loobagh river channel. Damage to the river bank due to livestock access can also be seen in the centre foreground of the photograph.

In relation to the forested areas within the catchment, best practice guidelines should be followed, in particular where plantations adjoin or occur in proximity to watercourses (Plate 24), when planting or harvesting. An adequate buffer should be observed to reduce the impact of the forestry operations on watercourses and in some situations the use of sediment traps should be considered. Buffer zones of 10m each side of the aquatic zone are recommended by The Forest Service on moderately sloping soils, increasing to 20m on very steep soils (The Forest Service 2000).

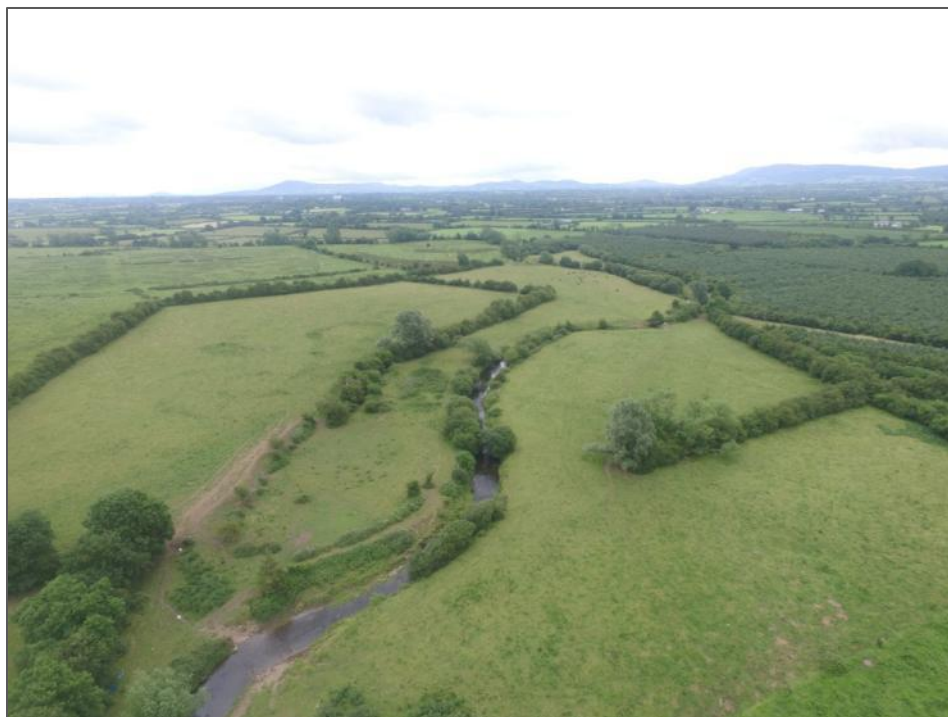
In terms of agriculture, there are a number of recommended management measures. These will require the cooperation of landowners if they are to be implemented successfully, and could potentially be facilitated through the waters and communities officer for the area. The main issues noted as a result of agriculture were (Plate 25):

- Cattle accessing rivers
- Bank side poaching
- Absence of functioning buffer zones
- Eutrophication as a result of nutrient run-off

Plate 25: Absence of functioning buffer zones with evidence of bank poaching and livestock access to Loobagh river.

It is recommended that livestock should not have access to watercourses. Fencing should be put in place where necessary to avoid animals entering the river. In addition, rivers should not be used as crossing points for livestock or farm vehicles, the creation of a livestock footbridge or use of alternative route are potential solutions. Bankside poaching is another issue that was recorded, which can lead to erosion and bank slumping. Fencing off certain areas from livestock or establishing a buffer zone would help to reduce bank damage and the amount of sediment entering watercourses.

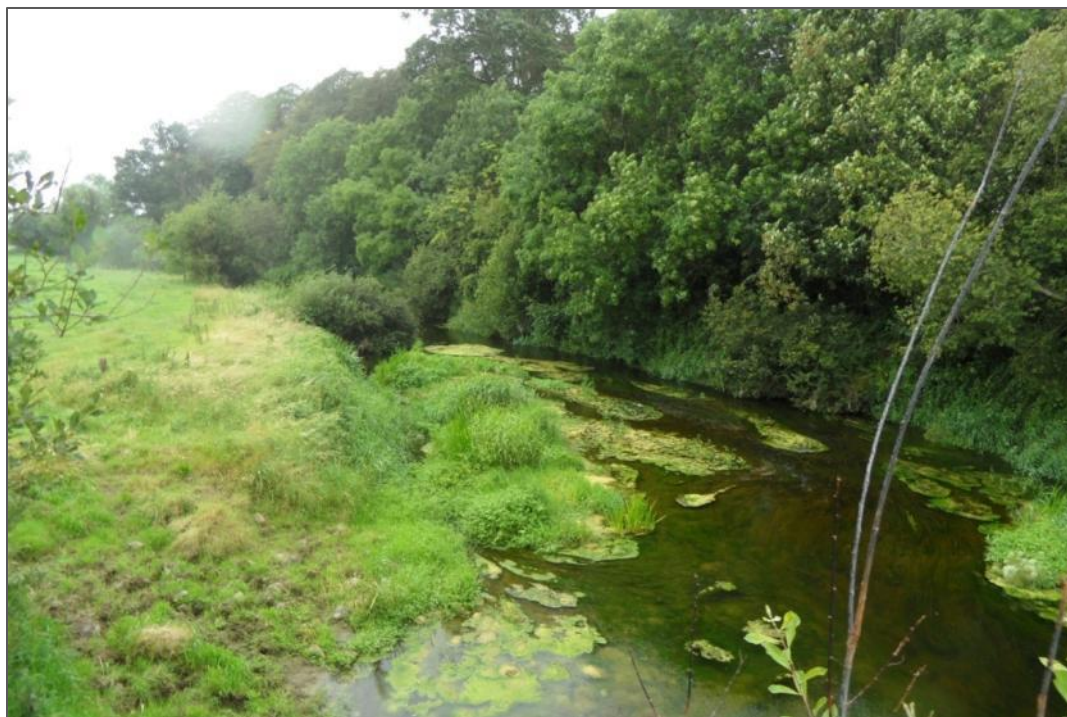
Plate 26: Cattle access to watercourse, with evidence of bank poaching and eutrophication (Site Code: CM14).

The establishment of buffer zones along river banks, in particular where the adjoining land use is improved agricultural grassland is a relatively simple measure that could greatly improve water quality within the rivers but also increase bank side biodiversity. Buffer zones can simply be created by fencing off areas along watercourses, or in some cases by establishing a hedgerow. These buffer zones would not only help to reduce any impacts of livestock on the rivers, but also help to promote bank stabilisation and reduce the amount of sediment and nutrients entering watercourses.

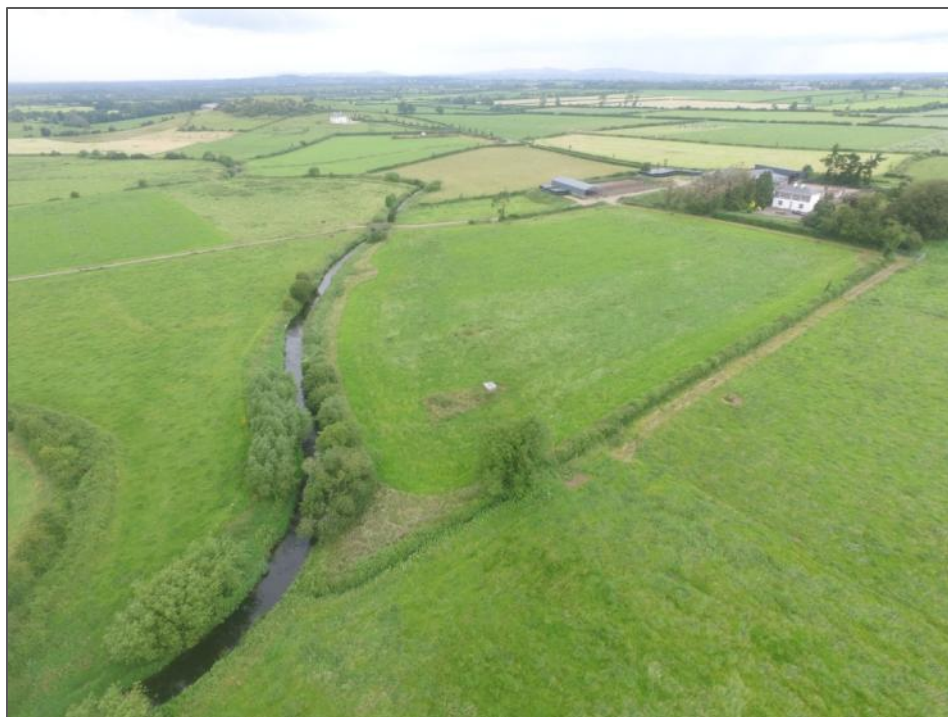
In general there was an absence of vegetation layers (generally shrub and or tree layer were missing) on one or both river banks throughout much of the catchment (Plate 5). All wooded areas recorded along the river banks are highly modified, generally comprising conifer plantation, estate / demesne planted areas, treelines, and hedgerows (Plate 6). Site MRS003 that was targeted for field survey comprised a good example of mature woodland in the catchment area, with a diverse range of tree species present. See Appendix I for more details.

Plate 5: The absence of riparian vegetation along the river channel within improved agricultural areas was a feature of much of the catchment, as seen on the Loobagh.

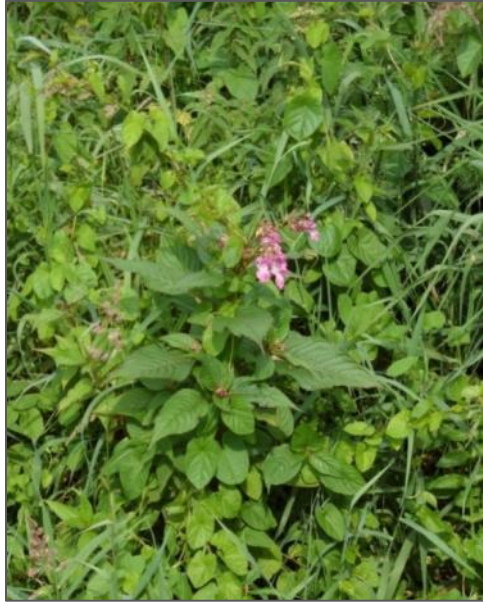
Plate 15: Himalayan Balsam on the banks of the Morningstar River (at sit MS03).

eradicated. Eradication is recommended to be carried out between mid-May and June (before the plant develops seed pods). As the seeds remain viable for two years it will be important to revisit this site for two years after the initial removal, to ensure that no new growth has occurred.

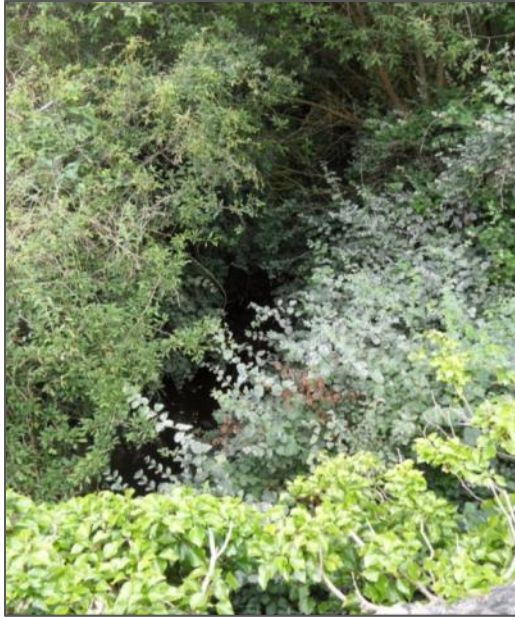
Snow Berry (*Symphoricarpos albus*), which an Amber listed invasive species according to Invasive Species Ireland, was also commonly recorded within the catchment area (Plate 16). Amber listed species are recognised as potentially representing a significant threat to native species or habitats, or potentially impacting either / or Natura 2000 sites or the goals of the WFD. Overall these species do not have a high risk rating, however, their presence still results in a loss of native biodiversity.

Plate 16: Snowberry is common in the catchment area, especially in hedgerow and scrub vegetation.

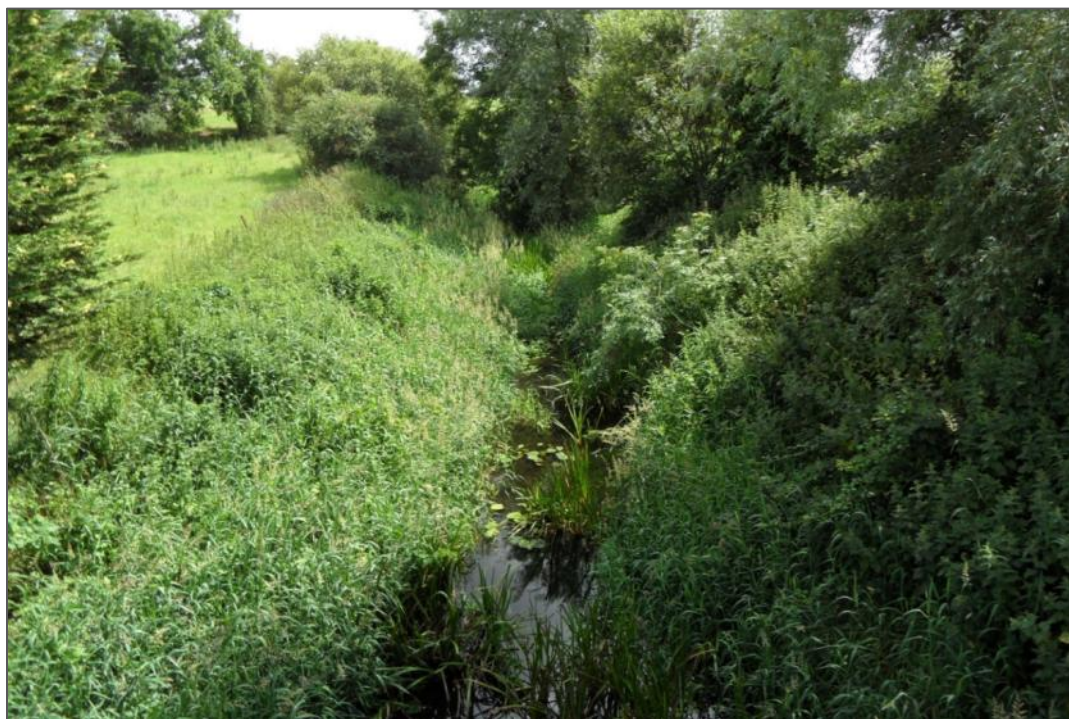
The Camoge river rises just to the south of Emly, runs through Knocklong, Knockainy, and Meanus before joining the Maigue to the south of Croom. The majority of land adjoining the river is comprised of improved agricultural grassland, with some areas of wet grassland. A number of areas that would previously have consisted of wet grassland were found to be comprised of improved agricultural grassland during the field survey. A number of highly modified wooded areas occur along the river, comprising conifer plantation and mixed broadleaved woodland. Overall there is a lack of continuous treelines and hedgerows along the river, and an absence of canopy layers as would be expected in an unaltered riparian zone.

Plate 19: Camoge River with narrow riparian zone dominated by Reed Canary Grass (*Phalaris arundinacea*) (Site Code: CM07).

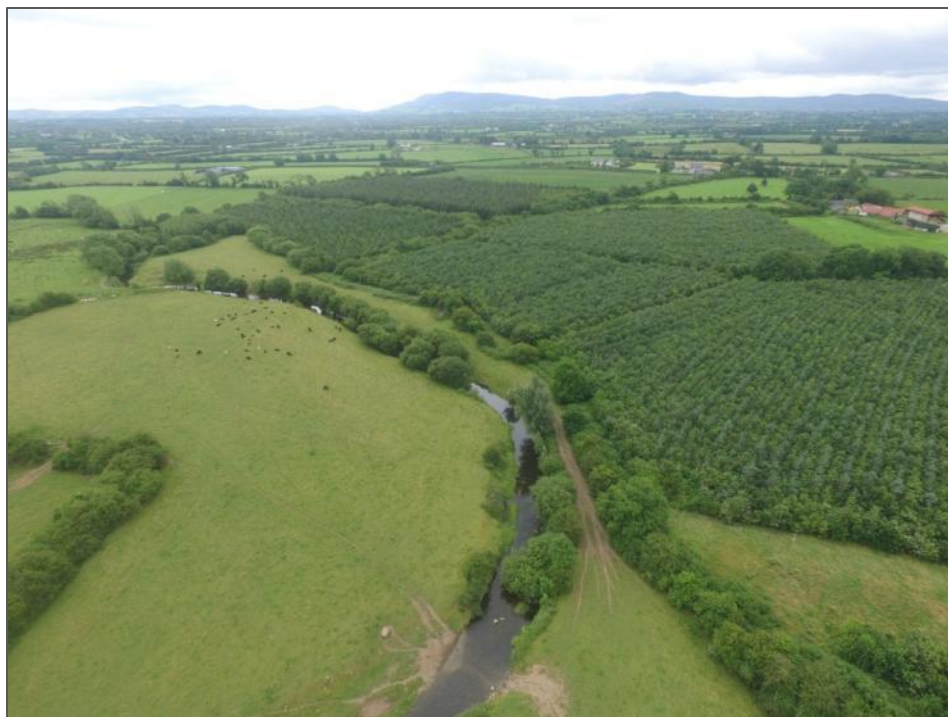
Plate 24: Conifer plantation in proximity to the Loobagh river channel. Damage to the river bank due to livestock access can also be seen in the centre foreground of the photograph.

In relation to the forested areas within the catchment, best practice guidelines should be followed, in particular where plantations adjoin or occur in proximity to watercourses (Plate 24), when planting or harvesting. An adequate buffer should be observed to reduce the impact of the forestry operations on watercourses and in some situations the use of sediment traps should be considered. Buffer zones of 10m each side of the aquatic zone are recommended by The Forest Service on moderately sloping soils, increasing to 20m on very steep soils (The Forest Service 2000).

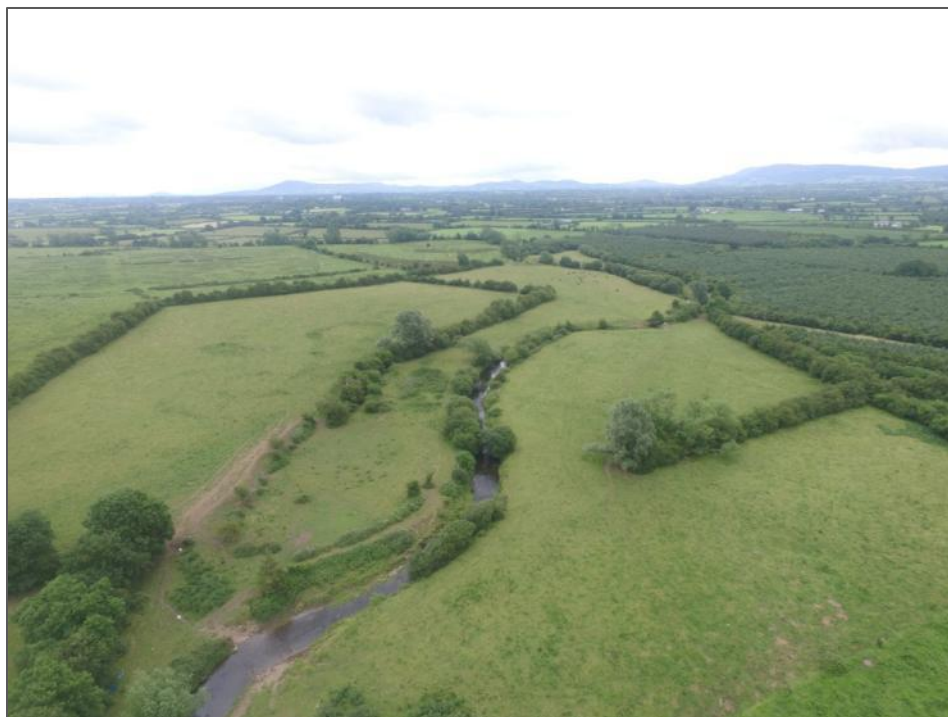
- Cattle accessing rivers
- Bank side poaching
- Absence of functioning buffer zones
- Eutrophication as a result of nutrient run-off

Plate 25: Absence of functioning buffer zones with evidence of bank poaching and livestock access to Loobagh river.

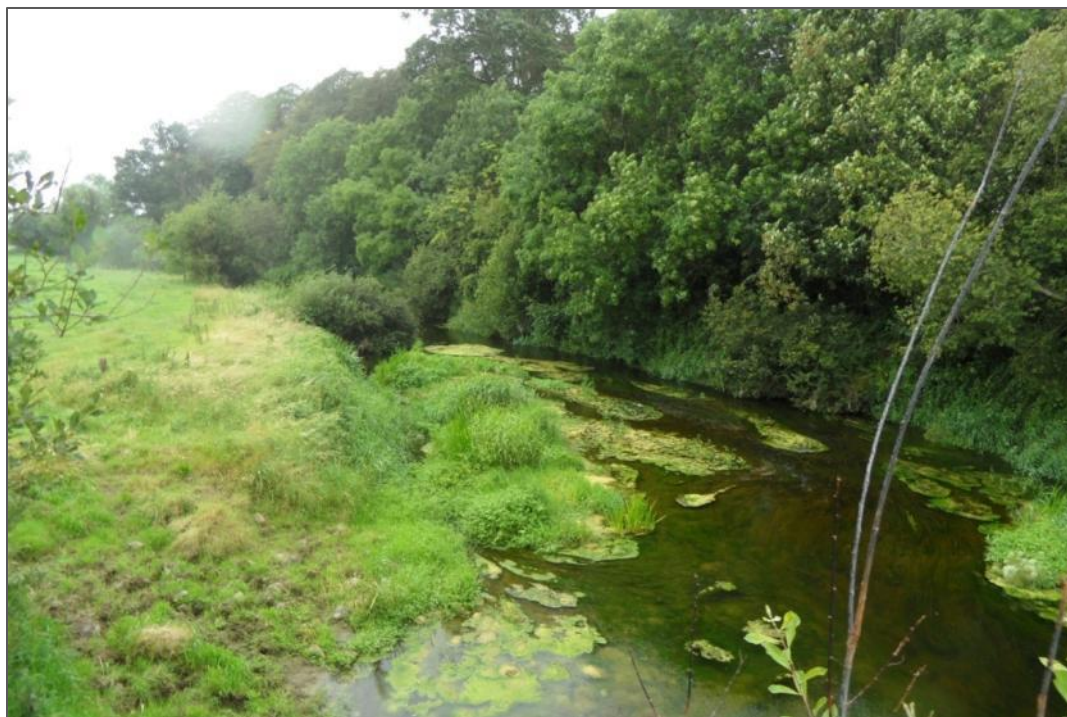
Plate 26: Cattle access to watercourse, with evidence of bank poaching and eutrophication (Site Code: CM14).

The establishment of buffer zones along river banks, in particular where the adjoining land use is improved agricultural grassland is a relatively simple measure that could greatly improve water quality within the rivers but also increase bank side biodiversity. Buffer zones can simply be created by fencing off areas along watercourses, or in some cases by establishing a hedgerow. These buffer zones would not only help to reduce any impacts of livestock on the rivers, but also help to promote bank stabilisation and reduce the amount of sediment and nutrients entering watercourses.
