Assessment of Habitat Quality and Future Directions for Enhancement of the River Drumcomoge

Compiled by the Maigne Rivers Trust 2019

The Drumcomogue sub-catchment, Co. Limerick

DRUMCOMOGE SUB-CATCHMENT AQUATIC HABITAT ASSESSMENT

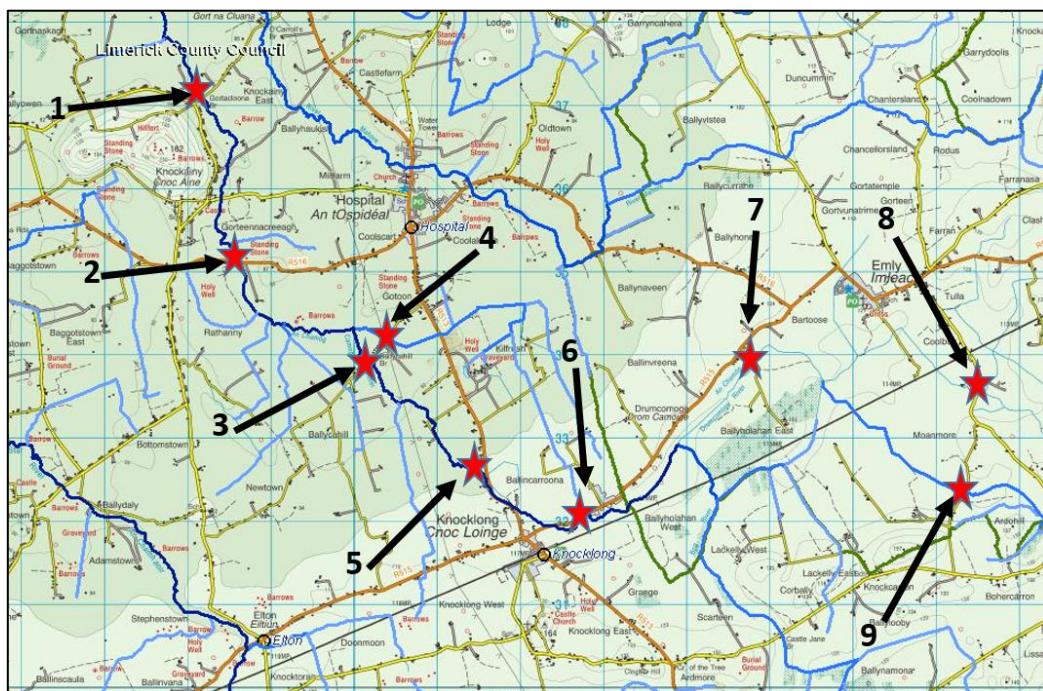
Fig. 1. Sites on the Drumcomoge kick-sampled in September 2019.

Of the nine sites selected only four sites were suitable for kick sampling. The other five could not be sampled due to depth of water, or excessive growth of in-stream vegetation (aquatic macrophytes). The macroinvertebrate profiles of the sites are given in **Appendix 2**. Q values and SSR Scores are given in **Table 1**. Three sites, Gortacloona, Ballycahill and d/s Knocklong had moderate water quality (Q3-4) and one site, just u/s of Knocklong WWTP had poor quality (Q3). Gortacloona, Ballycahill and u/s Knocklong WWTP had SSR scores < 7 and were deemed “At Risk”, while d/s of Knocklong was borderline and deemed “Probably at Risk”.

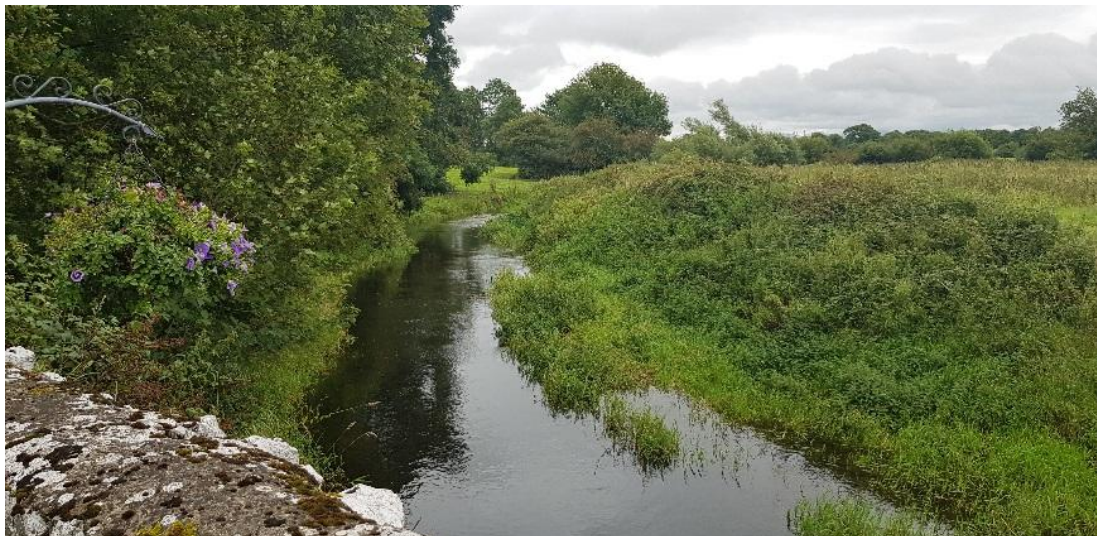
Site 1. Gortnacloona Bridge. The invertebrate community at site 1 gave an SSRS score of **4** (At Risk) and a Q-rating of **3-4** (Moderate). The river was sampled at a riffle approximately 100m upstream of the bridge.

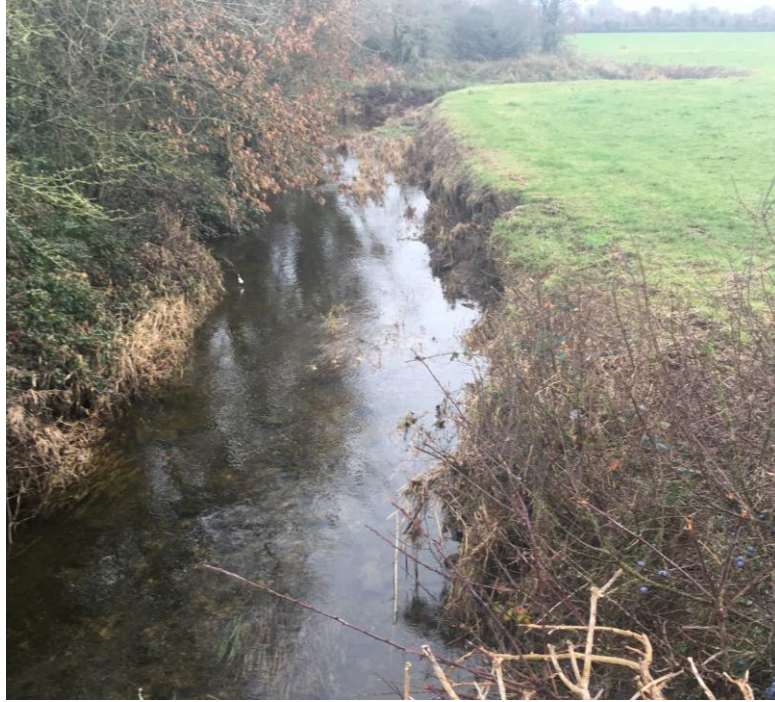
Site 3 Ballycahill Bridge. The invertebrate community at Site 3 gave an SSRS score of 5.6 (At Risk) and a Q-rating of 3-4 (Moderate).

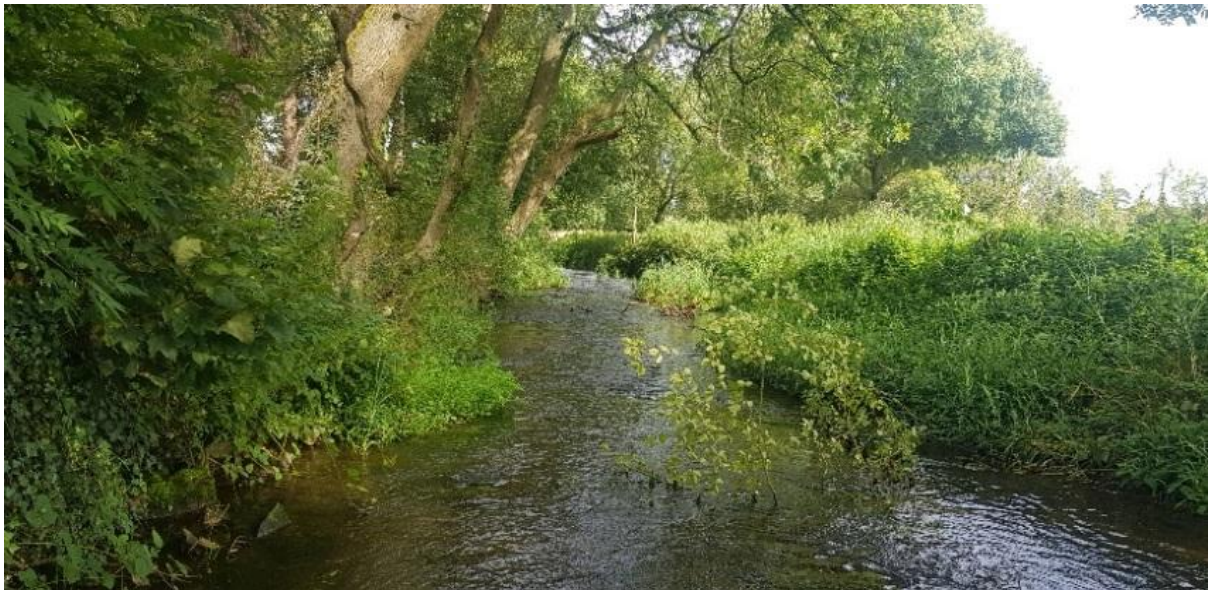
Site 5 Downstream of Knocklong .The invertebrate community at Site 4 gave an SSRS score of 7.2 (Stream Maybe At Risk) and a Q-rating of 3-4 (Moderate).

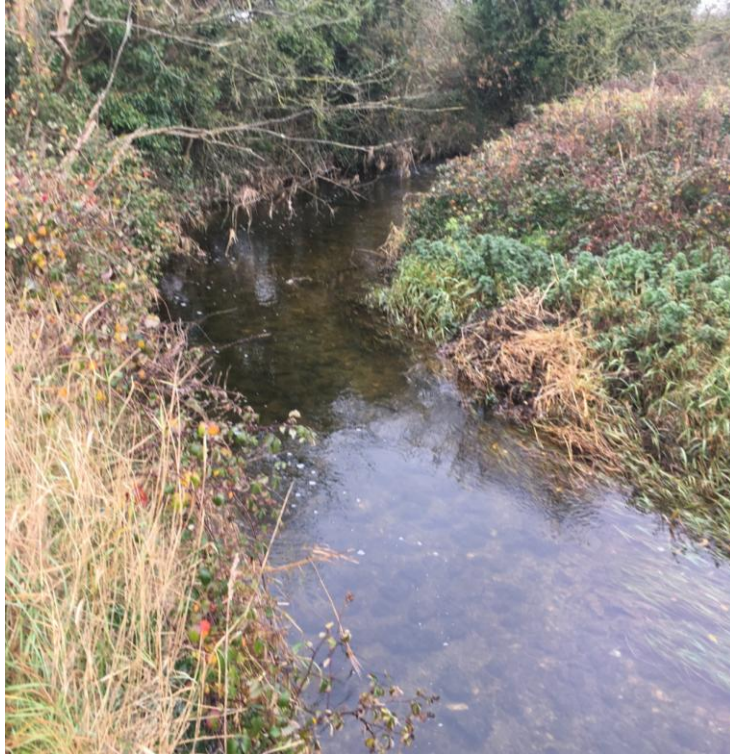
Site 6 Upstream of Knocklong WWTP. The invertebrate community at Site 6 gave an SSRS score of 4 (“At Risk”) and a Q-rating of 3 (Poor)

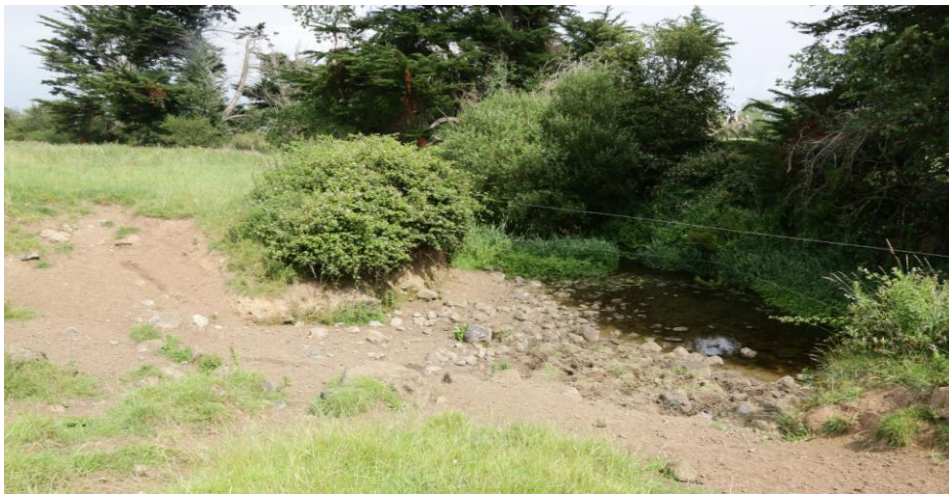
The river channels of the Dromcomoge sub-catchment (**Tables 2 and 3, Appendix 2**) at all the survey sites visited have been modified/subject to arterial drainage. The majority of the survey sites in the watercourses had a low gradient. Only five sites had medium gradient and there were no high gradient areas among the 30 sites. Twenty-three of the survey sites were moderately silted, 6 had heavy siltation and one (Site 16) had normal siltation levels (**Table 3, Appendix 2**). Livestock access to the river is common throughout the sub-catchment which lead to siltation and nutrient enrichment (**Fig. 3**)

Fig. 3. Livestock access point on the Drumcomoge R.

Improvements in water quality from Moderate to Good Status throughout the sub-catchment would enhance the potential of this stretch of the Drumcomoge for salmonid production. Such improvement is contingent on the success of measures being implemented in the Drumcomoge Priority Action areas as part of the River Basin Management Plan 2018-2012 and in future cycles of this plan. However, such measures may not include specific measures to improve salmonid habitat and biodiversity in general. These specific measures could include restoration of riparian habitat, and buffer zones, instream works to increase water flow and create pools, fencing to reduce livestock access (along with provisions of water sources for livestock), tree planting or removal where shading is excessive, specific measures to reduce erosion, siltation and run-off.

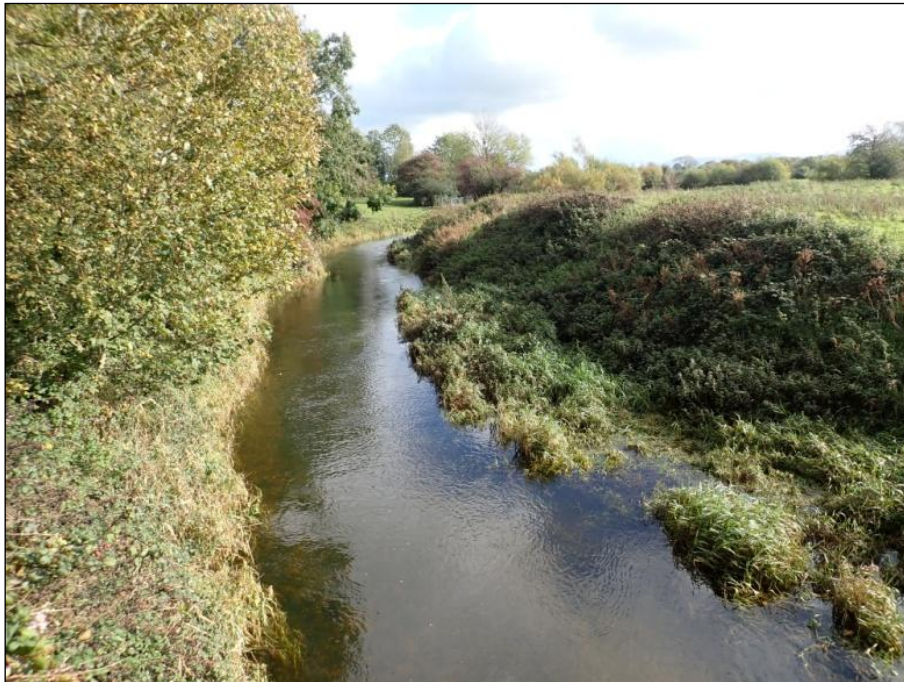
The stretch of the River Drumcamoge downstream of Site 1 is deep and sluggish but this is the least modified stretch and has a well-developed riparian zone. The upper reaches of the river and the tributaries are however all very modified and degraded.

Plate 1 Site 1 is located downstream of Knockainey and is the lowest survey site on the main channel of the Drumcomoge River.

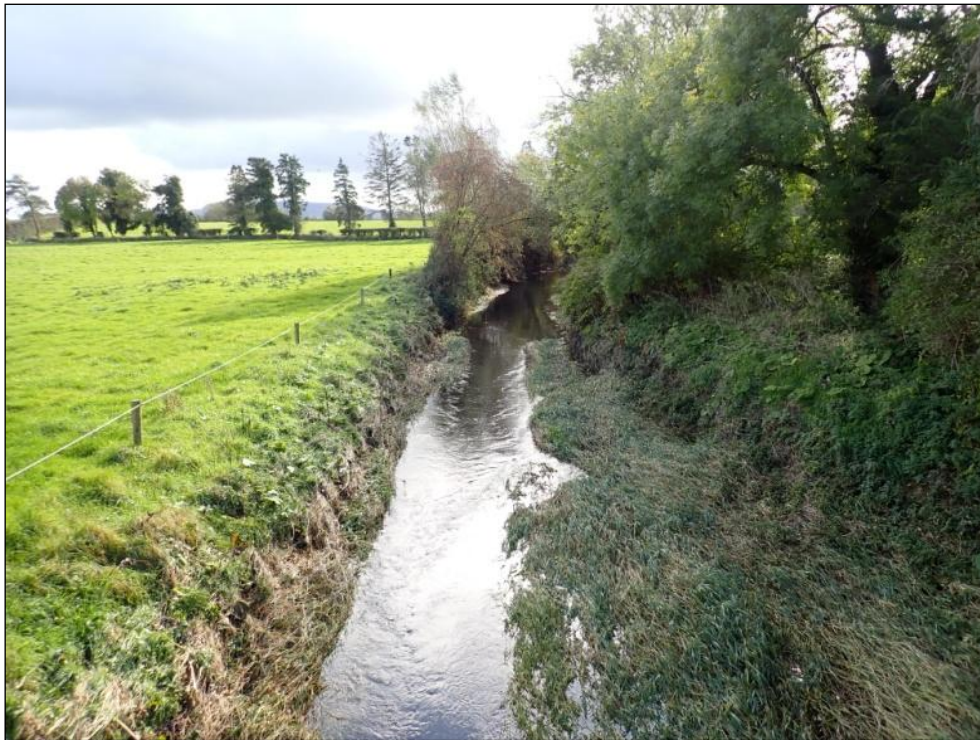
Plate 3 Channelised Drumcomoge channel at Site 3.

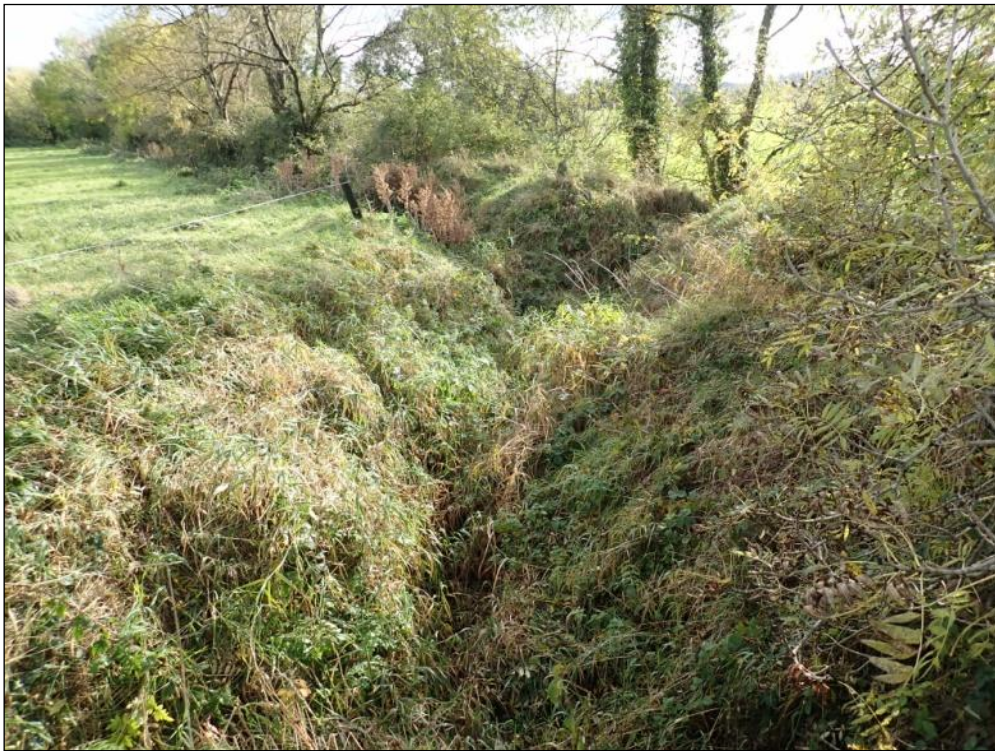
Plate 14 Little/no flow at Site 12 near the source on the main Drumcomoge River.

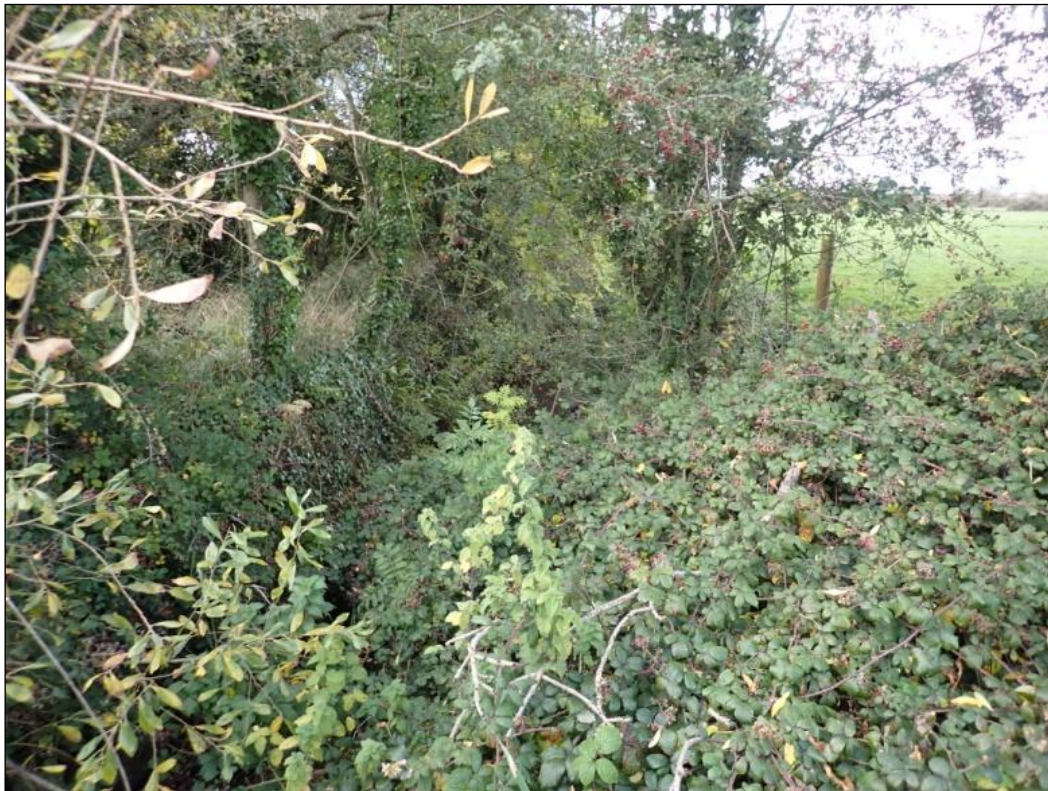
Plate 16 The watercourse of the Knocklong Tributary at Site 14 is hidden by heavy overgrowth of overhanging vegetation.

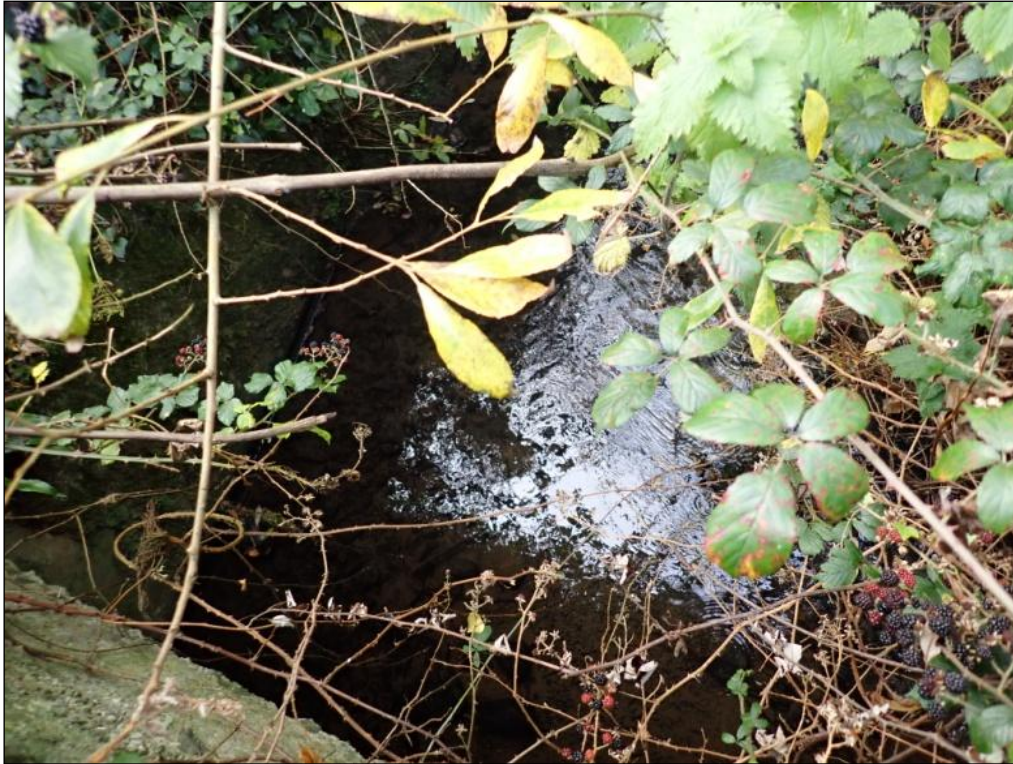
Plate 17 Watercourse at Site 14 on the Knocklong Tributary is hidden by heavy growth of briars.

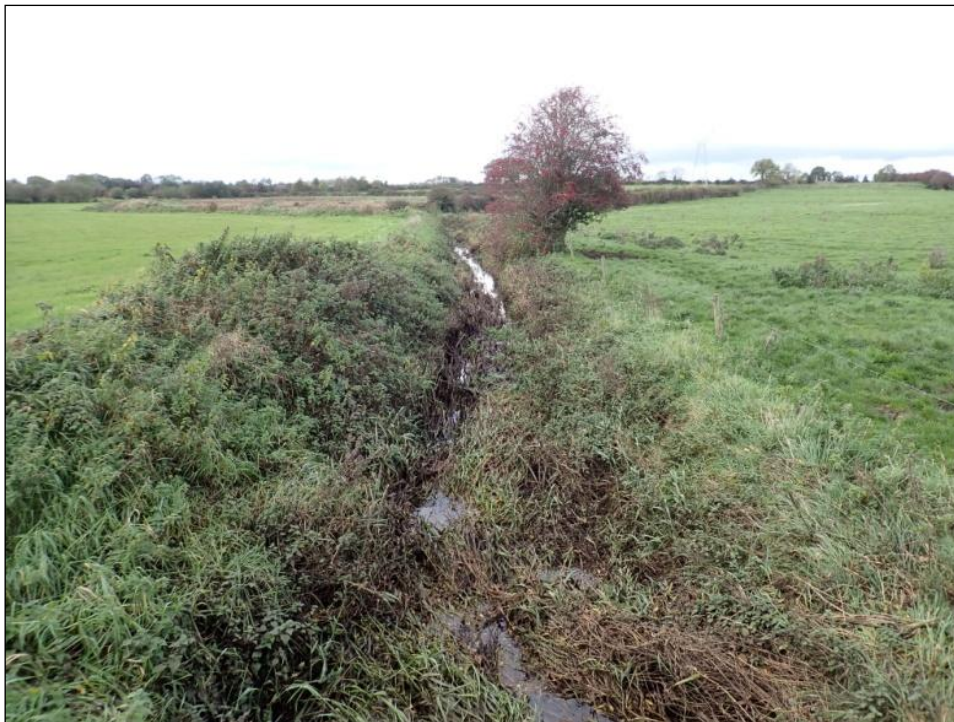
Plate 18 Watercourse is heavily encroached with instream vegetation at Site 15 on an unnamed tributary of the Drumcomoge.

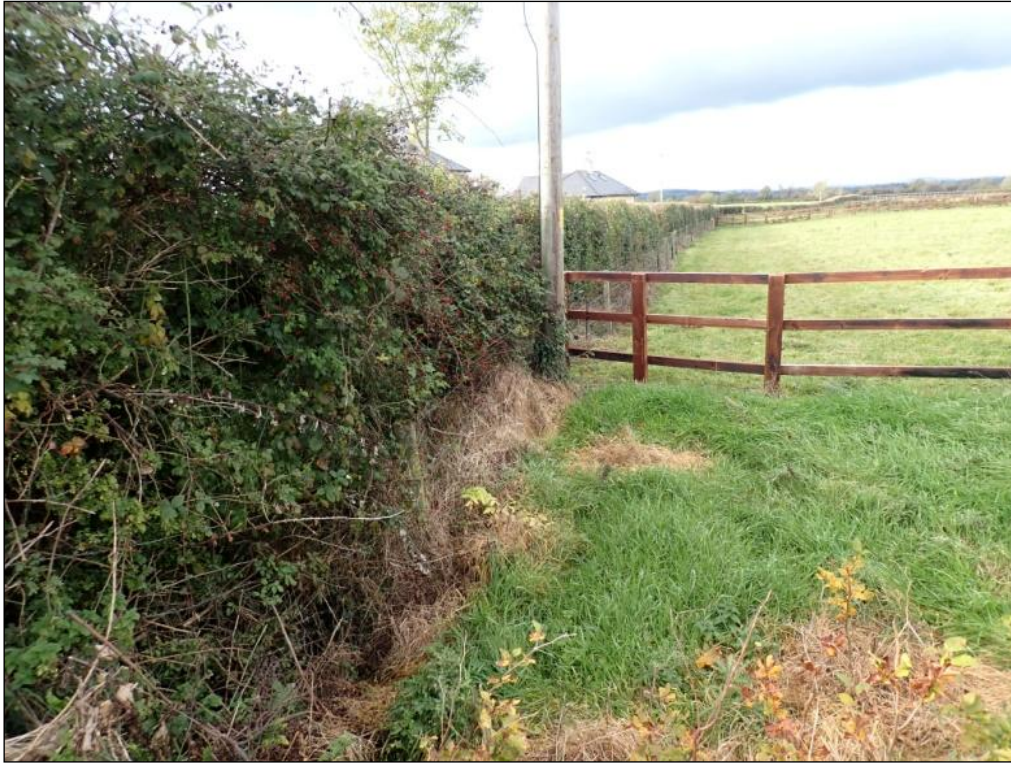
Plate 23 The Knocklong_West tributary is hidden with hedgerow at the perimeter of residential property at Site 20.

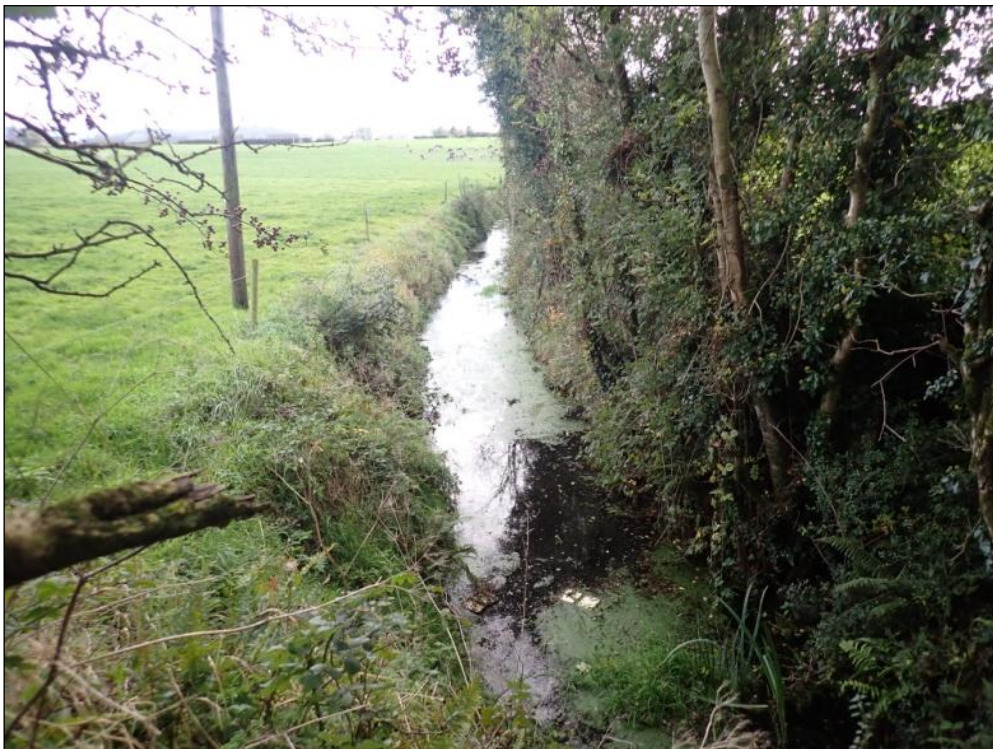
Plate 24 River flows through agricultural farmlands and algal blooms are present at Site 21 on the Lackelly East Sub-tributary.

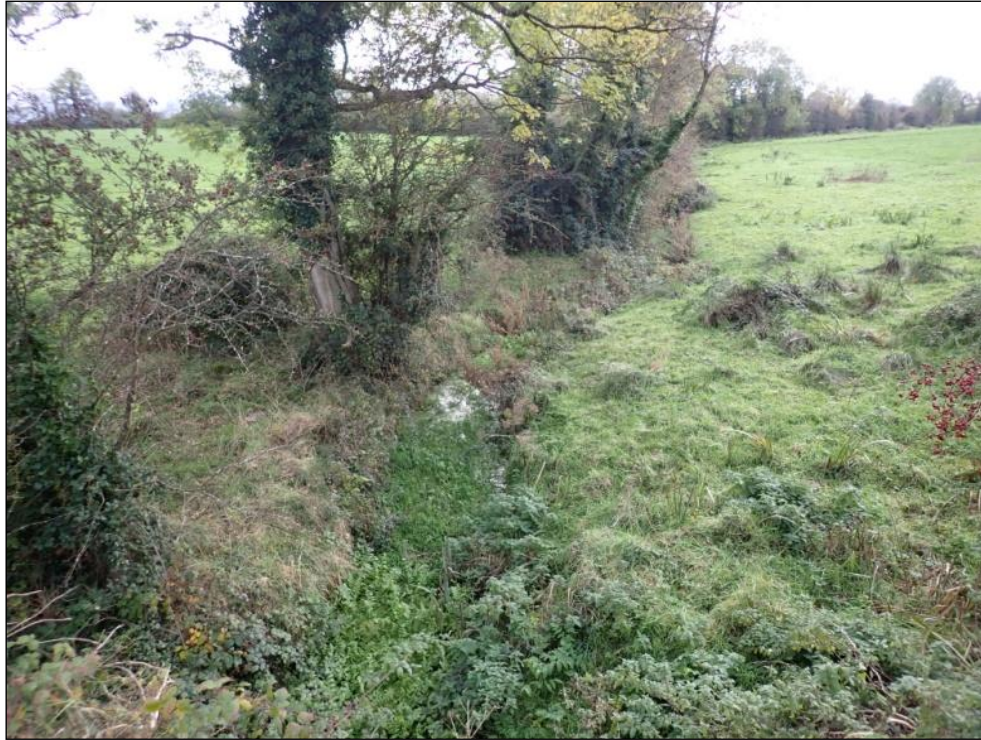
Plate 25 Heavy vegetation overgrowth encroaching on the watercourse at Site 22, upstream of Site 21 on the Lackelly East Stream.

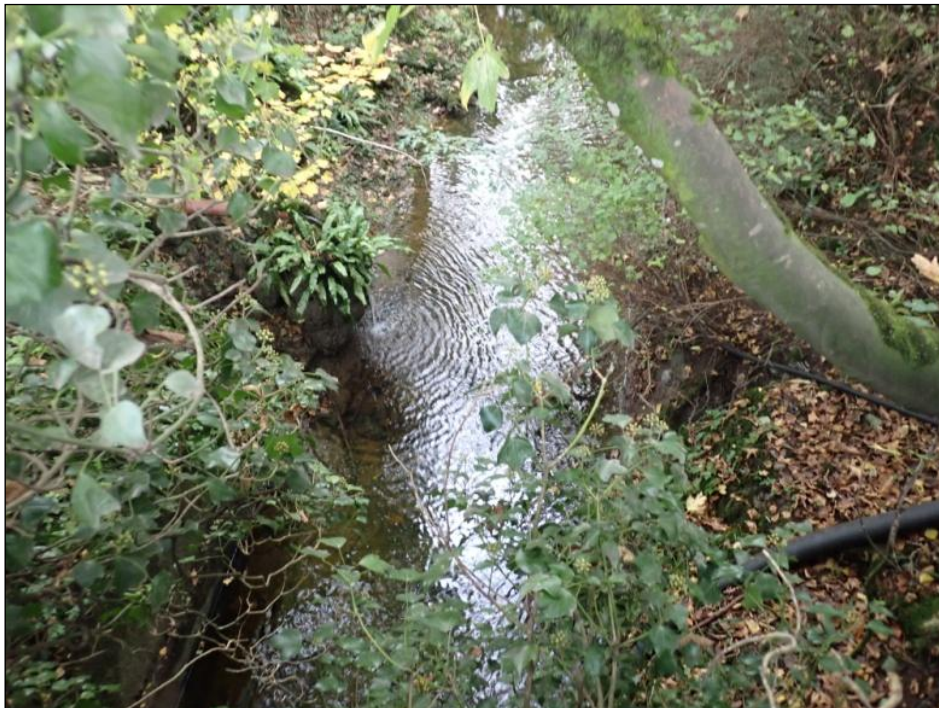
Plate 26 The West Ballyholohan Stream is surrounded by heavy overhanging vegetation at Site 23.

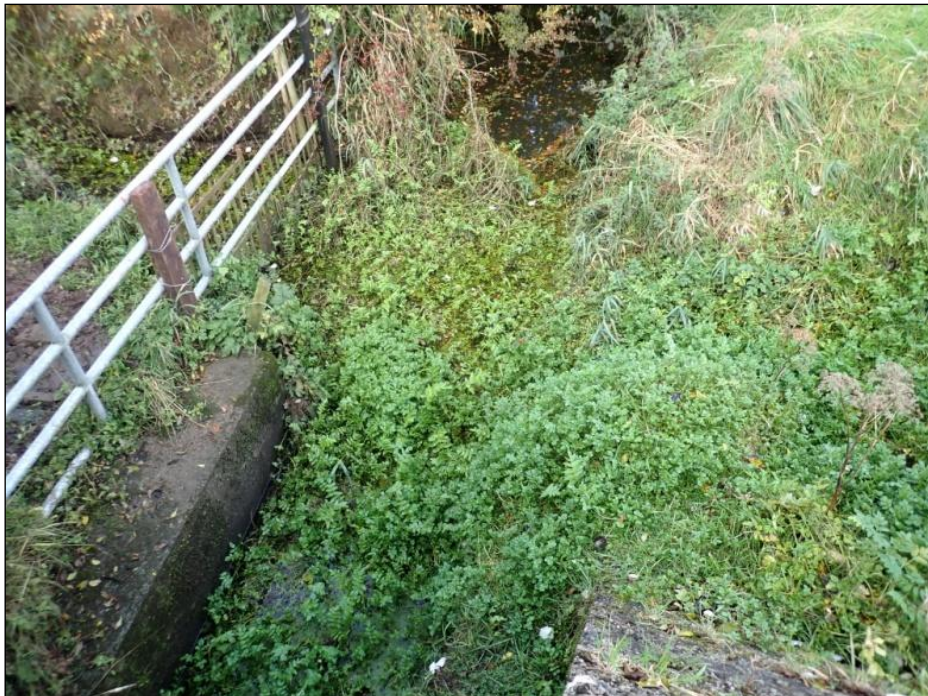
Plate 28 Heavy vegetation mass covering the watercourse at Site 25 on the Eml 24 Tributary.

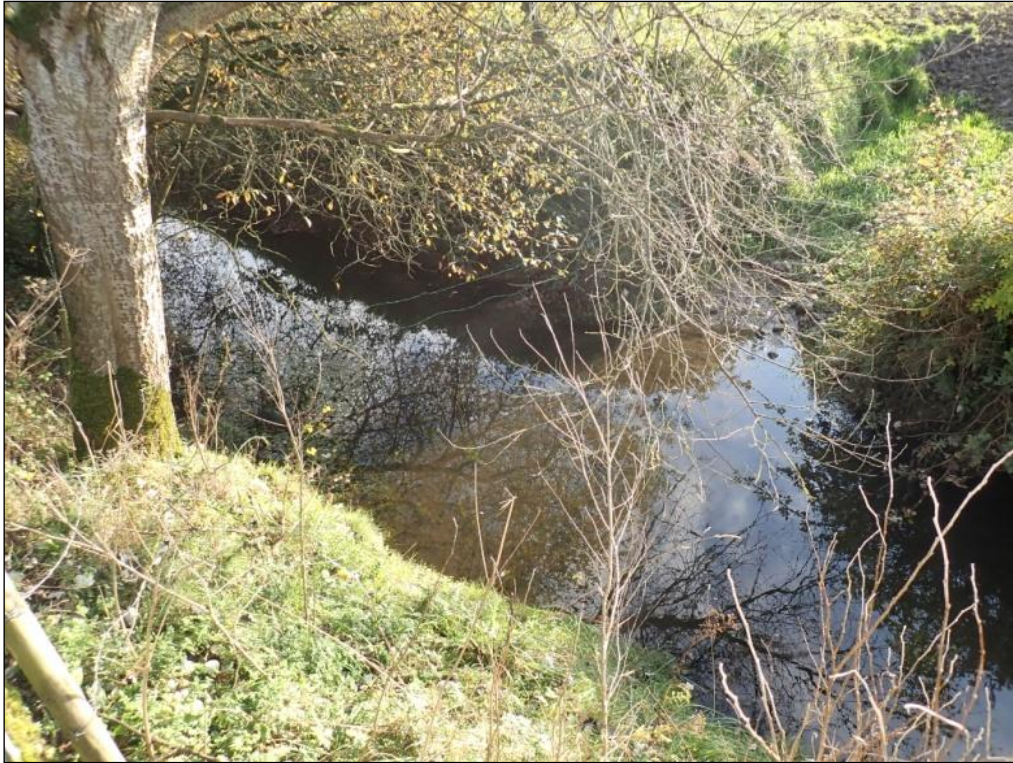
Plate 29 Livestock river access to the Emly 24 watercourse at Site 25.

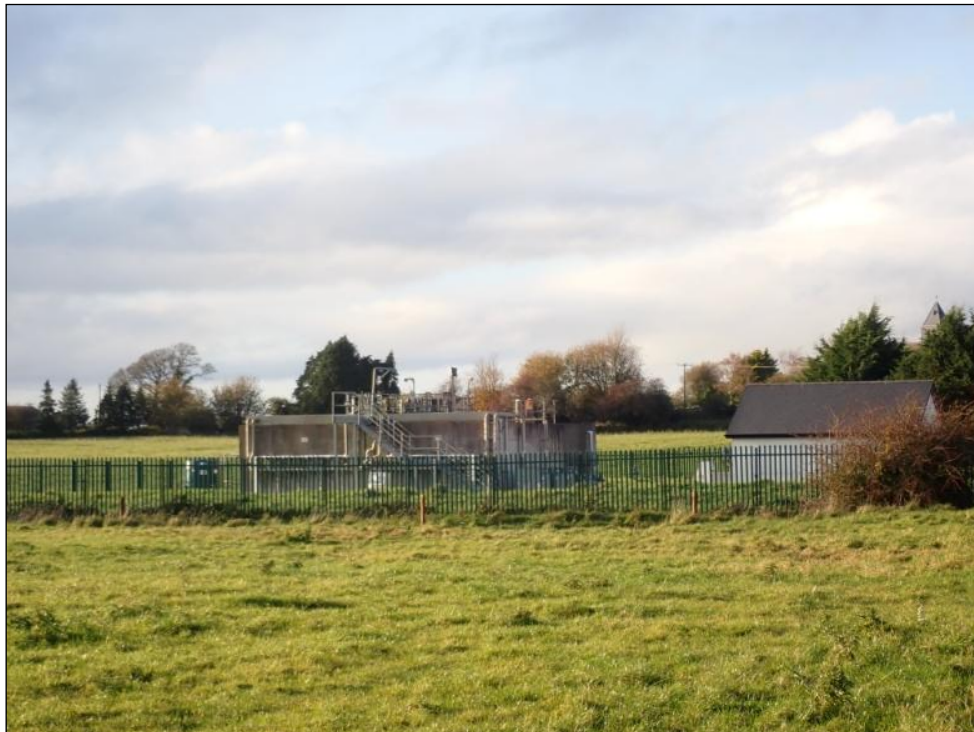
Plate 30 Emly Wastewater Treatment Facility which discharges into the Emly 24 near Site 26.

There are no Annual Environmental Reports (AERs) in the EPA files for the Knocklong and Emly WWTPs. The last entries in the WWDA file are from 2011. Irish Water will be asked to provide updated information on the performance and monitoring of these plants. Monthly chemical and biological monitoring are required upstream and downstream of these discharges and waste assimilation capacity assessments needs to be completed.

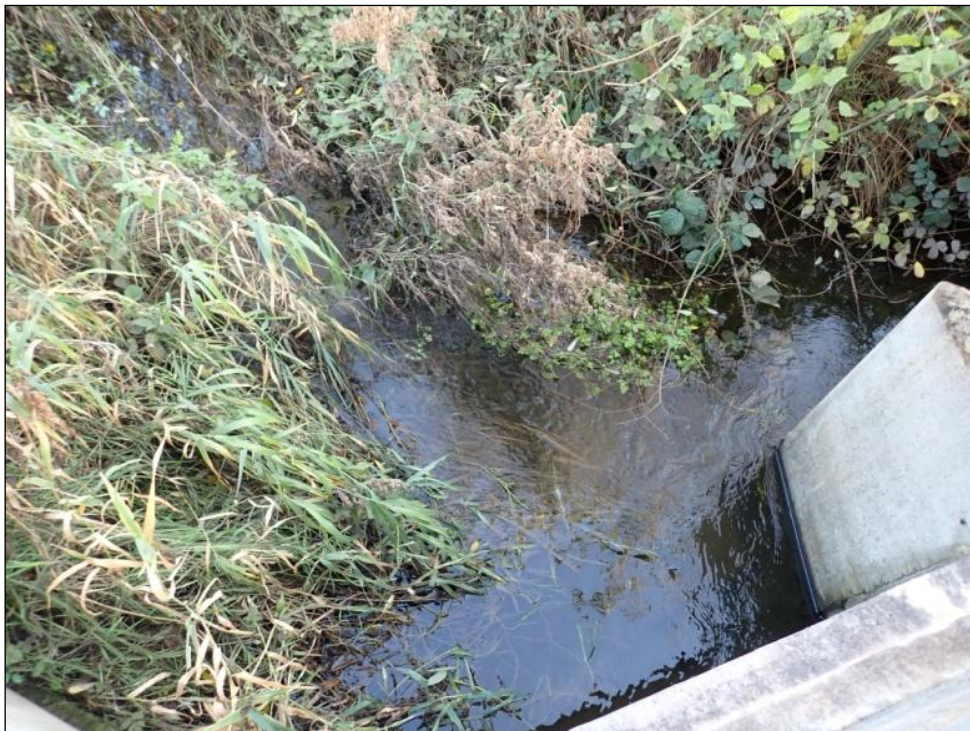
Plate 32 Water silted in the Emly 24 Tributary at Site 27 and encroached by vegetation from the banks.

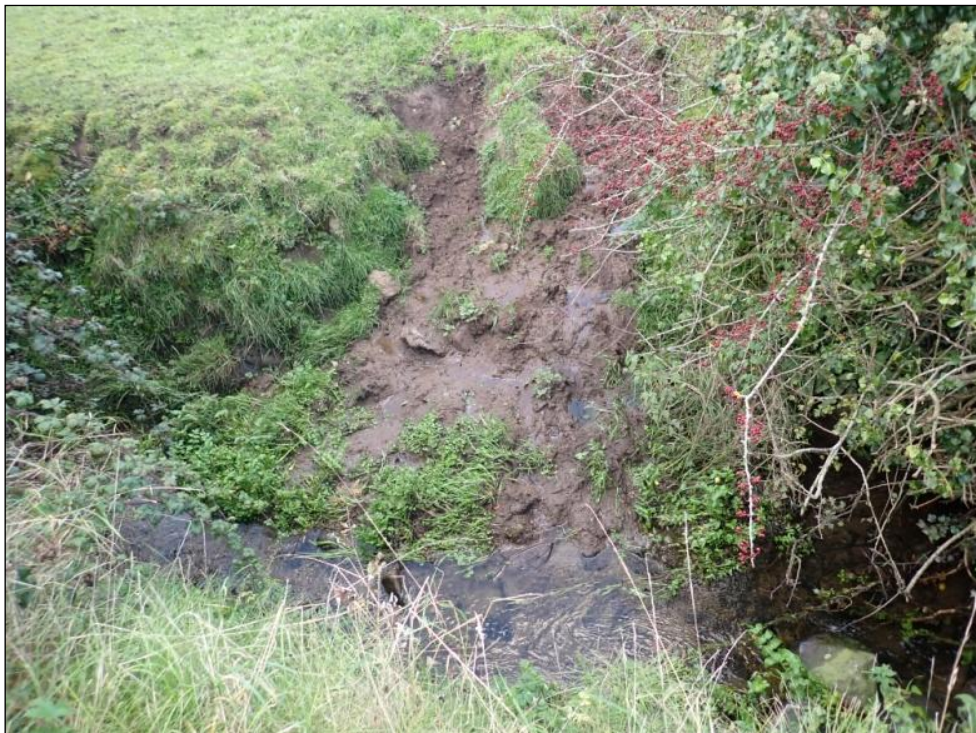
Plate 34 Livestock river access at Site 29 on the Lissobihane Stream.

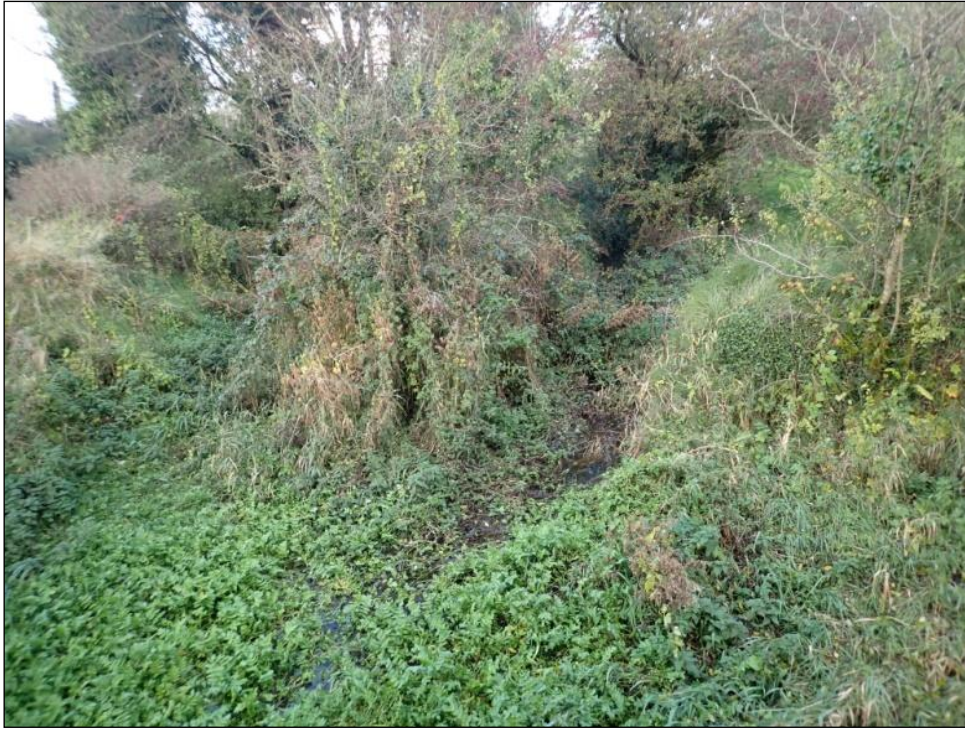
Plate 35 Thick mass of vegetation smothers watercourse at Site 30 in the upper reaches of the Emly 24 Stream.
