# Assessment of Habitat Quality and Future Directions for Enhancement of the River Drumcomoge

**The Drumcomoge sub-catchment, Co. Limerick**

# DRUMCOMOGE SUB-CATCHMENT AQUATIC HABITAT ASSESSMENT

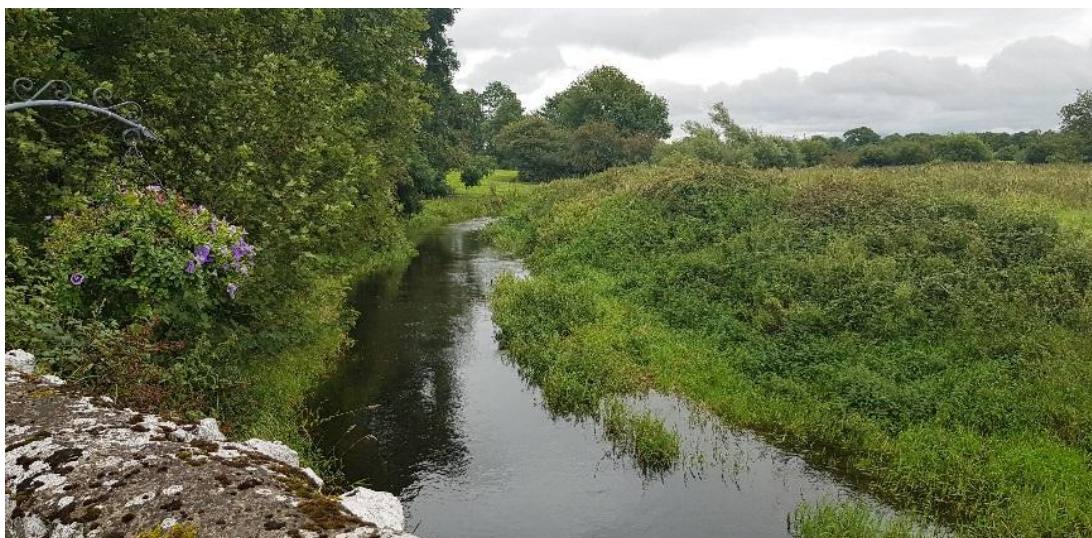
**Site 1. Gortnacloona Bridge.** The invertebrate community at site 1 gave an SSRS score of **4** (At Risk) and a Q-rating of **3-4** (Moderate). The river was sampled at a riffle approximately 100m upstream of the bridge.

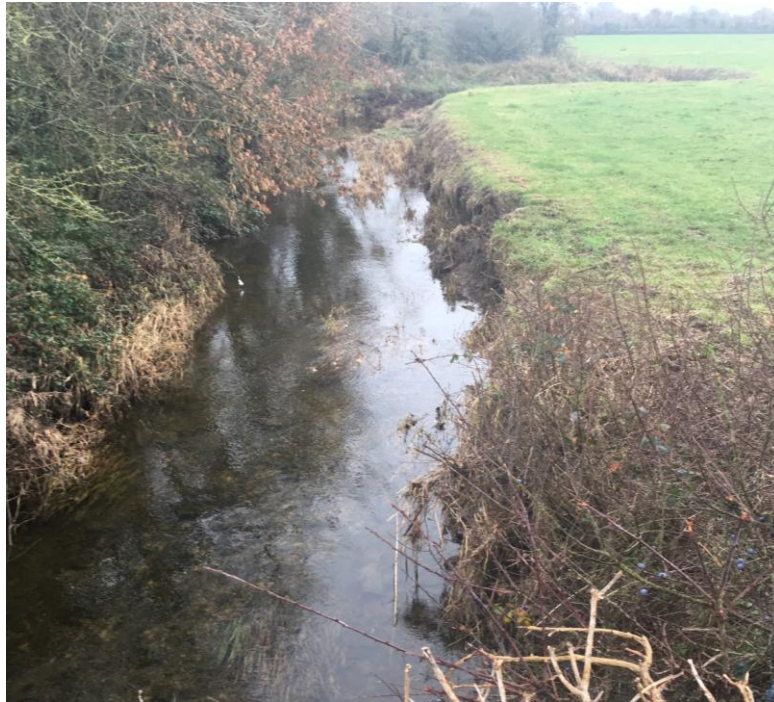
**Site 3 Ballycahill Bridge.** The invertebrate community at Site 3 gave an SSRS score of 5.6 (At Risk) and a Q-rating of 3-4 (Moderate).

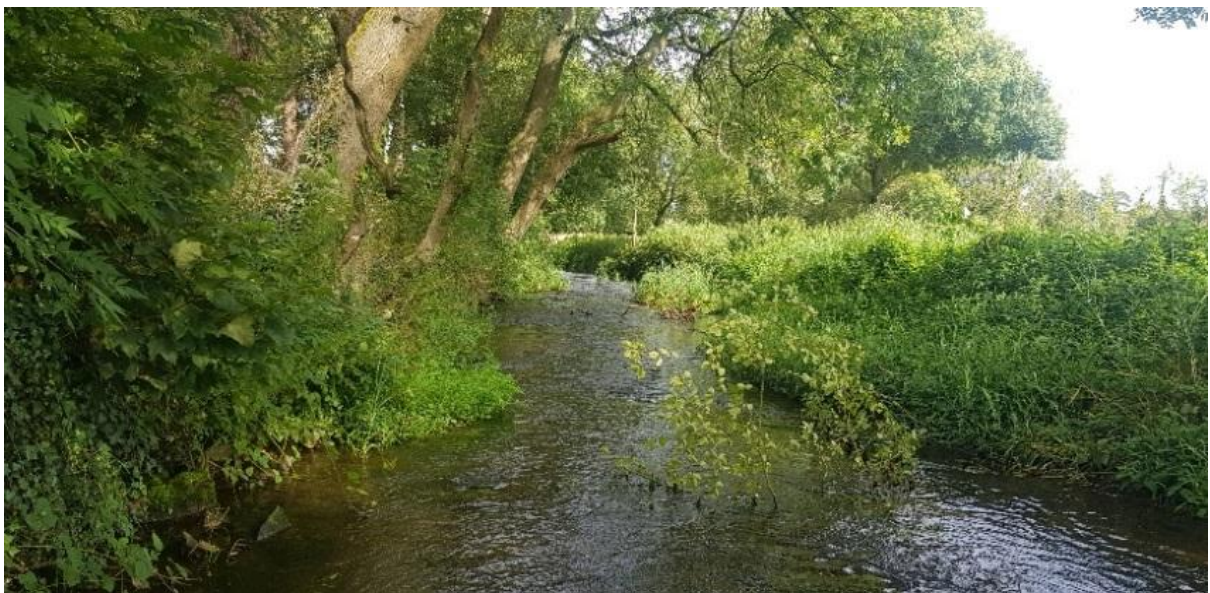
**Site 5 Downstream of Knocklong .**The invertebrate community at Site 4 gave an SSRS score of 7.2 (Stream Maybe At Risk) and a Q-rating of 3-4 (Moderate).

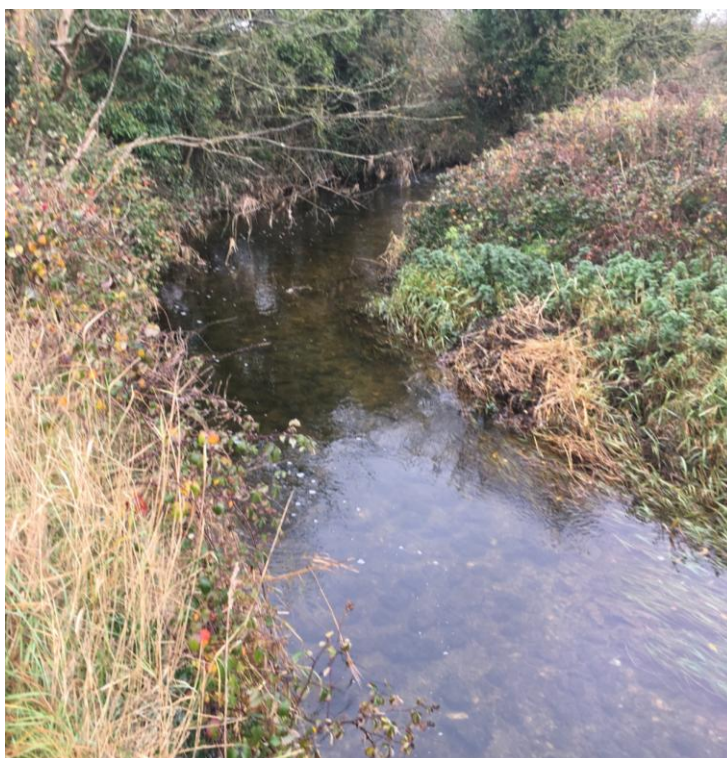
**Site 6 Upstream of Knocklong WWTP.** The invertebrate community at Site 6 gave an SSRS score of 4 (“At Risk”) and a Q-rating of 3 (Poor)

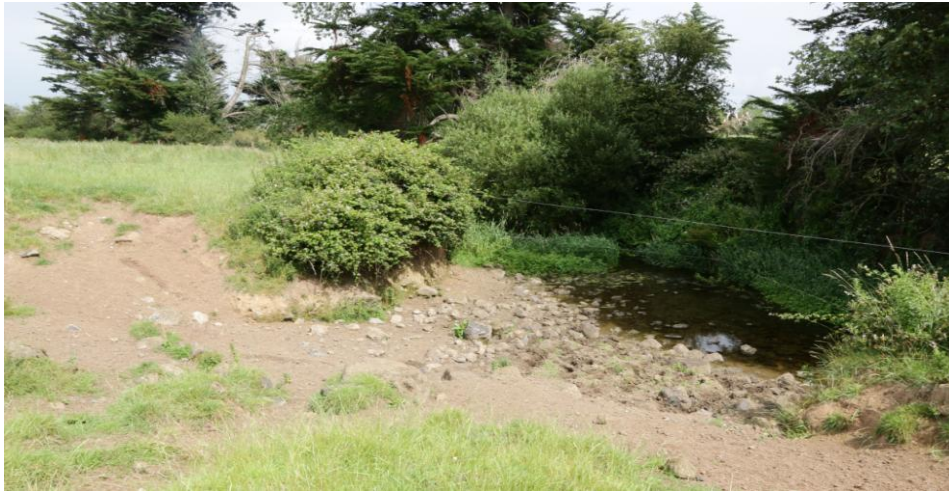
The river channels of the Dromcomoge sub-catchment (**Tables 2 and 3, Appendix 2**) at all the survey sites visited have been modified/subject to arterial drainage. The majority of the survey sites in the watercourses had a low gradient. Only five sites had medium gradient and there were no high gradient areas among the 30 sites. Twenty-three of the survey sites were moderately silted, 6 had heavy siltation and one (Site 16) had normal siltation levels (**Table 3, Appendix 2**). Livestock access to the river is common throughout the sub-catchment, which leads to siltation and nutrient enrichment (**Fig. 3**)

**Fig. 3.** Livestock access point on the Drumcomoge R.

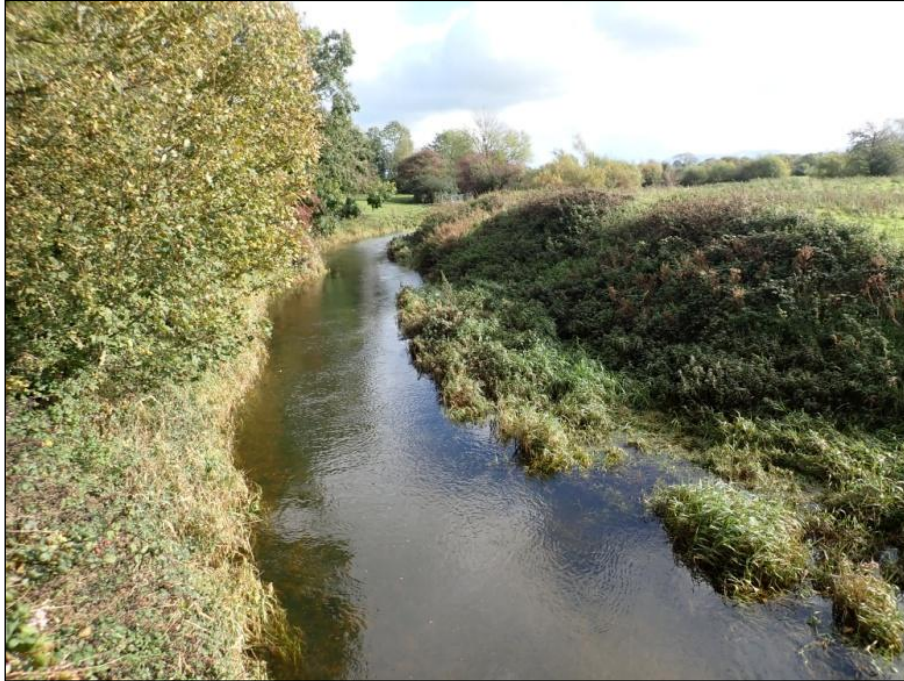
The stretch of the River Drumcamoge downstream of Site 1 is deep and sluggish but this is the least modified stretch and has a well-developed riparian zone. The upper reaches of the river and the tributaries are however all very modified and degraded.

**Plate 1** Site 1 is located downstream of Knockainey and is the lowest survey site on the main channel of the Drumcomoge River.

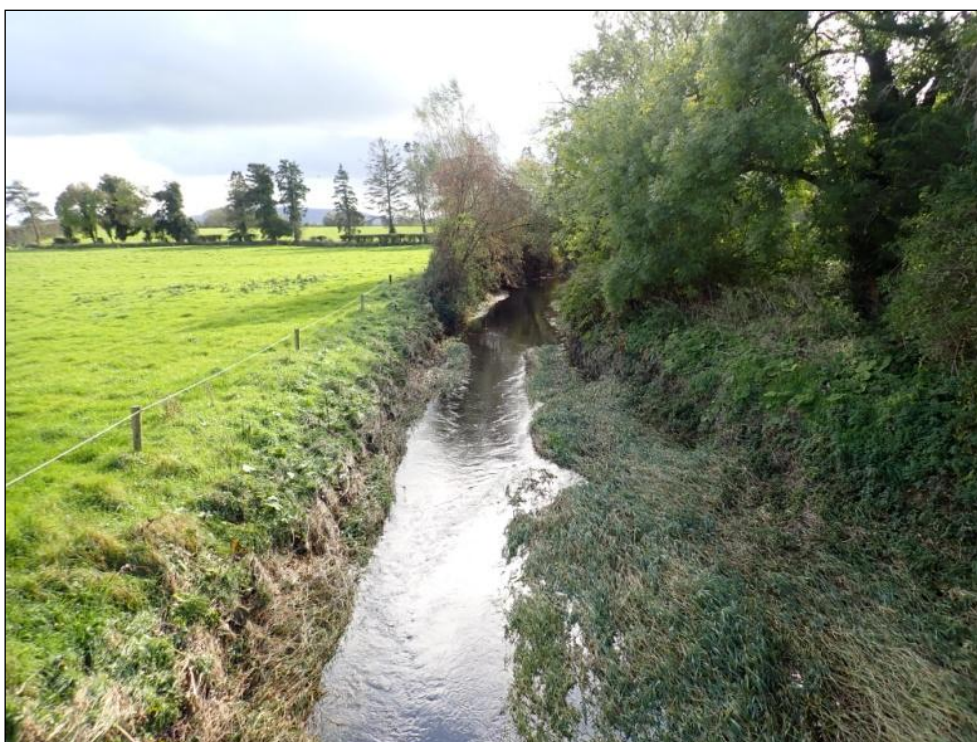
**Plate 3** Channelised Drumcomoge channel at Site 3.

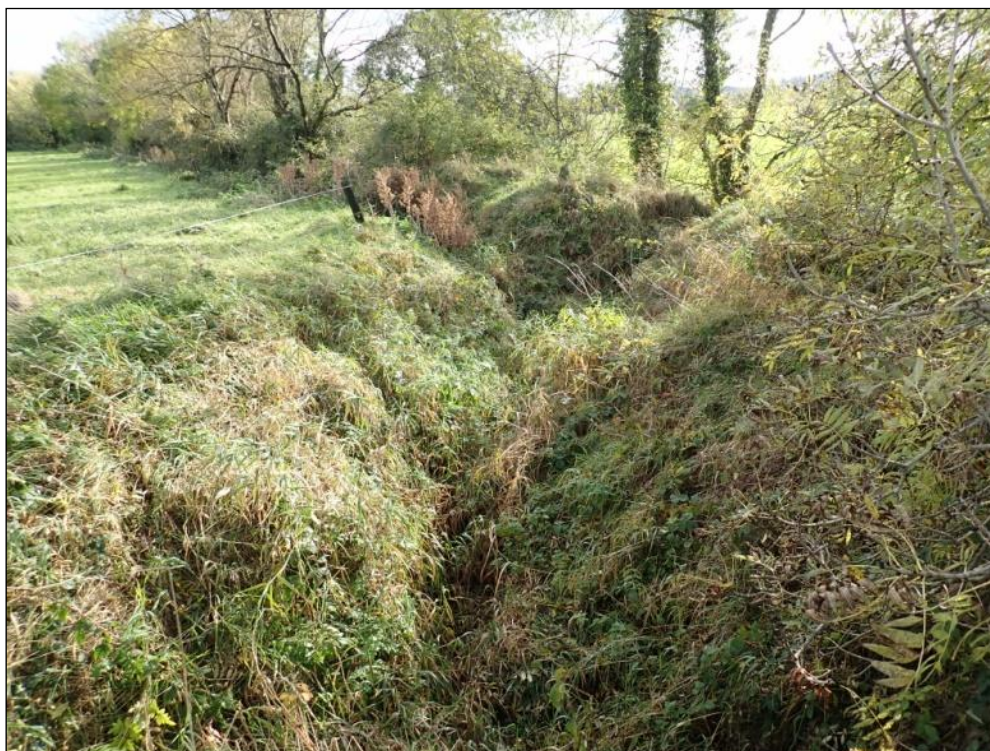
**Plate 14** Little/no flow at Site 12 near the source on the main Drumcomoge River.

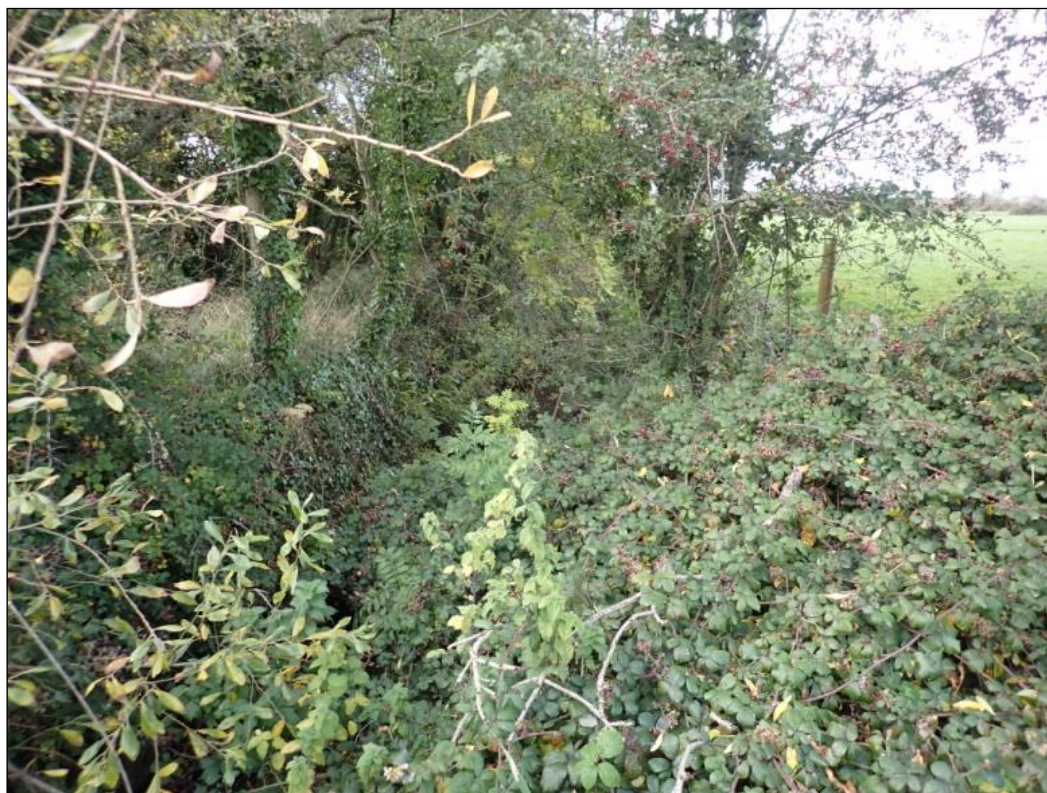
**Plate 16** The watercourse of the Knocklong Tributary at Site 14 is hidden by heavy overgrowth of overhanging vegetation.

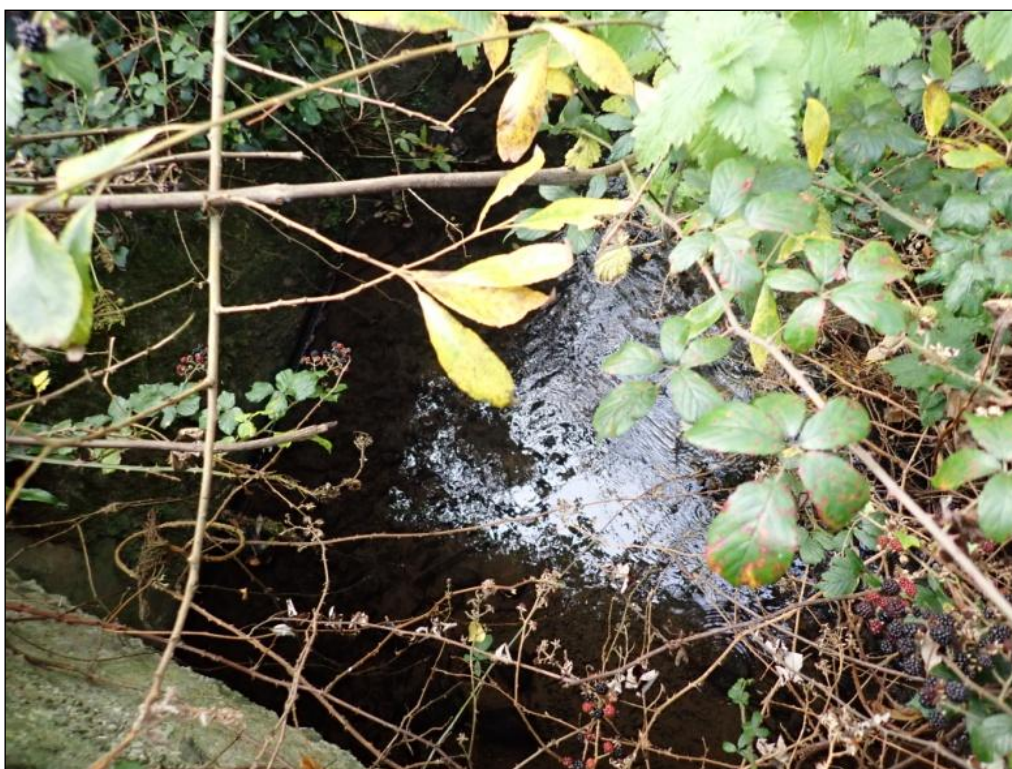
**Plate 17** Watercourse at Site 14 on the Knocklong Tributary is hidden by heavy growth of briars.

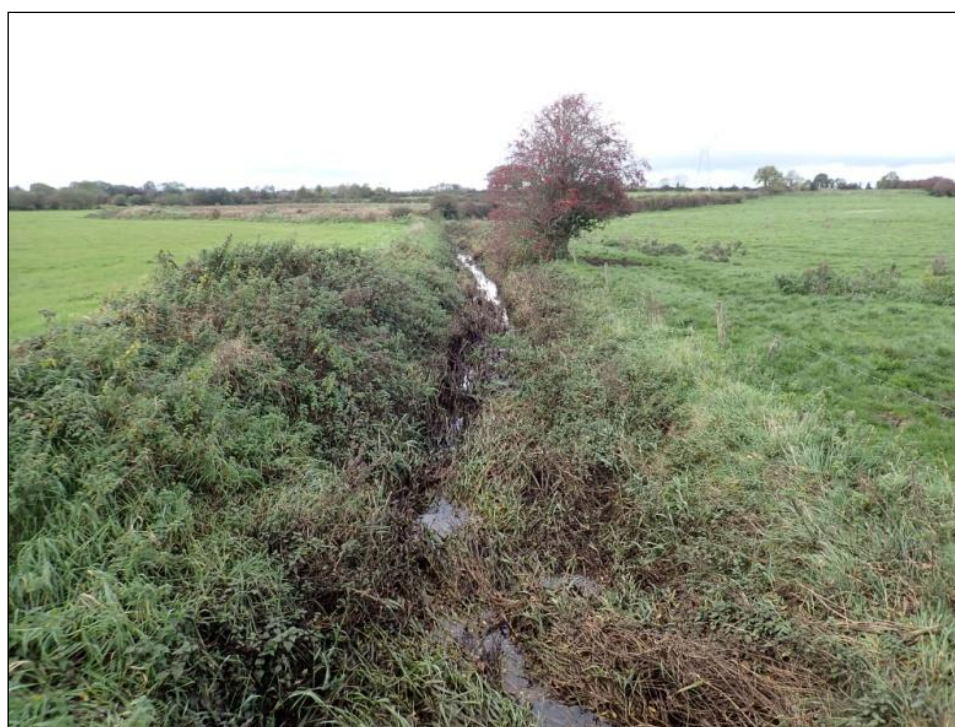
**Plate 18** Watercourse is heavily encroached with instream vegetation at Site 15 on an unnamed tributary of the Drumcomoge.

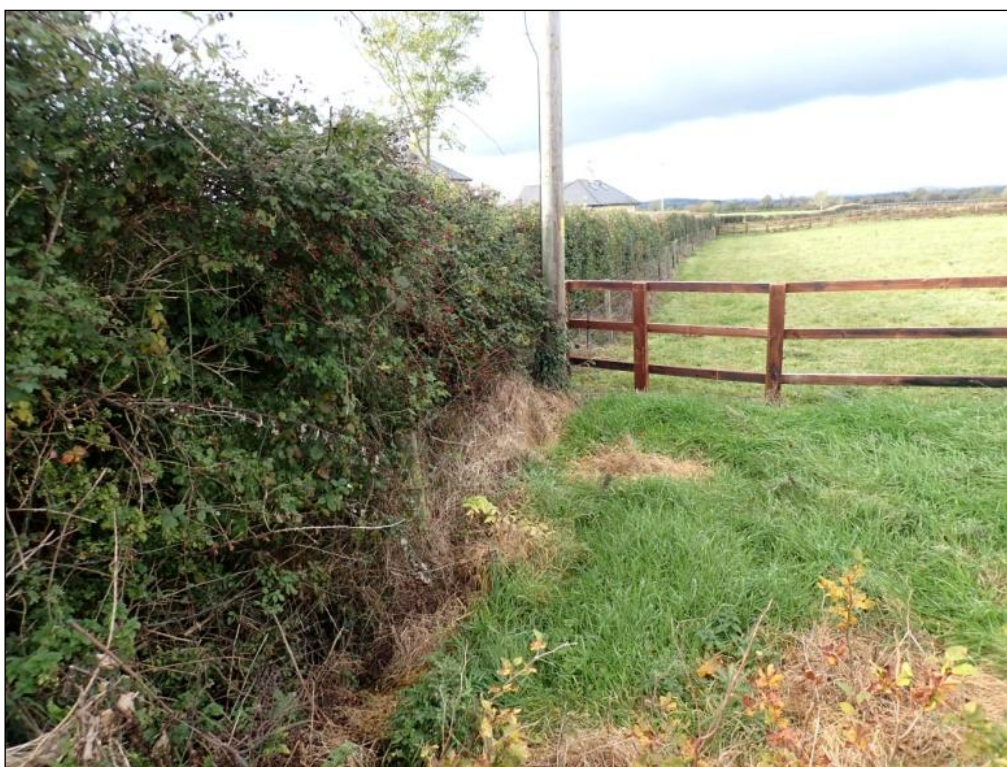
**Plate 23** The Knocklong\_West tributary is hidden with hedgerow at the perimeter of residential property at Site 20.

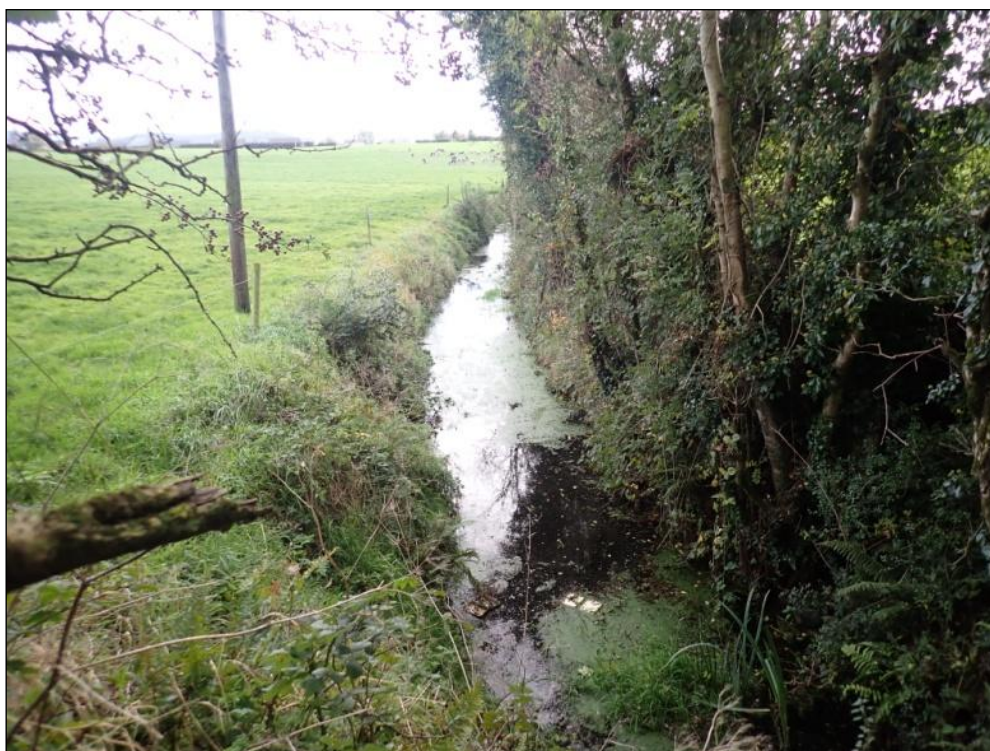
**Plate 24** River flows through agricultural farmlands and algal blooms are present at Site 21 on the Lackelly East Sub-tributary.

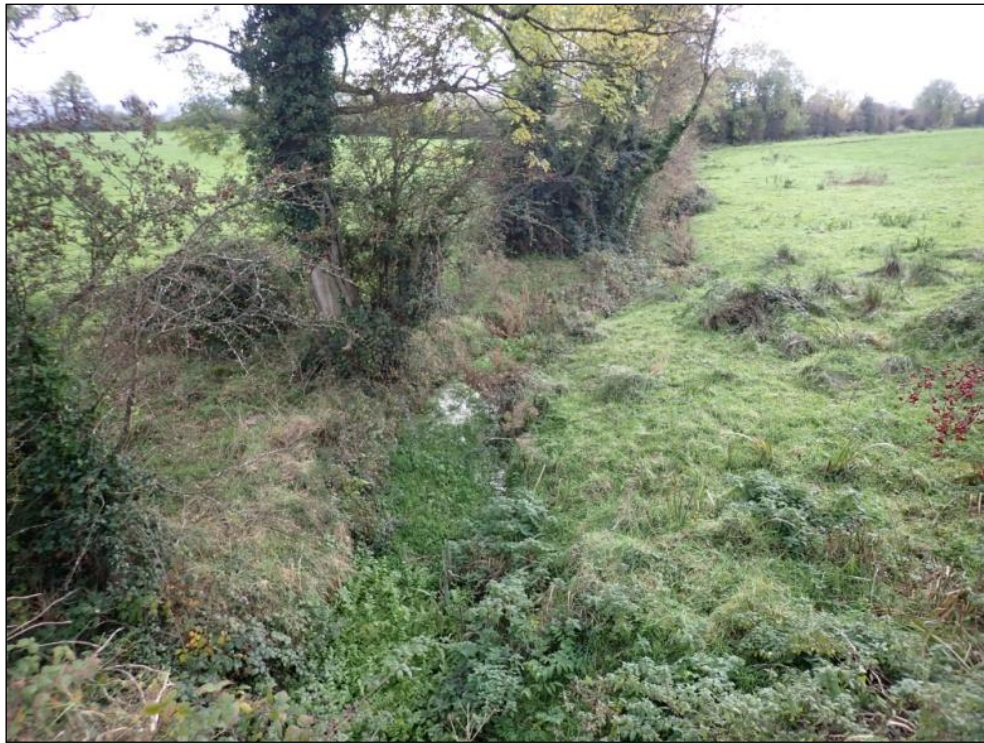
**Plate 25** Heavy vegetation overgrowth encroaching on the watercourse at Site 22, upstream of Site 21 on the Lackelly East Stream.

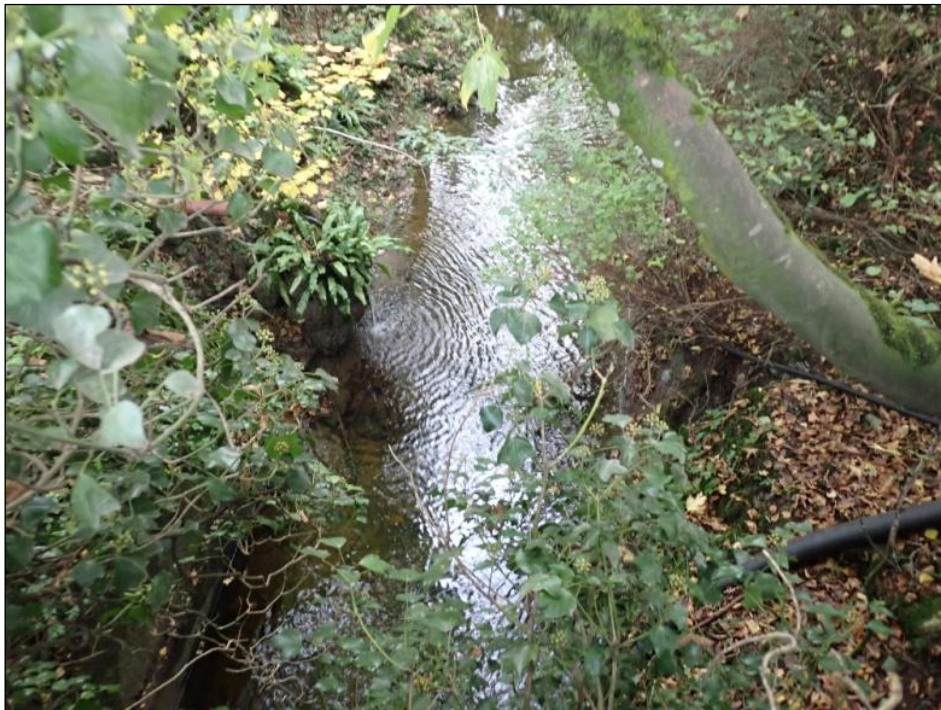
**Plate 26** The West Ballyholohan Stream is surrounded by heavy overhanging vegetation at Site 23.

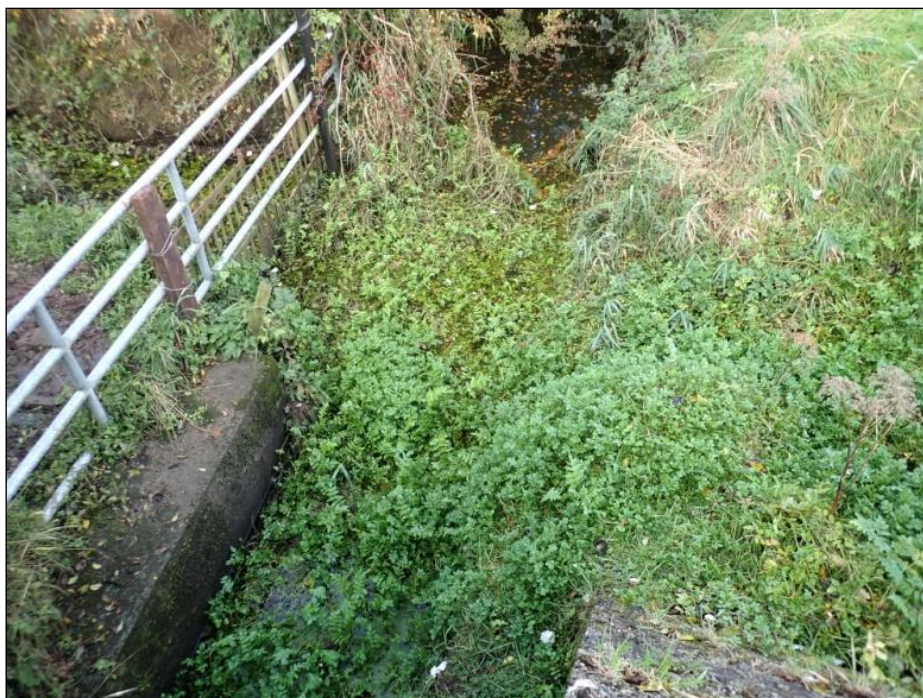
**Plate 28** Heavy vegetation mass covering the watercourse at Site 25 on the Eml 24 Tributary.

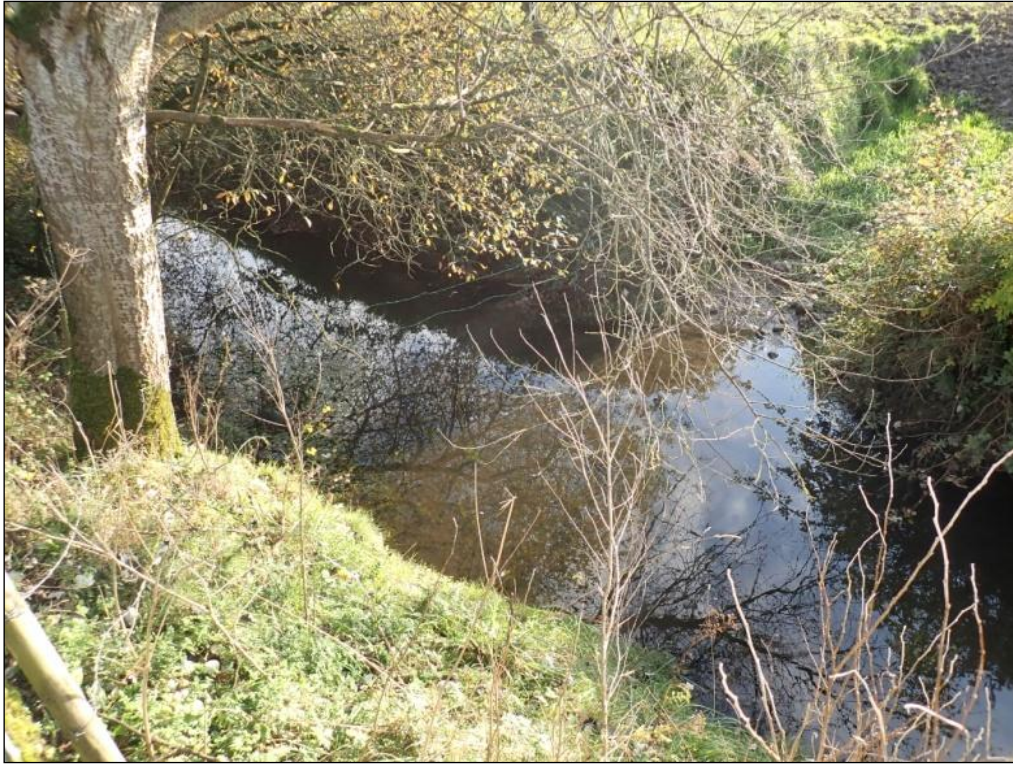
**Plate 29** Livestock river access to the Emly 24 watercourse at Site 25.

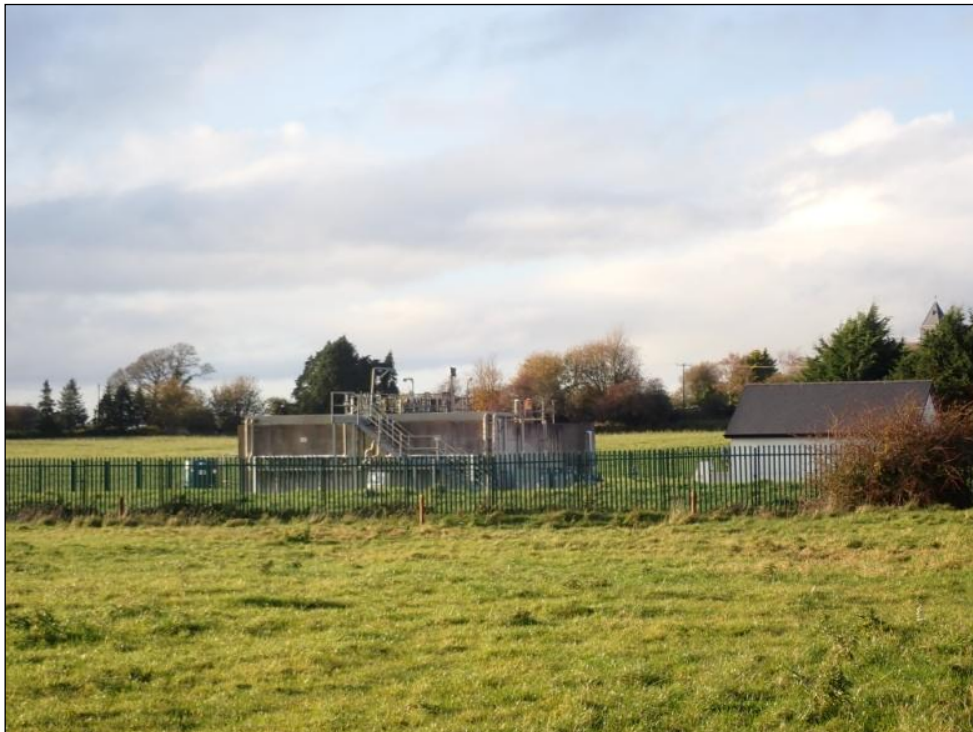
**Plate 30** Emly Wastewater Treatment Facility which discharges into the Emly 24 near Site 26.

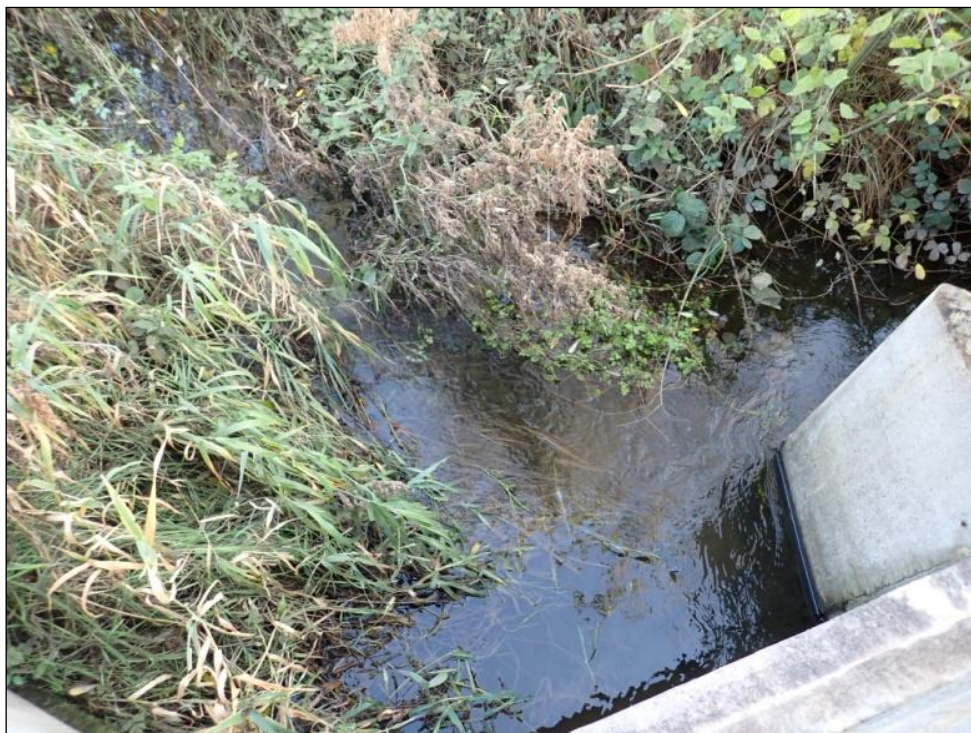
**Plate 32** Water silted in the Emly 24 Tributary at Site 27 and encroached by vegetation from the banks.

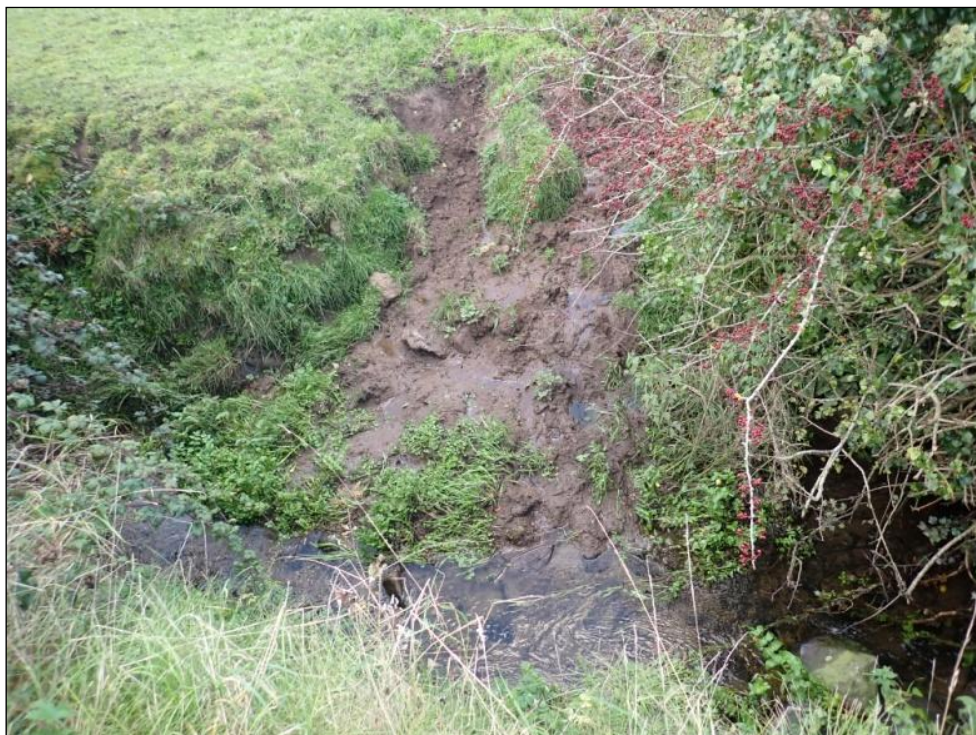
**Plate 34** Livestock river access at Site 29 on the Lissobihane Stream.

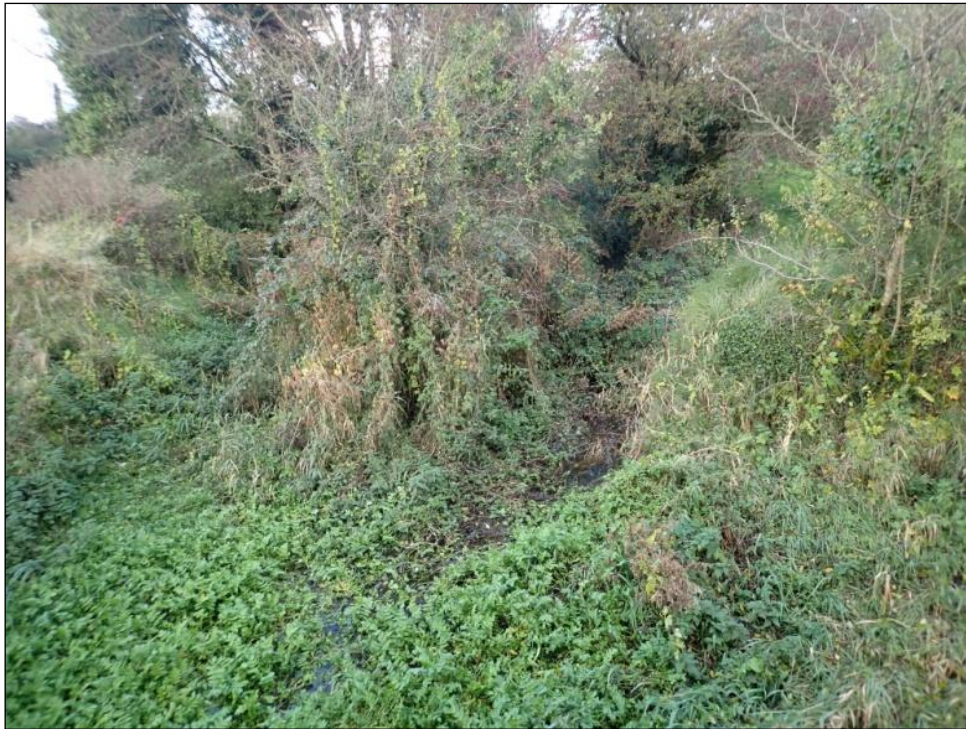
**Plate 35** Thick mass of vegetation smothers watercourse at Site 30 in the upper reaches of the Emly 24 Stream.
