River Maigue Catchment Riparian Habitat Study

RIVER MAIGUE RIPARIAN HABITAT SURVEYS

FINAL REPORT

Prepared by Wetland Surveys

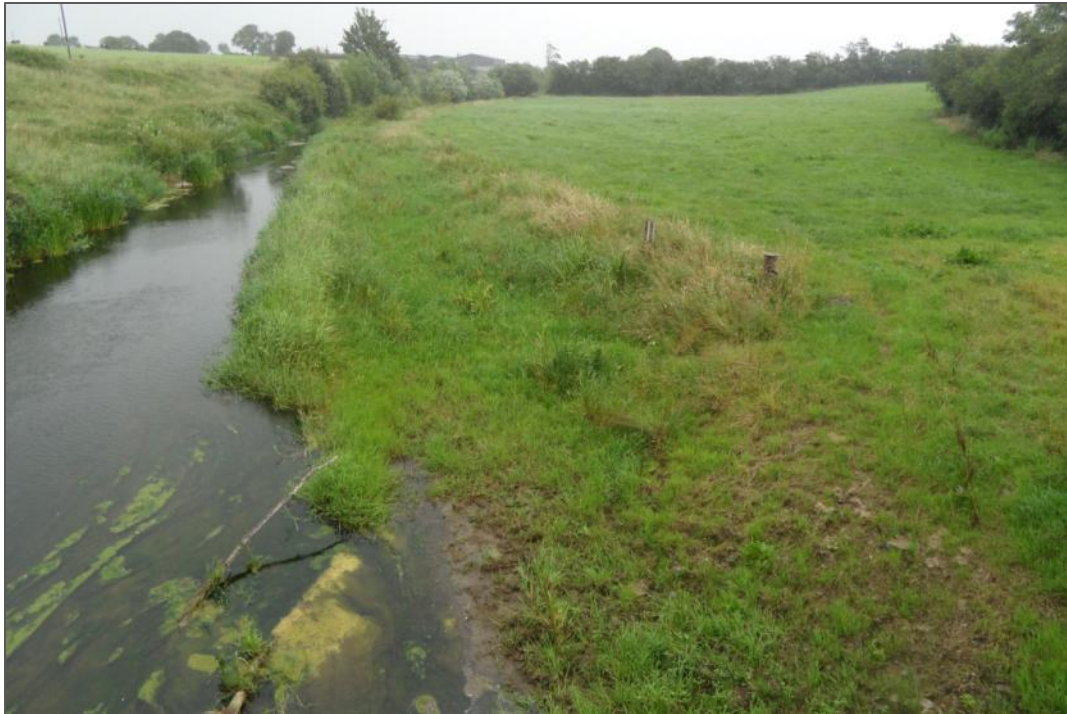
Improved agricultural grassland is the dominant habitat in the survey area. This habitat is generally dominated by Perennial Rye Grass (*Lolium perenne*), with additional species such as White Clover (*Trifolium repens*), Creeping Buttercup (*Ranunculus repens*), Dandelion (*Taraxacum* agg.), and Docks (*Rumex* sp.) commonly present. Many improved agricultural grassland fields encountered during field survey have an absence of any riparian vegetation or buffer strip along the river banks (Plate 1). In numerous locations cattle are accessing the river from such improved agricultural grassland areas.

Plate 1: Example of improved agricultural field without riparian habitat or buffer zone. Note cattle access point to river in lower right hand corner (Site Code: CM14).

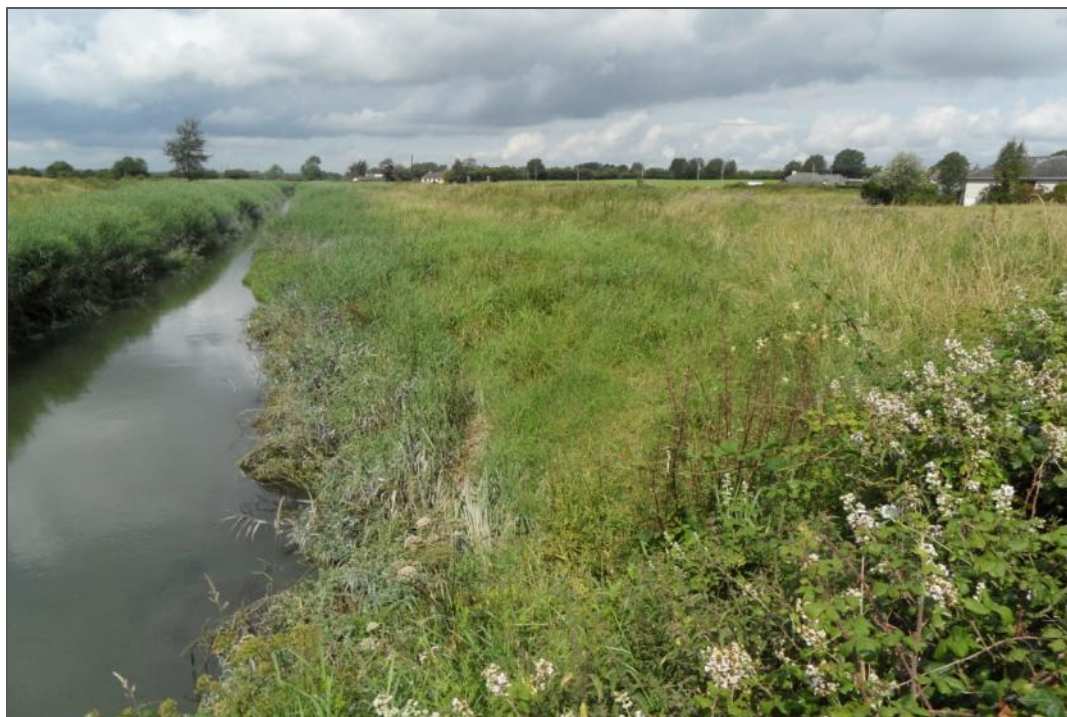
Where a buffer strip, or area of semi-natural vegetation is present, this is generally comprised of dry meadow and grassy verge vegetation and or a narrow band of reed and large sedge swamps (Plate 2). Dry meadow and grassy verge vegetation is typically dominated by Hedge bindweed (*Calystegia sepium*), Greater Willowherb (*Epilobium hirsutum*), and rank grasses (*Arrhenatherum elatius* and *Dactylis glomerata*). Reed and large swamps are generally dominated by Reed Canary Grass (*Phalaris arundinacea*), with Branched Bur-reed (*Sparganium erectum*), and Common Club-rush (*Schoenoplectus lacustris*) also occurring. In areas with good semi-natural vegetation all three of these species occur together, however, this was not regularly recorded.

Plate 2: Dry meadow and grassy verge vegetation grading into reed and tall herb swamp on right bank of river (Site Code: BK02).

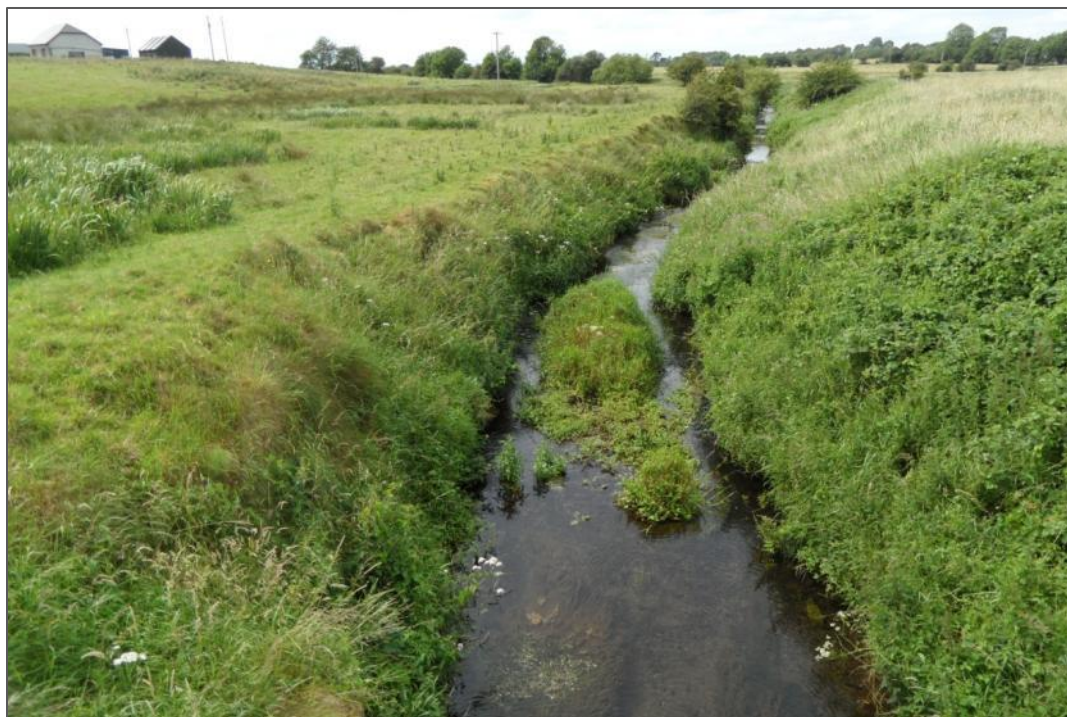
Mosaics of improved agricultural grassland and wet grassland occur frequently within the catchment. In general there is a paucity of wet grassland species, with Rushes (*Juncus* sp.), Iris (*Iris pseudocarus*), and Meadowsweet (*Filipendula ulmaria*) generally dominant (Plate 3). Of the sites targeted for field survey, MRS013 is one of the better examples of a grassland site. The site is relatively unmanaged, and there are a series of runnels running across the surface that are colonised by wet grassland species. See Appendix I for further details.

Plate 3: Mosaic of improved agricultural grassland and wet grassland (left bank) (Site Code: MS03).

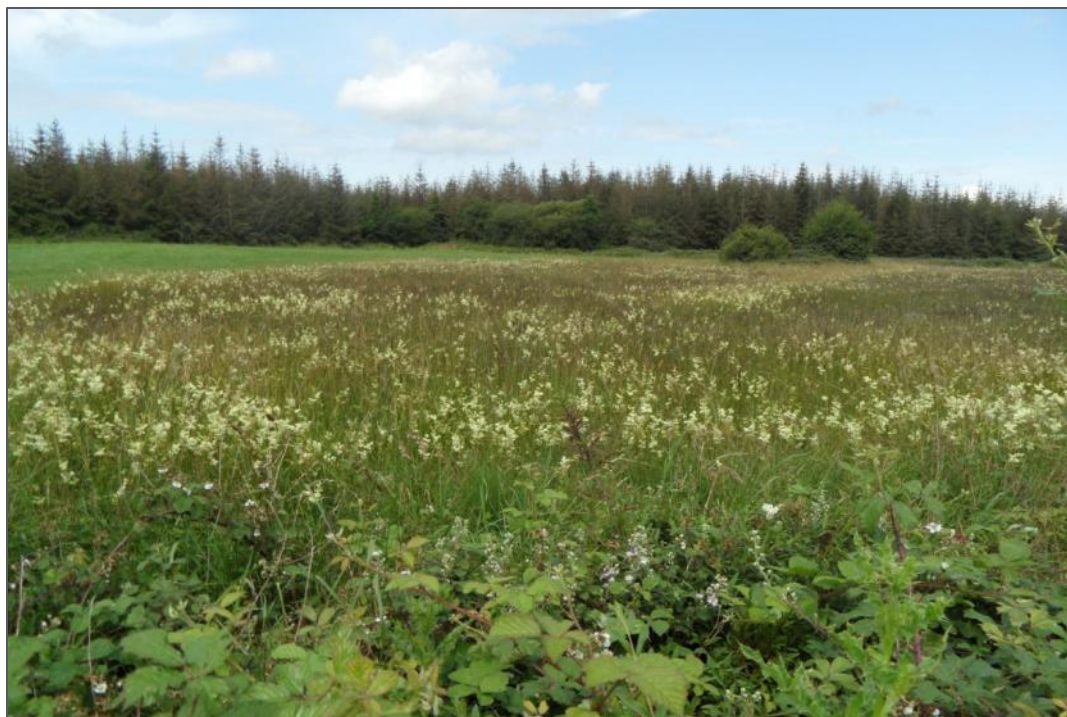
One area of high quality *Molinia* grassland was recorded at Kilgrogan, in proximity to the Curraghchase North River (Plate 4). This grassland occurs just outside the 50m buffer along the river channel and is adjoined by improved agricultural grassland and conifer forestry. Species present include Meadowsweet, Purple Moor-grass (*Molinia caerulea*), Meadow Thistle (*Cirsium dissectum*), Marsh Bedstraw (*Gallium palustre*), Sharp-flowered Rush (*Juncus acutiflorus*), Tufted Vetch (*Vicia cracca*), Purple Loosetrife (*Lythrum salicaria*), Ragged Robin (*Silene flos-cuculi*), Star Sedge (*Carex echinata*) and other sedge species (*Carex* sp.), Devil's-bit Scabious (*Succisa pratensis*), Lesser Spearwort (*Ranunculus flammula*), Common Meadow-grass (*Poa pratensis*), Greater Bird's-foot Trefoil (*Lotus uliginosus*), and Yorkshire Fog (*Holcus lanatus*). This area of grassland is of high ecological value and, based on the absence of similar habitat in the study area efforts should be made towards ensuring it's conservation.

Plate 4: High quality species rich wet grassland with Meadowsweet.

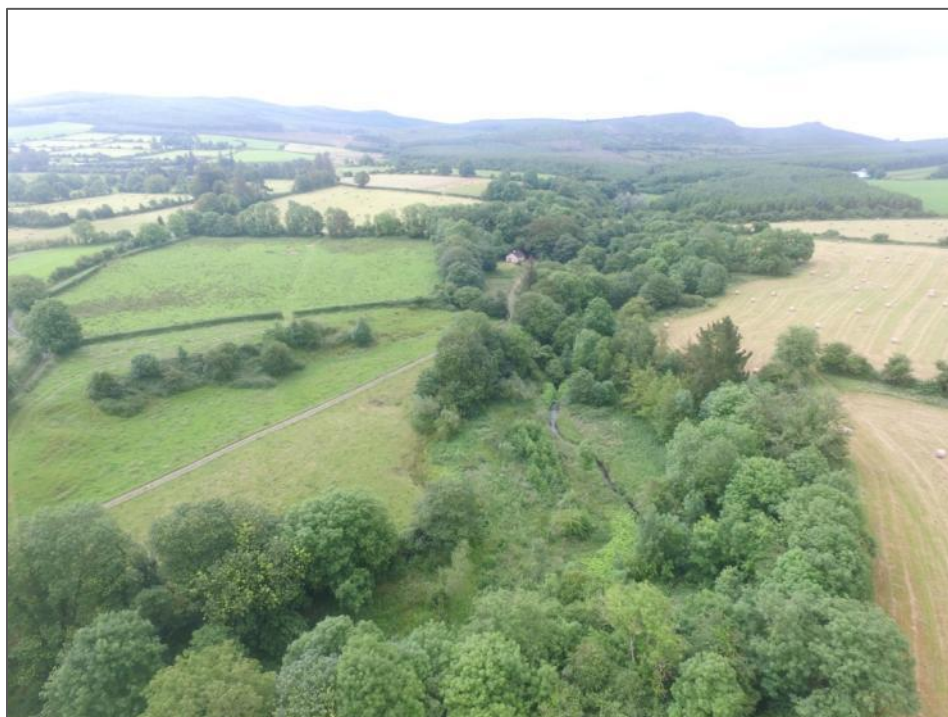
Plate 6: Example of a section of the Loobagh river channel (looking east) where modified woodland was present on lands adjacent to the river channel.

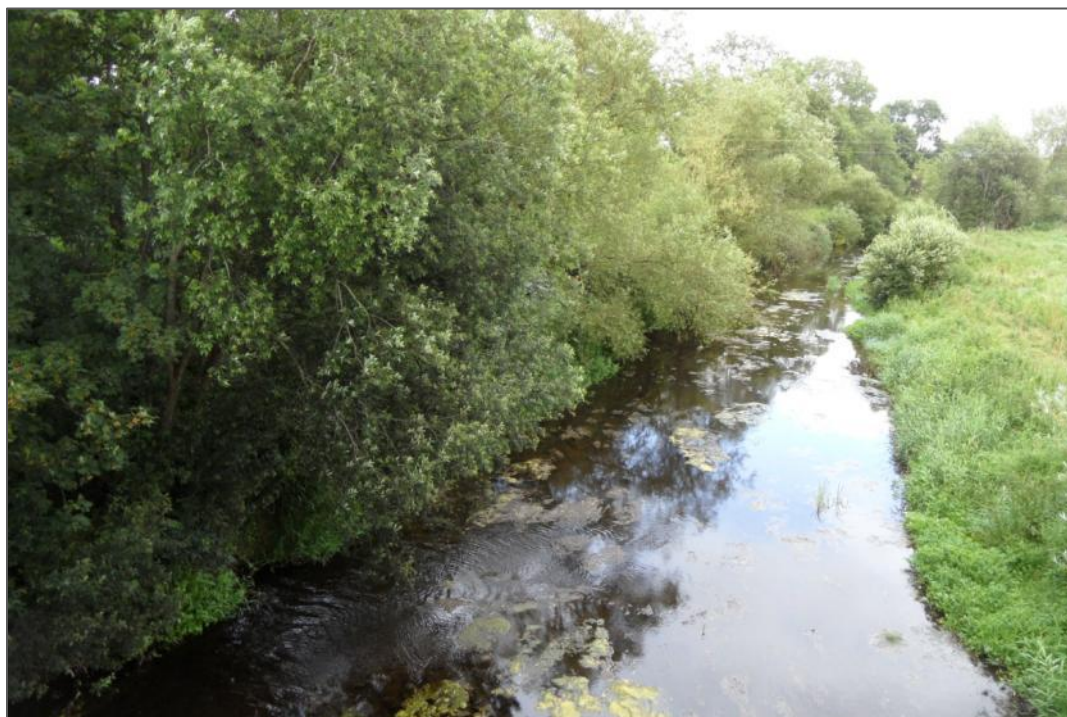
Where a woodland or shrub layer is present, it is generally comprised of Willows (*Salix cinerea* and *S. viminalis*), with Ash (*Fraxinus excelsior*). Other commonly recorded species include Beech (*Fagus sylvatica*), Sycamore (*Acer pseudoplatanus*), Hawthorn (*Crataegus monogyna*), Blackthorn (*Prunus spinosa*), and occasional Alder (*Alnus glutinosa*) (Plate 7).

Plate 7: Treeline present along the left river bank and absent from the right bank (Site Code: CM11).

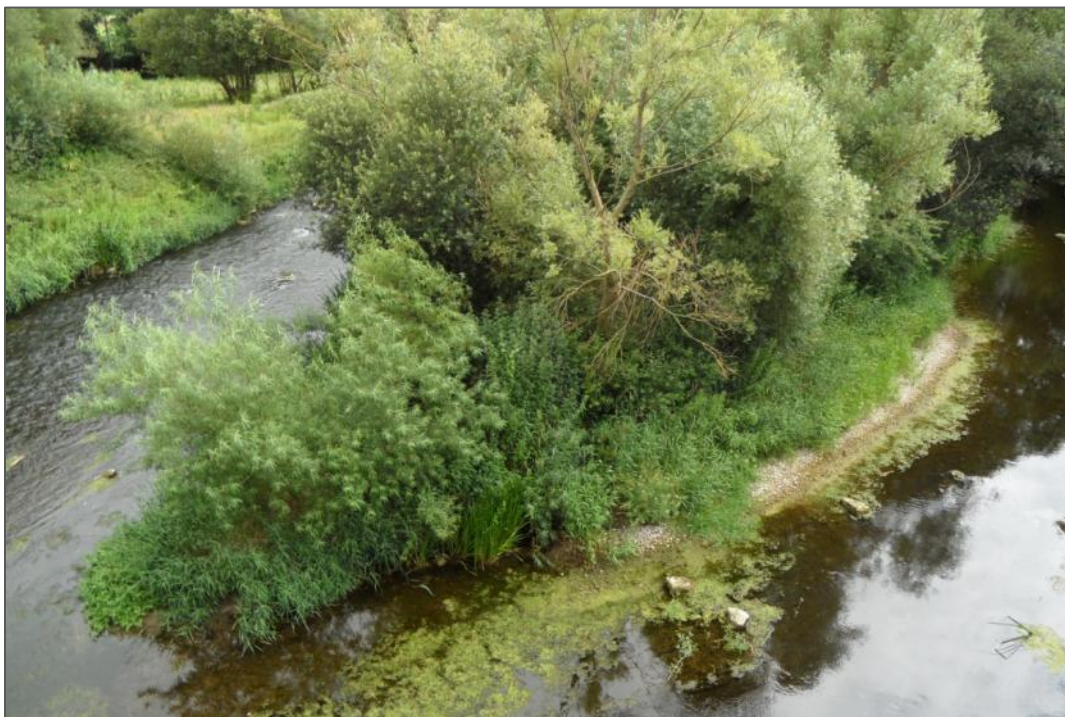
Riparian woodlands are an extremely rare type of native woodland in Ireland (Little *et al.* 2008) and were only recorded on a few islands in the main Maigue channel. These woodlands were surveyed using binoculars, given their isolated location. Riparian woodlands are subject to periodic flooding, during winter flood periods. Flooding can be irregular, but occurs for long enough periods to determine the vegetation (Little *et al.* 2008). Species recorded on these islands include Willows (*Salix cinerea*, *S. alba* and *S. viminalis*), Ash, and occasional Alder in the tree layer. Other species recorded include Nettles (*Urtica dioica*), Hairy Willowherb, Reed Canary Grass, Bramble (*Rubus fruticosus* agg.), Branched bur-reed, and Fool's-water-cress (*Apium nodiflorum*).

Plate 8: Riparian woodland on island in middle of the Maigue river channel, south of Adare (Site Code: MG13).

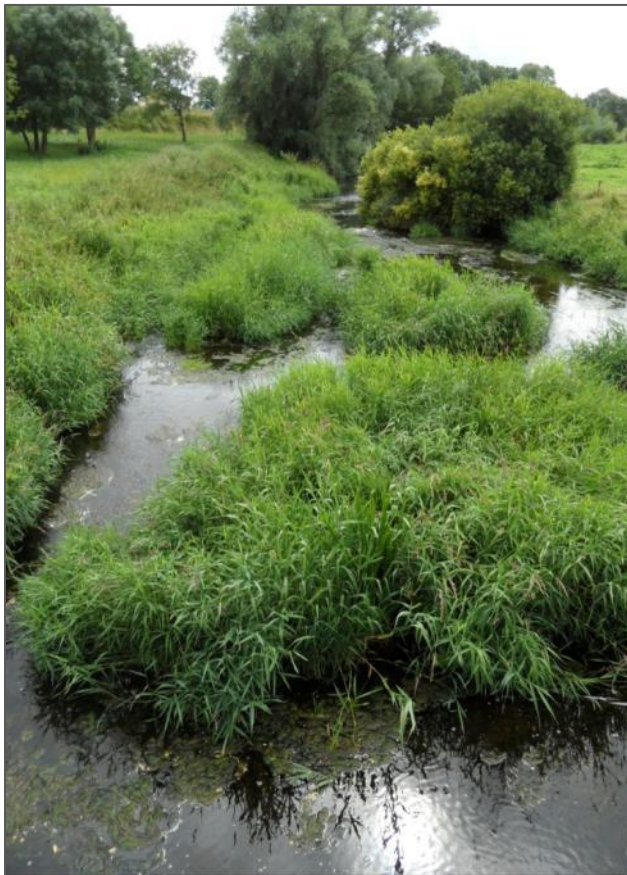
Reed Canary Grass is the dominant species in the smaller in-stream reed bed areas, which are typically species poor habitats (Plate 9). The larger reed swamp areas in the lower part of the main Maigue channel are dominated by Common Reed (*Phragmites australis*), with other species present including Yellow Flag Iris, Nettle, Hemlock Water-dropwort (*Oenanthe crocata*) and Bindweed (Plate 10). Additional species present in this habitat included Fool's Water-cress, Horetail (*Equisitum* sp.), Water Plantain (*Alisma plantago-aquatica*), and Brooklime (*Veronica beccabunga*).

Plate 9: Area of in-stream and stream edge reedswamp dominated by Reed Canary Grass on the Camoge near Coolfune (Site Code: CM12).

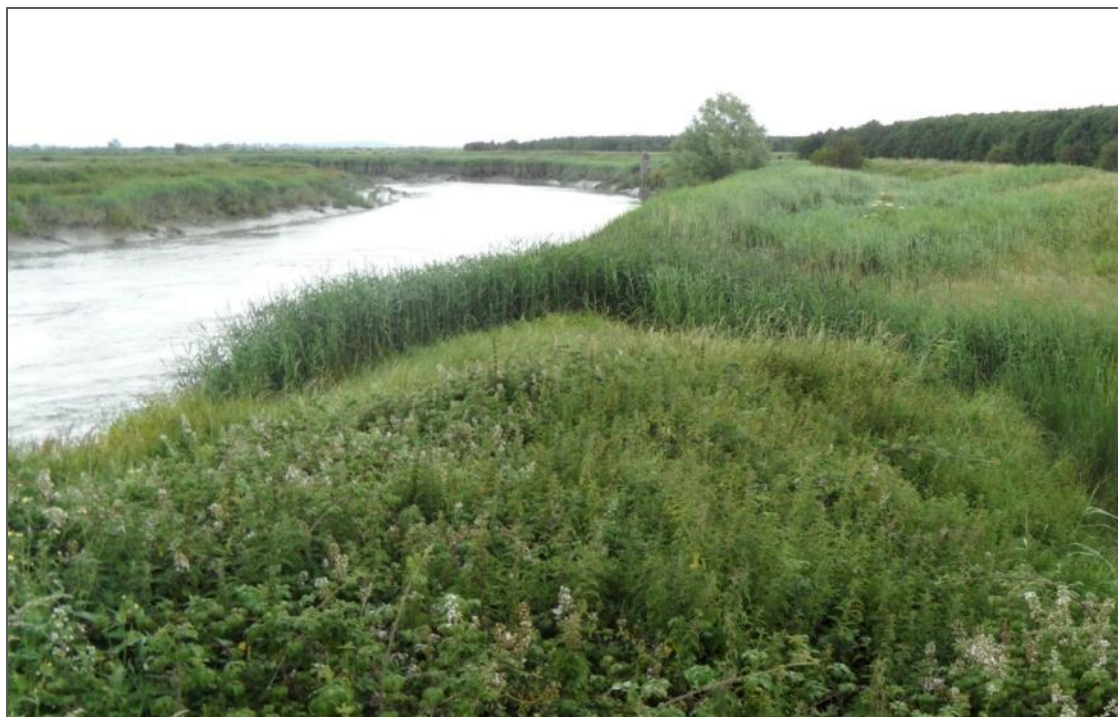
Plate 10: Large areas of reedswamp dominated by Common Reed on the Maigue at Ferrybridge (Site Code: MG18).

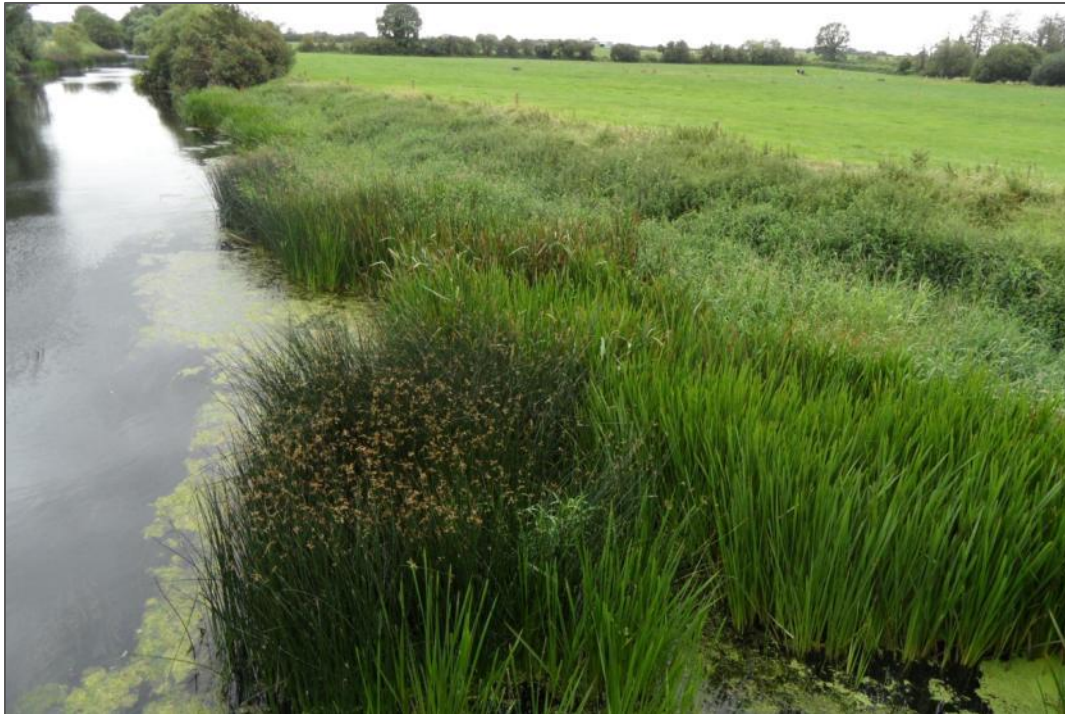
In areas where the bank side and in channel vegetation was well developed Branched Bur-reed and Common Club-rush were present in addition to Reed Canary Grass, though this was not a frequent occurrence (Plate 11).

Often, areas of reedswamp were the only buffer between agricultural fields and the river, however, frequently there was a band of dry meadow and grassy verge vegetation present between the reedswamp and the grassland field (Plate 11). These areas were generally comprised of Nettles, Hedge Bindweed, Greater Willowherb, rank grasses and scattered Bramble patches.

Plate 11: Area of dry meadow and grassy verge vegetation grading into a more diverse area of reedswamp at the edge of the Maigue river channel with Branched Bur-reed, Common Club-rush and Reed Canary Grass (Site Code: MG14).

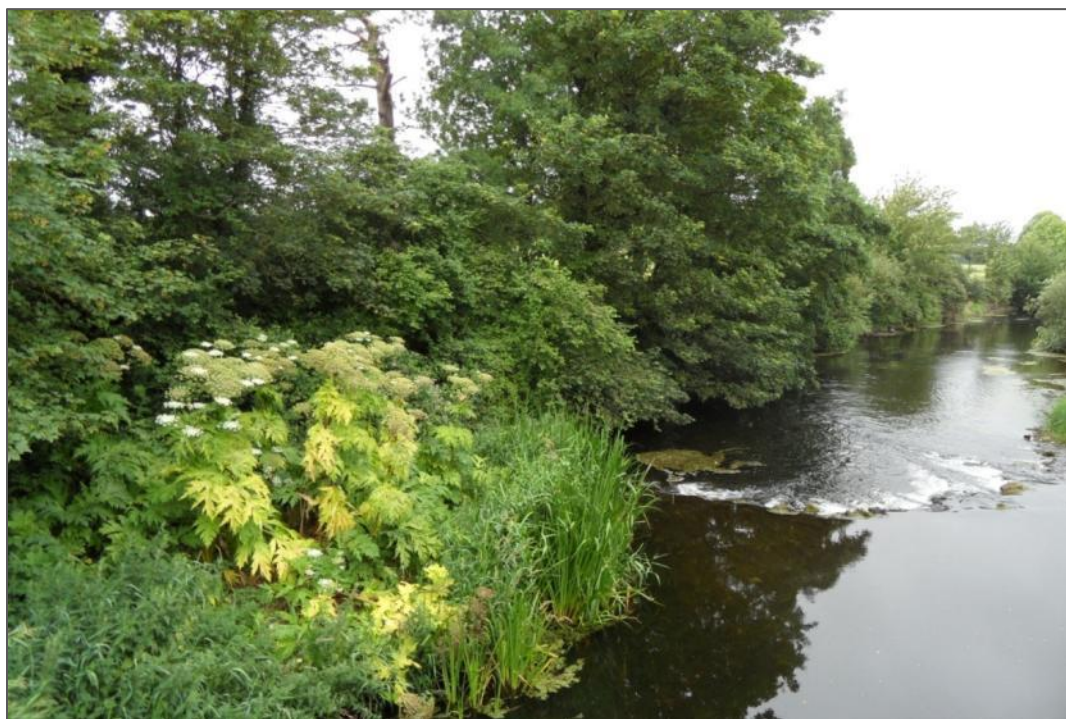
Plate 12: Giant Hogweed (left hand side) on the banks of the river Maigue (Site Code: MG11).

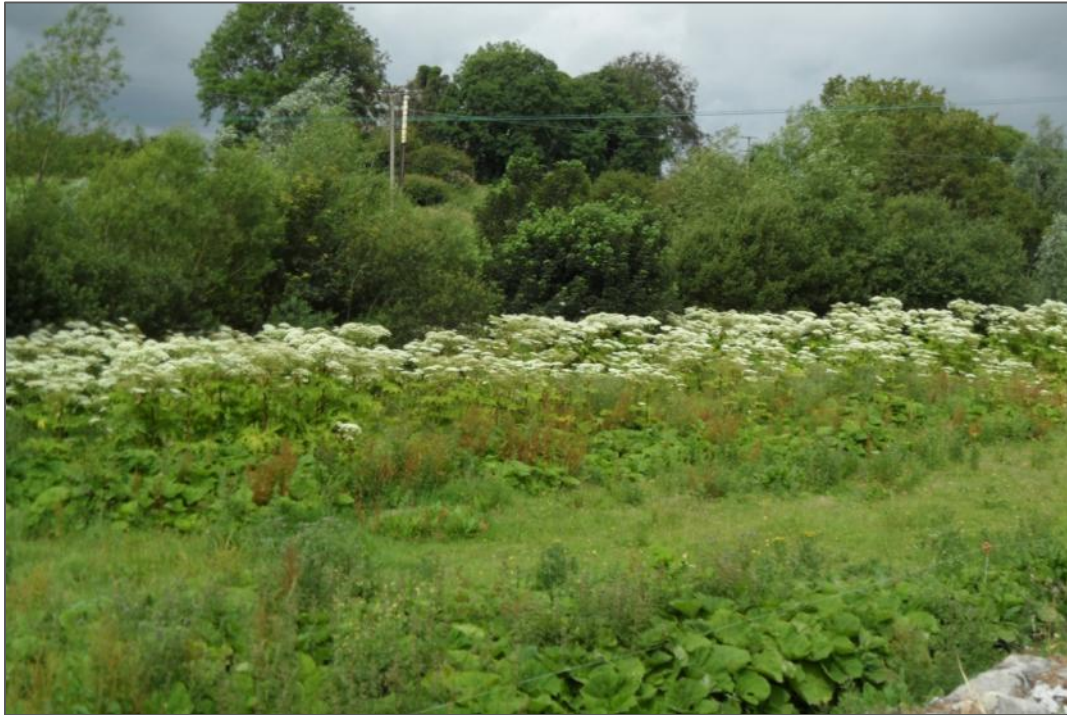
Most notably, Giant Hogweed was abundant along the banks of the Maigue and the Loobagh (Plate 13). The sap of the Giant Hogweed plant is phototoxic. Contact with the plant sap prevents the skin from being able to protect itself from sunlight, which leads to phytophotodermatitis, a serious skin inflammation. Therefore the presence of this plant poses a threat to native ecosystems and public health.

Plate 13: Giant Hogweed is common along the banks of the Maigue and Loobagh and may spread from the river channel edge into adjacent agricultural lands (near site LB07).

There are ongoing efforts to try and control Giant Hogweed along the banks of the Maigue and the Loobagh, including a pilot project collaboration between the Maigue Rivers Trust and Ballyhoura Development CLG, along a 12km stretch of the Loobagh to its confluence with the Maigue. A new three-year project has just been initiated by Limerick City and County Councils to control the spread of Giant Hogweed along the Loobagh. This project aims to include members of the public in identifying areas where this species is present and helping to eradicate it. As the eradication of this invasive species will require multiple years of effort, it is recommended that information signs, warning of the danger posed by Giant Hogweed be placed in any areas along river banks where there is public access or public walkways.

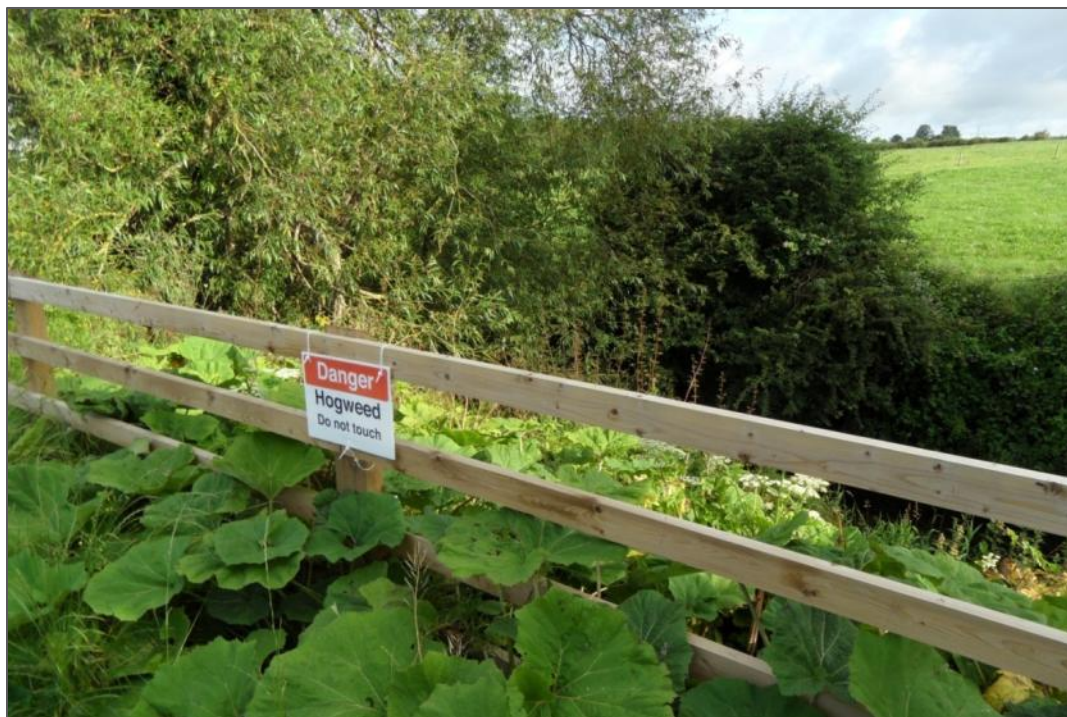
placed along the fence of the river walk in Kilmallock warning of the danger of Giant Hogweed (Plate 14), however, at the majority of other locations where this species was recorded, there are no information signs present or any other form of warning to members of the public about the dangers posed by this species.

Plate 14: Notices relating to the presence of Giant Hogweed along the river walkway in Kilmallock.

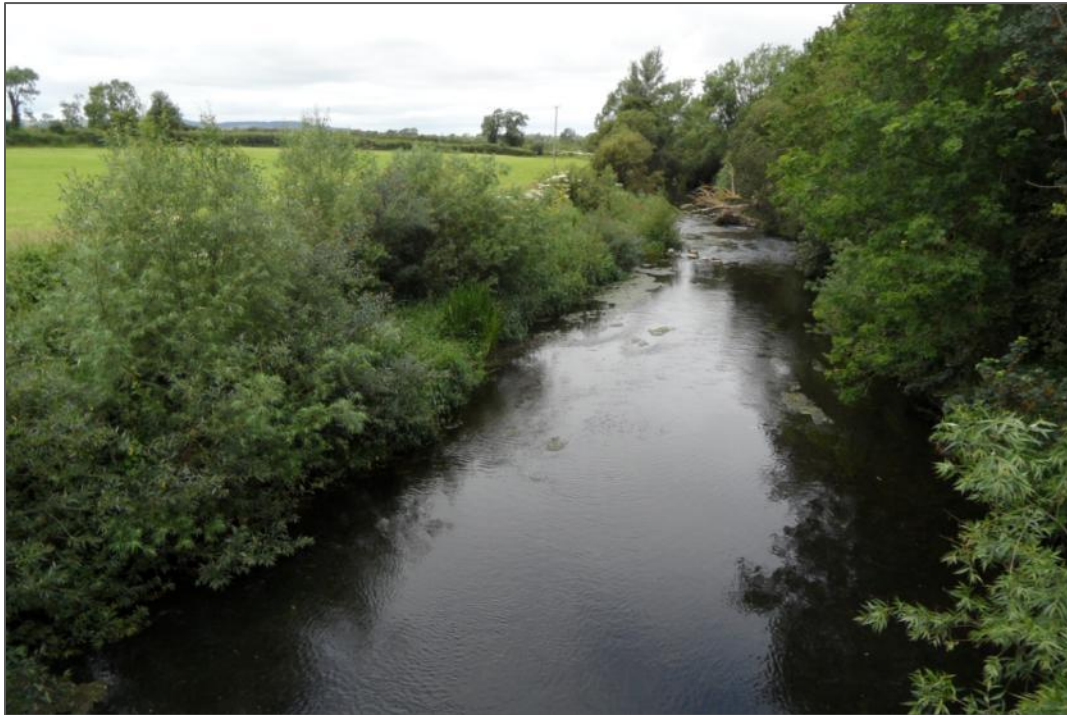
Plate 17: Maigue River with highly modified woodland on right hand side. The white flowers of Giant Hogweed are visible on left bank in distance (Site Code: MG09).

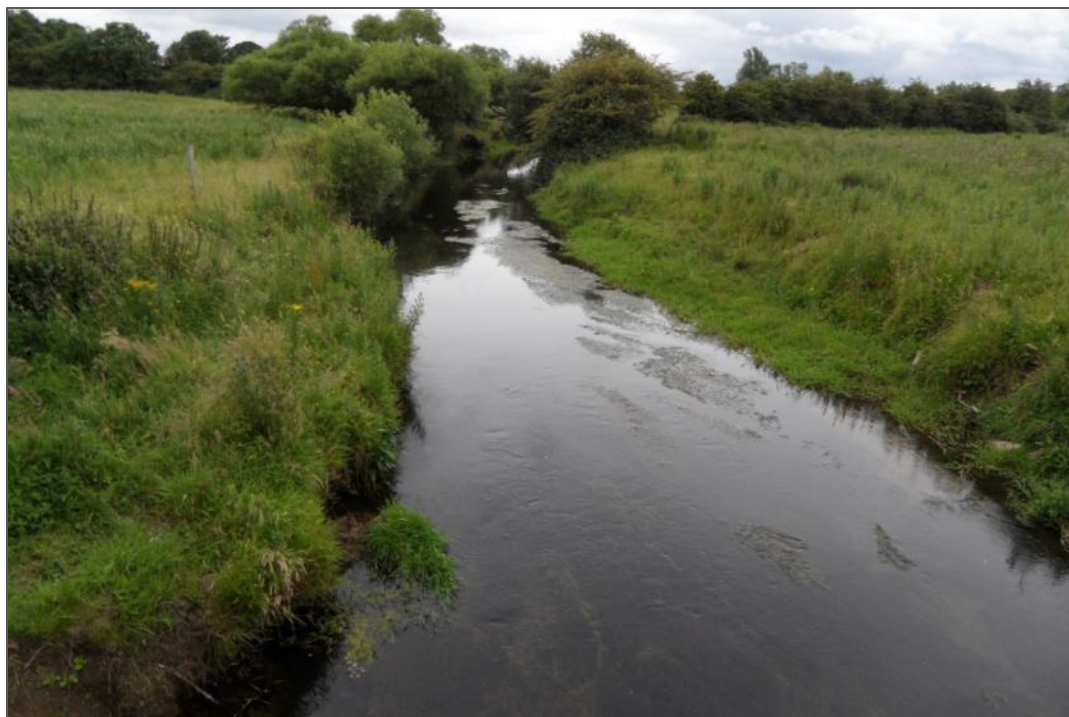
Plate 18: Loobagh River showing improved agricultural grassland to river edge and general lack of riparian vegetation (Site Code: LB06).

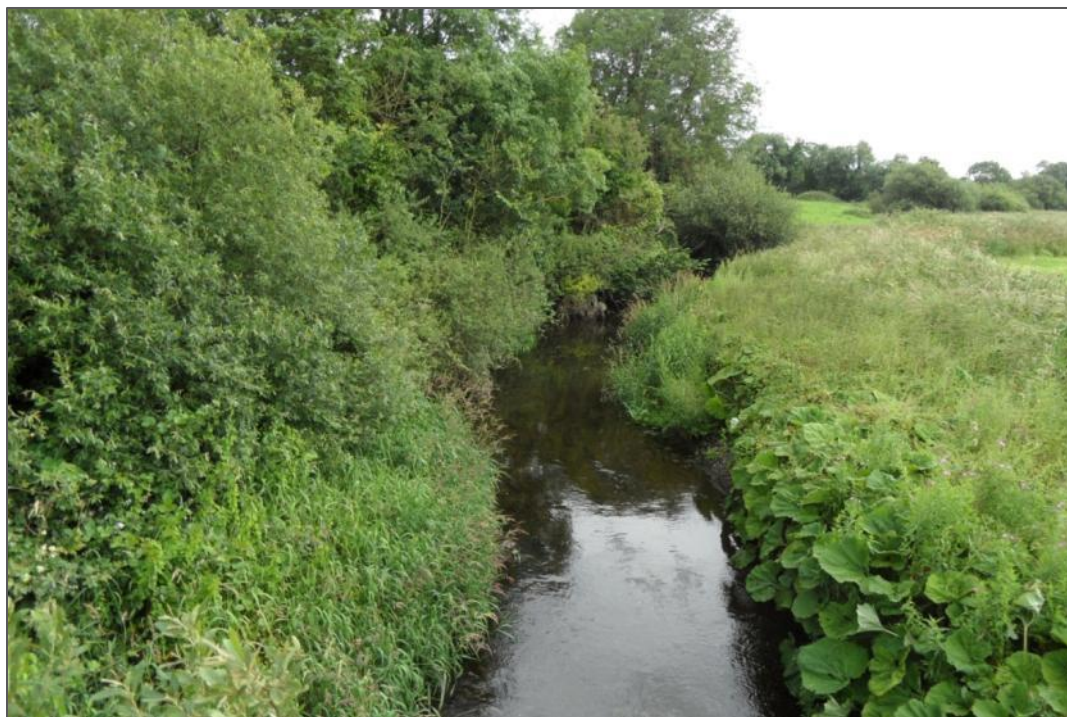
Plate 20: Morningstar River with scrub woodland on the left bank and rank grassland zone with Butterbur (*Petasites hybridus*) on right bank (Site Code: MS03).

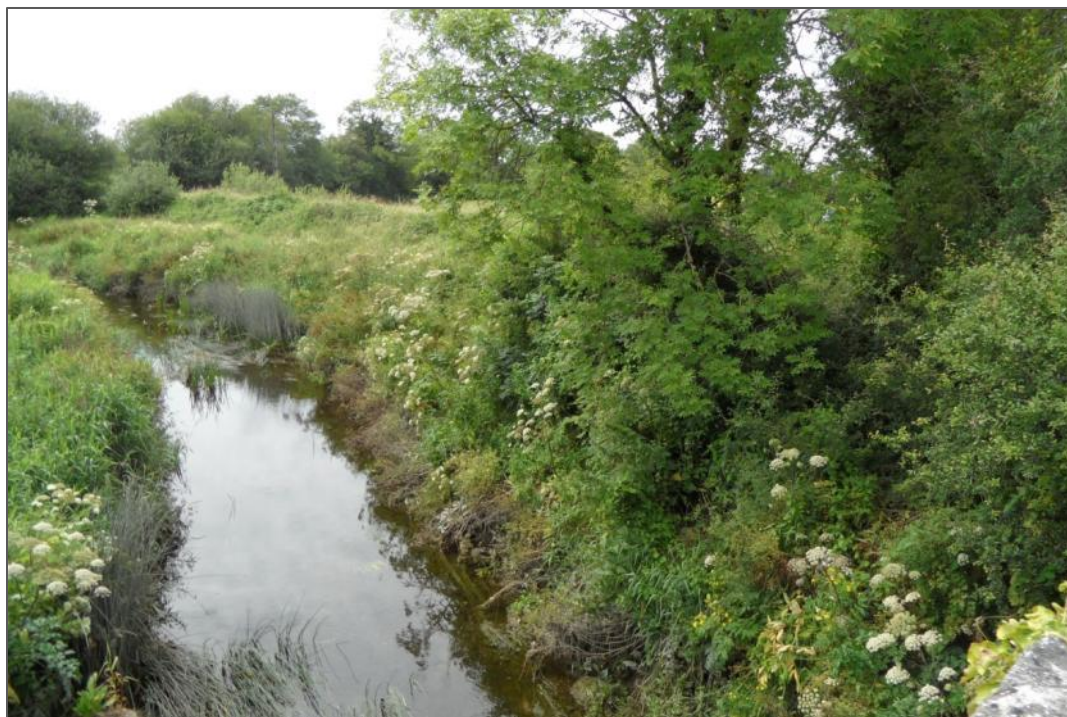
Plate 21: Clonshire River showing scrub and rank grassland community along the bank edge (Site Code: CS04).

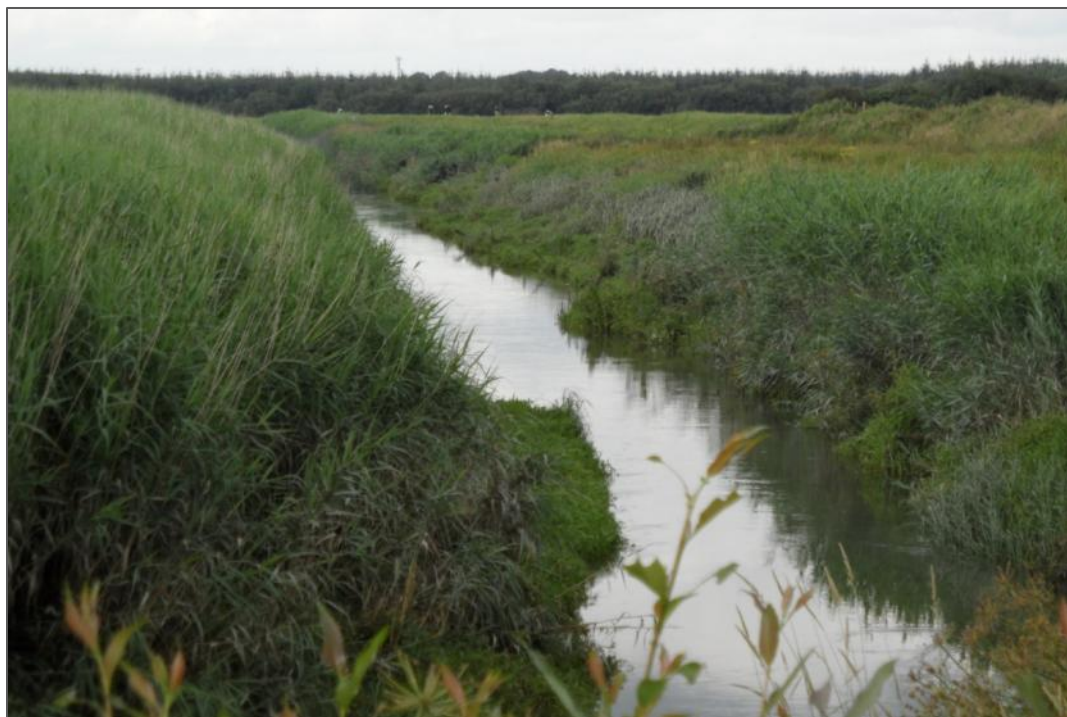
Plate 22: Barnakyle River with reedswamp vegetation dominating on the left bank of the river (Site Code: BK03).

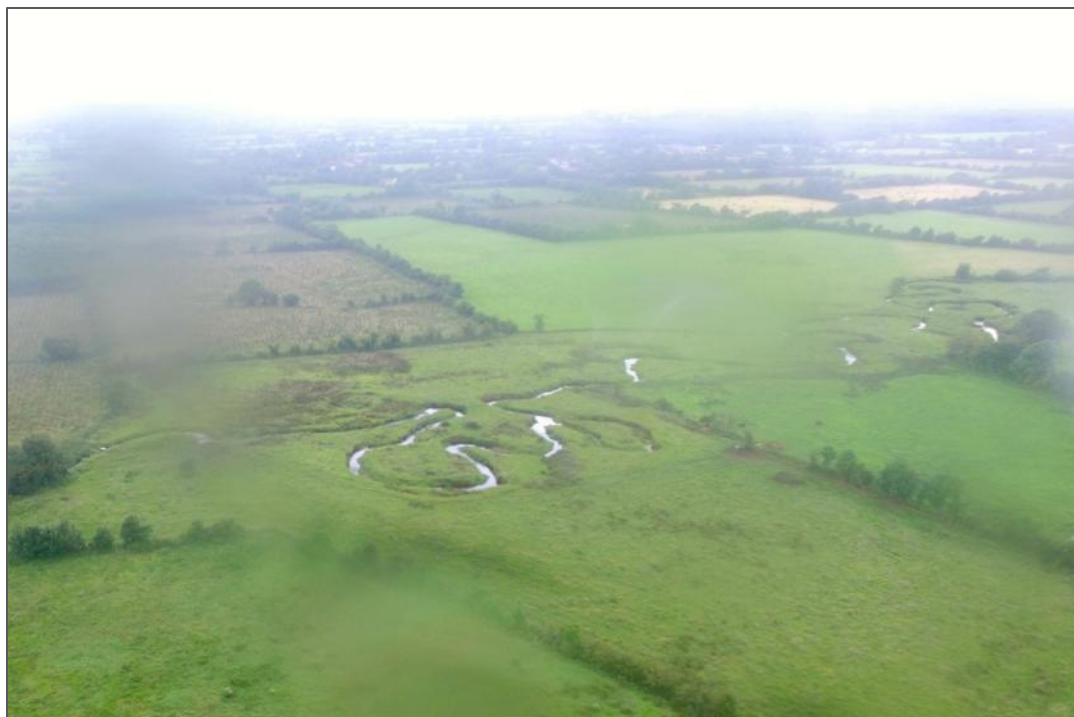
While the previous drainage work carried out in the Maigue catchment dramatically altered the river channel and associated riparian vegetation and habitats, there is little that can be done in terms of management to try and rectify this issue. Any future channel clearance or drainage should only be carried out where deemed absolutely necessary and should be subject to an environmental impact assessment prior to being carried out. Isolated sections of the main Maigue channel and channels of the tributaries retain natural meanders (Plate 23), however, the majority of the channel length has been straightened.

Plate 23: Section of the Loobagh river showing natural meanders and ox bows near Kilfinane Lands.

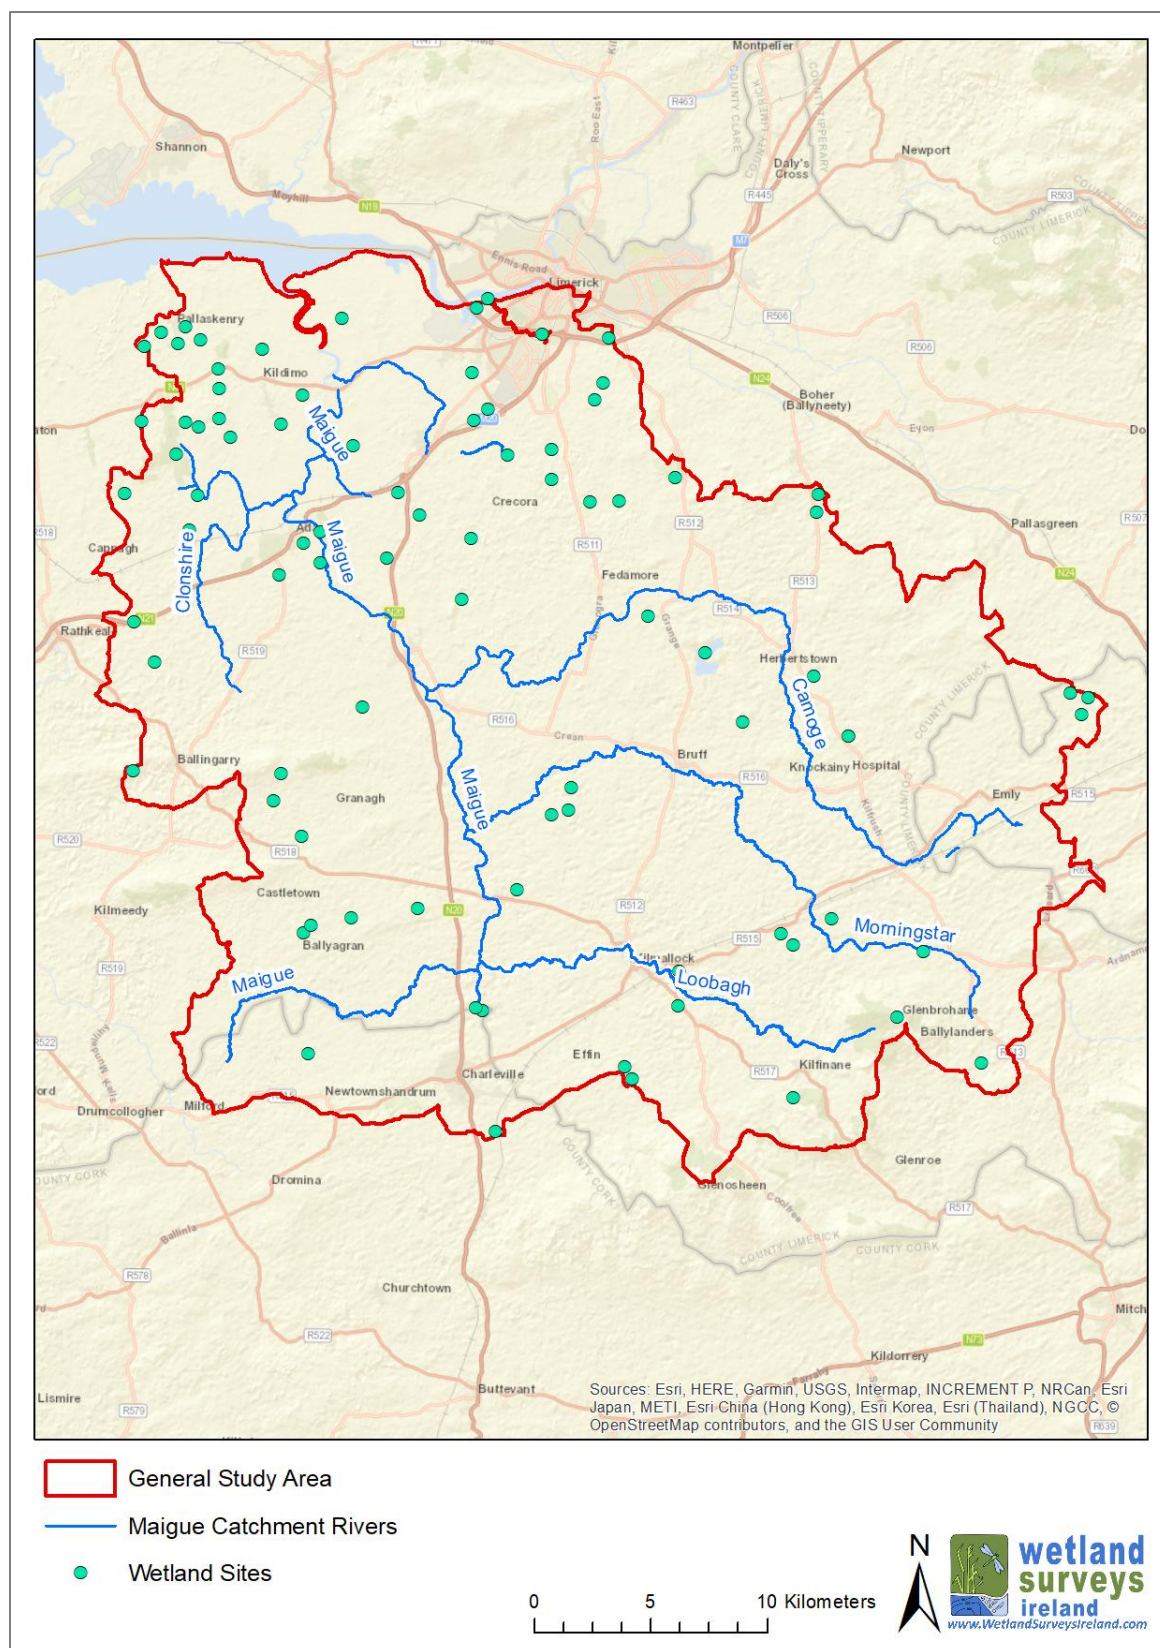
While there was an absence of wetland sites present on the banks of the Maigue and the main tributaries within the 50m survey zone, there are a number of wetland sites present in the wider catchment. A review of the Map of Irish Wetlands (Foss & Crushell 2019) identified 75 wetland sites in the area (Figure 4). It may be worth reviewing and surveying these sites, to build an inventory of wetlands in the catchment area, provide management recommendations for them, and ensure their protection as valuable biodiversity areas.

Figure 4: Location of wetland sites (Foss and Crushell 2019) within the Maigue catchment.

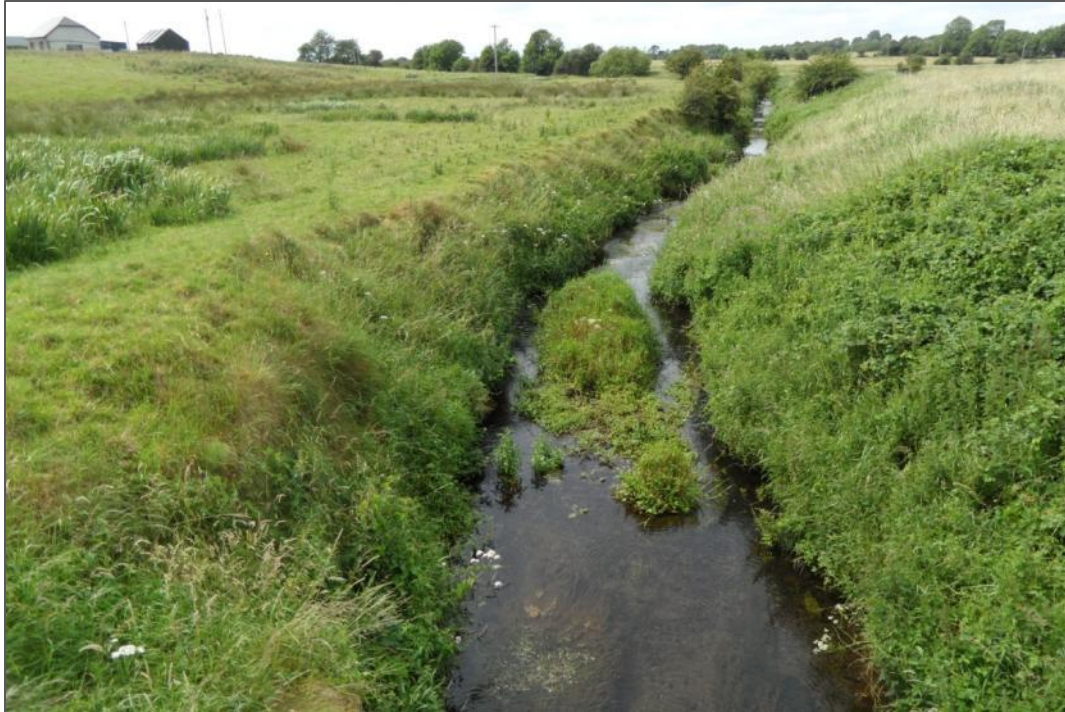
Plate 3: Mosaic of improved agricultural grassland and wet grassland (left bank) (Site Code: MS03).

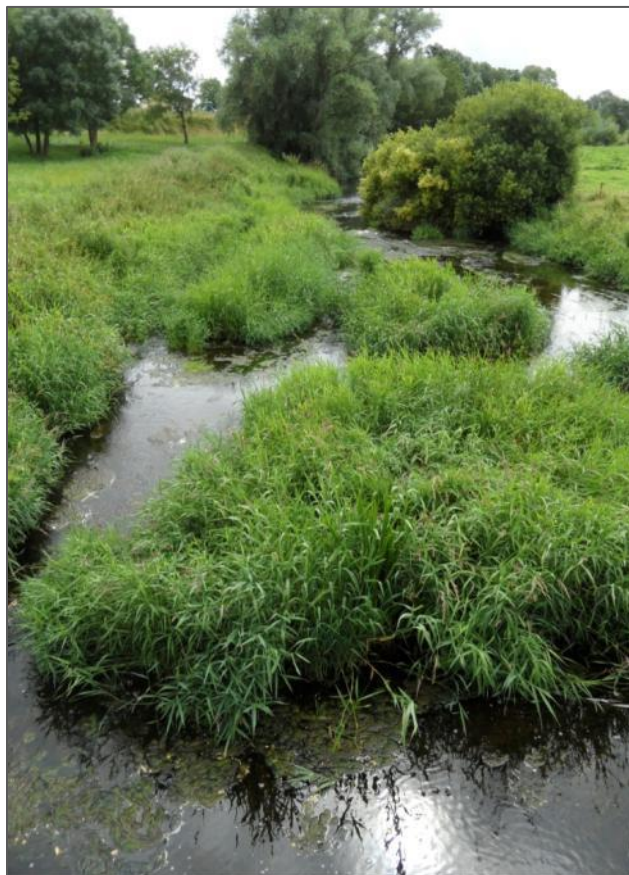
Reed Canary Grass is the dominant species in the smaller in-stream reed bed areas, which are typically species poor habitats (Plate 9). The larger reed swamp areas in the lower part of the main Maigue channel are dominated by Common Reed (*Phragmites australis*), with other species present including Yellow Flag Iris, Nettle, Hemlock Water-dropwort (*Oenanthe crocata*) and Bindweed (Plate 10). Additional species present in this habitat included Fool's Water-cress, Horetail (*Equisitum* sp.), Water Plantain (*Alisma plantago-aquatica*), and Brooklime (*Veronica beccabunga*).

Plate 9: Area of in-stream and stream edge reedswamp dominated by Reed Canary Grass on the Camoge near Coolfune (Site Code: CM12).

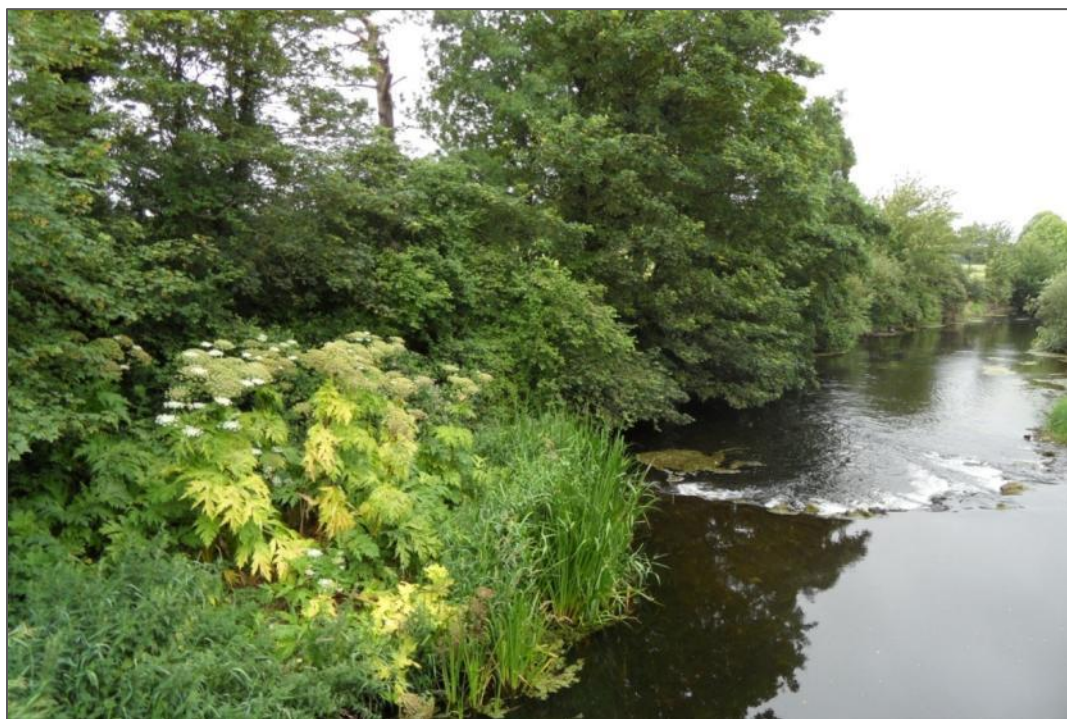
Plate 12: Giant Hogweed (left hand side) on the banks of the river Maigue (Site Code: MG11).

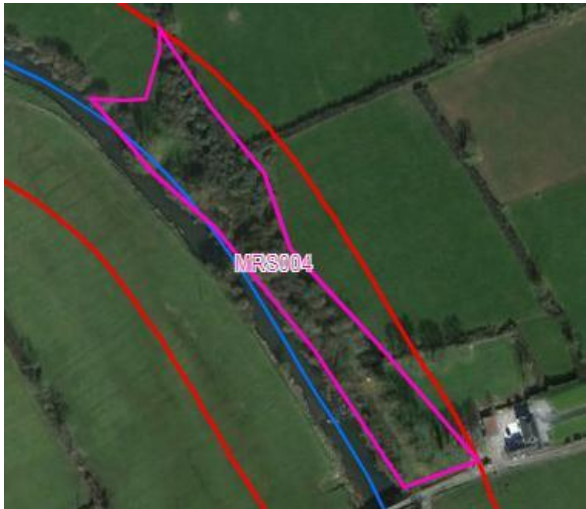
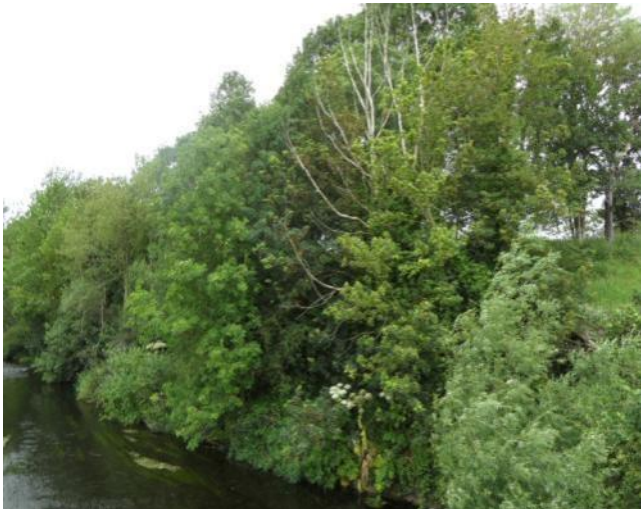
Site Code: MRS 004	River: Maigue
Habitat Code: WL2	Biodiversity value: Local value
Description: Double treeline along track parallel with river. The stream side is on a very steep bank, which drops 10m to the river. Sycamore (<i>Acer pseudoplatanus</i>) is dominant, with Ash (<i>Fraxinus excelsior</i>) and Willow (<i>Salix</i> sp.) bushes near the river. Grassy understory. Giant Hogweed (<i>Heracleum mantegazzianum</i>) present.

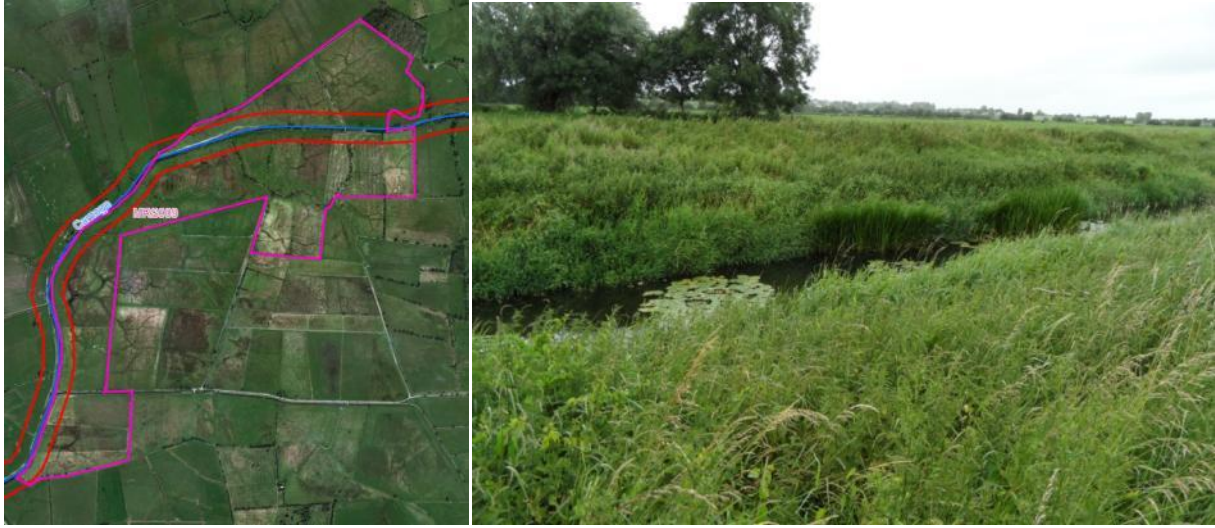
Site Code: MRS 009	River: Camoge
Habitat Code: GA1	Biodiversity value: Local value
<p>Description: Area has been extensively drained and is now covered by improved agricultural grassland. Hay was being cut during field visit. Along the river channel there is a thin band of dry meadow and grassy verge vegetation. Species present include Creeping Thistle (<i>Cirsium arvense</i>), False oat-grass (<i>Arrhenatherum elatius</i>), Hedge Bindweed (<i>Calystegia sepium</i>), and Nettles (<i>Urtica dioica</i>). This band of vegetation grades into reed and large sedge swamp dominated by Reed Canary Grass (<i>Phalaris arundinacea</i>). Yellow Water-lily (<i>Nuphar lutea</i>) was also present adjacent to the area of reed swamp.</p>
