River Maigue Catchment Riparian Habitat Study

RIVER MAIGUE RIPARIAN HABITAT SURVEYS

FINAL REPORT

Prepared by Wetland Surveys

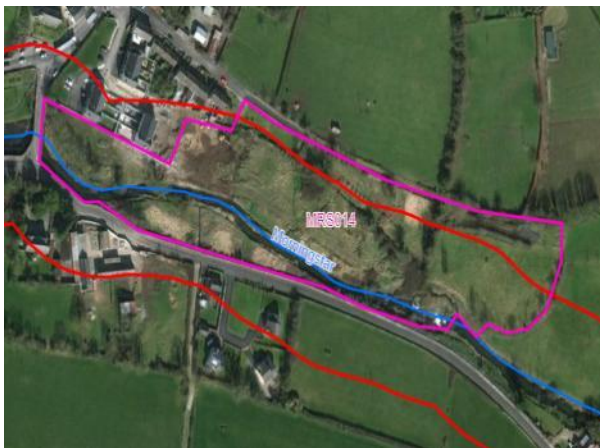
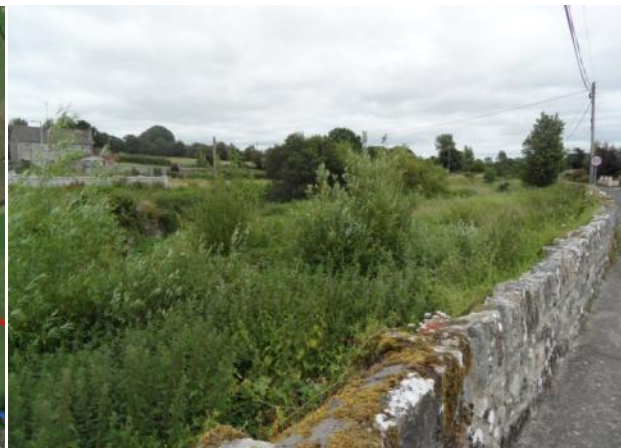
Site Code: MRS 014	River: Morningstar
Habitat Code: GS2 / WS1	Biodiversity value: Local value
<p>Description: Nettle (<i>Urtica dioica</i>) dominated area with some Willow (<i>Salix</i> sp.) scrub. Rank grasses, Brambles (<i>Rubus fruticosus</i> agg.), Thistle (<i>Cirsium arvense</i>), and Butterbur (<i>Petasites hybridus</i>). Highly disturbed ground.</p>

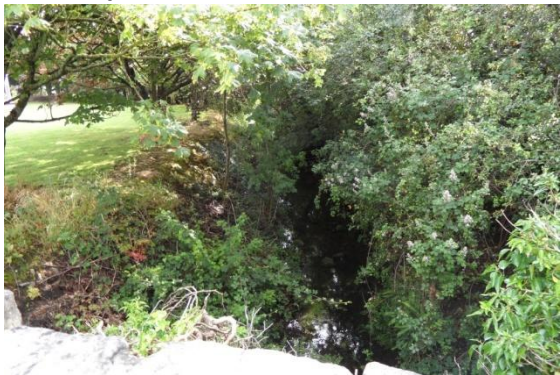
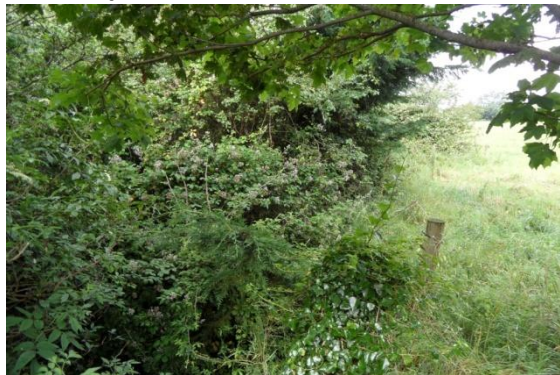
River: Barnakyle	Site Code: BK01																											
Survey Date: 16/07/2019	Surveyors: PF and MCG																											
Photo U/S

U/S	D/S	Channel form and flow	0	0	Channel vegetation	2	2	Substrate condition	2	2	Barriers to continuity	4	4	Bank structure and stability	0	0	Bank vegetation	0	0	Riparian land cover	0	0	Floodplain connectivity	0	0
	U/S	D/S																										
Channel form and flow	0	0																										
Channel vegetation	2	2																										
Substrate condition	2	2																										
Barriers to continuity	4	4																										
Bank structure and stability	0	0																										
Bank vegetation	0	0																										
Riparian land cover	0	0																										
Floodplain connectivity	0	0																										
Total Score: 16	Spot-Check Class: Poor																											
Comments: Upper reaches of the river, channel width approx 2m. Channel has been deepened, limited vegetation present on bank, some erosion present upstream. Adjoining land use comprises residential houses, and roads.

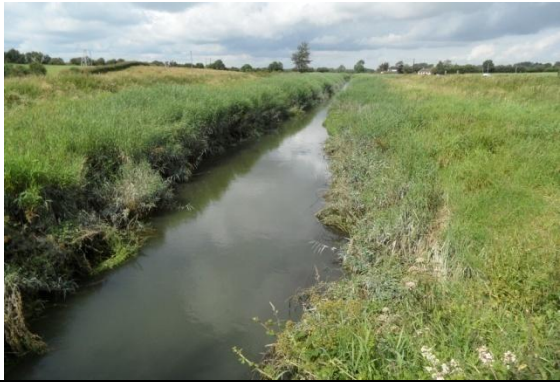
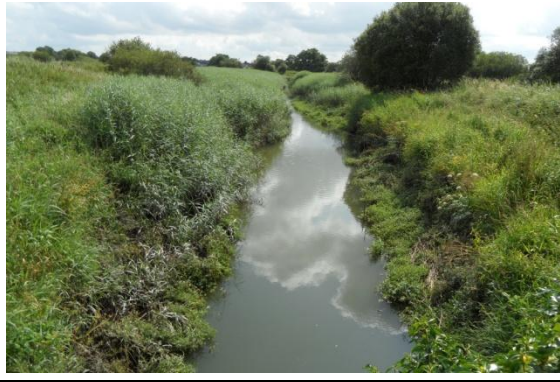
River: Barnakyle	Site Code: BK02																												
Survey Date: 16/07/2019	Surveyors: PF and MCG																												
Photo U/S

U/S	D/S	Channel from and flow	0	0	Channel vegetation	4	4	Substrate condition	4	4	Barriers to continuity	4	4	Bank structure and stability	0	0	Bank vegetation	4	4	Riparian land cover	3	3	Floodplain connectivity	0	0
	U/S	D/S																											
Channel from and flow	0	0																											
Channel vegetation	4	4																											
Substrate condition	4	4																											
Barriers to continuity	4	4																											
Bank structure and stability	0	0																											
Bank vegetation	4	4																											
Riparian land cover	3	3																											
Floodplain connectivity	0	0																											
Total Score: 38	Spot-Check Class: Moderate																												
Comments: Channel approx 6m wide. The channel has been extensively widened, with sediment placed on adjoining land to create earth bank. Thick band of Common Reed (<i>Phragmites australis</i>) present on both sides of the channel.

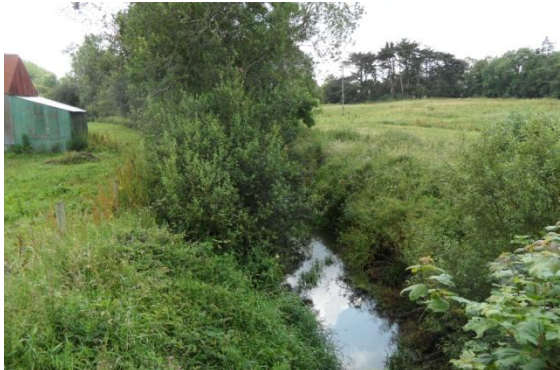
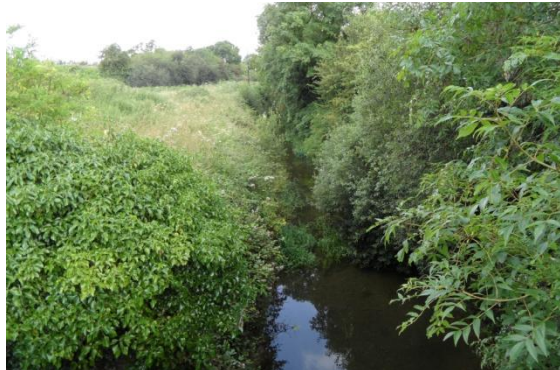
River: Barnakyle	Site Code: BK03																												
Survey Date: 16/07/2019	Surveyors: PF and MCG																												
Photo U/S

U/S	D/S	Channel form and flow	0	0	Channel vegetation	3	3	Substrate condition	2	2	Barriers to continuity	4	4	Bank structure and stability	2	2	Bank vegetation	2	2	Riparian land cover	0	0	Floodplain connectivity	0	0
	U/S	D/S																											
Channel form and flow	0	0																											
Channel vegetation	3	3																											
Substrate condition	2	2																											
Barriers to continuity	4	4																											
Bank structure and stability	2	2																											
Bank vegetation	2	2																											
Riparian land cover	0	0																											
Floodplain connectivity	0	0																											
Total Score: 26	Spot-Check Class: Poor																												
Comments: Channel width 3-4m. No treeline on left bank upstream or downstream. Fishing platform present downstream, bare soil and source of sedimentation present surrounding it.

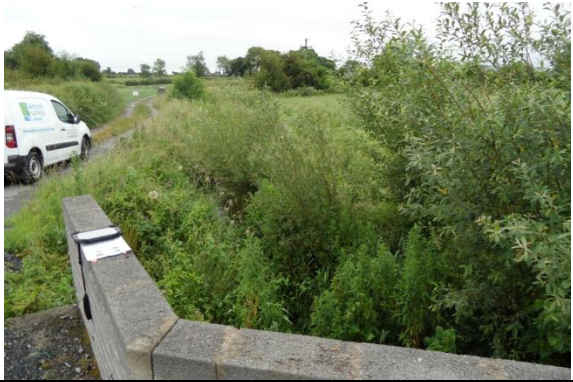
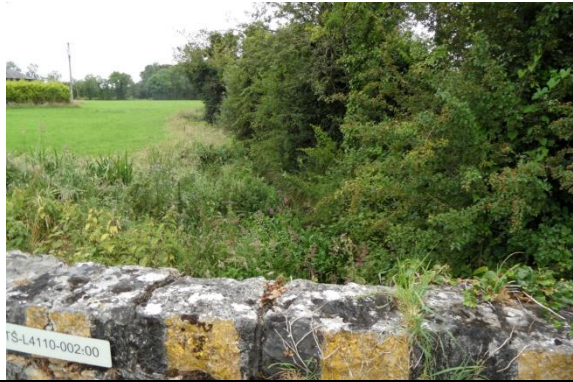
River: Camoge	Site Code: CM01																											
Survey Date: 11/07/2019	Surveyors: PF and MCG																											
Photo U/S

U/S	D/S	Channel from and flow	0	0	Channel vegetation	4	4	Substrate condition	3	3	Barriers to continuity	4	4	Bank structure and stability	4	4	Bank vegetation	1	1	Riparian land cover	0	0	Floodplain connectivity	0	0
	U/S	D/S																										
Channel from and flow	0	0																										
Channel vegetation	4	4																										
Substrate condition	3	3																										
Barriers to continuity	4	4																										
Bank structure and stability	4	4																										
Bank vegetation	1	1																										
Riparian land cover	0	0																										
Floodplain connectivity	0	0																										
Total Score: 32	Spot-Check Class: Moderate																											
Comments: Narrow channel up to 2m wide. Channel is infilled with Reed Canary Grass (<i>Phalaris arundinacea</i>) and Fool's-water-cress (<i>Apium nodiflorum</i>) with Thistle (<i>Cirsium</i> sp.) and Nettles (<i>Urtica dioica</i>) on the banks. River is just a slow trickle at this point.

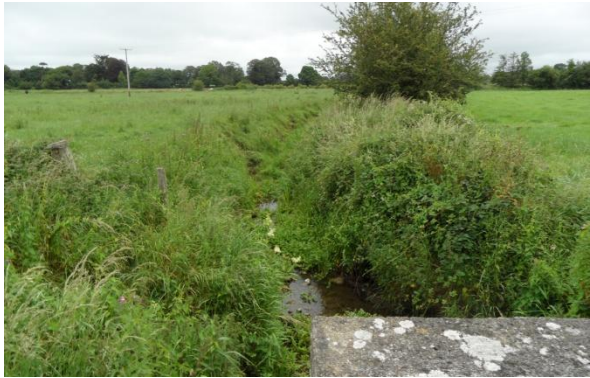
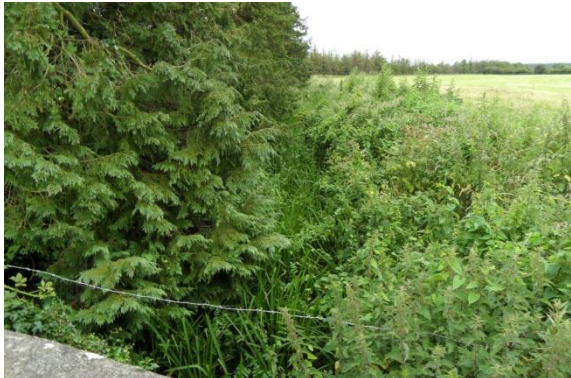
River: Camoge	Site Code: CM02																											
Survey Date: 11/07/2019	Surveyors: PF and MCG																											
Photo U/S

U/S	D/S	Channel from and flow	0	0	Channel vegetation	4	4	Substrate condition	1	1	Barriers to continuity	4	4	Bank structure and stability	1	2	Bank vegetation	0	0	Riparian land cover	1	0	Floodplain connectivity	0	0
	U/S	D/S																										
Channel from and flow	0	0																										
Channel vegetation	4	4																										
Substrate condition	1	1																										
Barriers to continuity	4	4																										
Bank structure and stability	1	2																										
Bank vegetation	0	0																										
Riparian land cover	1	0																										
Floodplain connectivity	0	0																										
Total Score: 22	Spot-Check Class: Poor																											
Comments: Stream 1m wide, with Fool's-water-cress (<i>Apium nodiflorum</i>) and Branched Bur-reed (<i>Sparganium erectum</i>) in channel. Bank erosion present. No fence. Downstream channel is subject to extensive shading from Cypress (<i>Cypress sp.</i>) treeline.

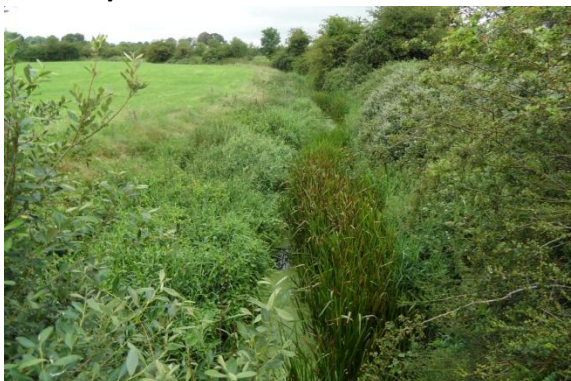
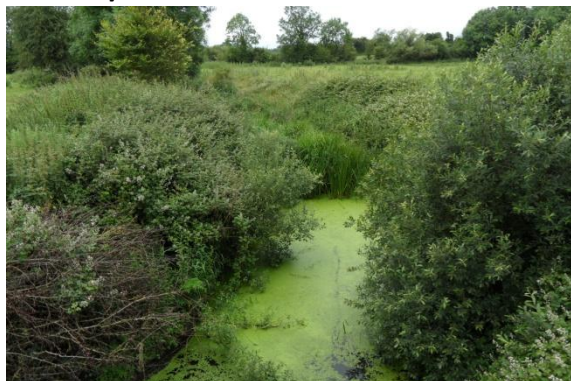
River: Camoge	Site Code: CM03																												
Survey Date: 11/07/2019	Surveyors: PF and MCG																												
Photo U/S

U/S	D/S	Channel from and flow	0	0	Channel vegetation	4	4	Substrate condition	2	2	Barriers to continuity	4	4	Bank structure and stability	3	3	Bank vegetation	1	1	Riparian land cover	0	0	Floodplain connectivity	0	0
	U/S	D/S																											
Channel from and flow	0	0																											
Channel vegetation	4	4																											
Substrate condition	2	2																											
Barriers to continuity	4	4																											
Bank structure and stability	3	3																											
Bank vegetation	1	1																											
Riparian land cover	0	0																											
Floodplain connectivity	0	0																											
Total Score: 28	Spot-Check Class: Poor																												
Comments: <p>This stretch of the river is highly altered and has been straightened and widened. Channel width is approx. 3m and is infilled with Branched Bur-reed (<i>Sparganium erectum</i>), Reed Canary Grass (<i>Phalaris arundinacea</i>) and Bindweed (<i>Calystegia sepium</i>). Duckweed (<i>Lemna</i> sp.) present in open channel areas.</p>

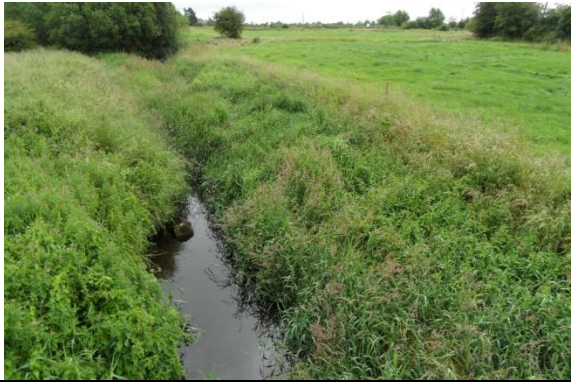
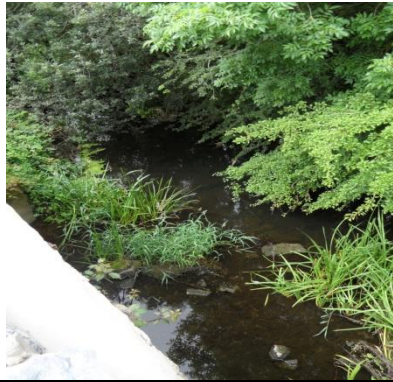
River: Camoge	Site Code: CM04																												
Survey Date: 11/07/2019	Surveyors: PF and MCG																												
Photo U/S

U/S	D/S	Channel from and flow	0	2	Channel vegetation	4	3	Substrate condition	2	3	Barriers to continuity	4	4	Bank structure and stability	0	1	Bank vegetation	1	2	Riparian land cover	0	1	Floodplain connectivity	0	0
	U/S	D/S																											
Channel from and flow	0	2																											
Channel vegetation	4	3																											
Substrate condition	2	3																											
Barriers to continuity	4	4																											
Bank structure and stability	0	1																											
Bank vegetation	1	2																											
Riparian land cover	0	1																											
Floodplain connectivity	0	0																											
Total Score: 27	Spot-Check Class: Poor																												
Comments: Upstream channel is approx. 2.5-3m wide, infilled with Reed Canary Grass (<i>Phalaris arundinacea</i>). The downstream stretch has a steep bank which is overgrown with Willow (<i>Salix</i> sp.) / Ash (<i>Fraxinus excelsior</i>) scrub. Downstream section is less altered than upstream section.

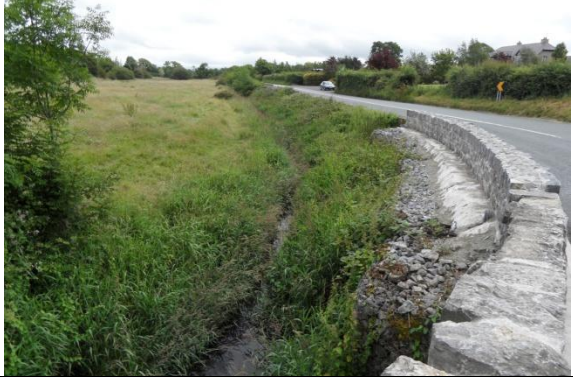
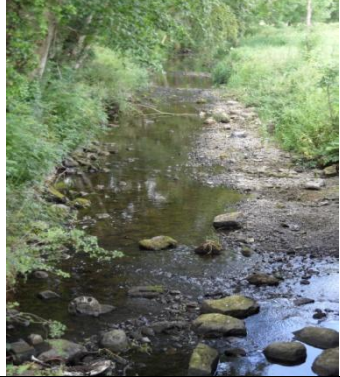
River: Camoge	Site Code: CM05																											
Survey Date: 11/07/2019	Surveyors: PF and MCG																											
Photo U/S

U/S	D/S	Channel from and flow	0	4	Channel vegetation	4	4	Substrate condition	2	4	Barriers to continuity	4	4	Bank structure and stability	0	4	Bank vegetation	1	3	Riparian land cover	1	1	Floodplain connectivity	0	0
	U/S	D/S																										
Channel from and flow	0	4																										
Channel vegetation	4	4																										
Substrate condition	2	4																										
Barriers to continuity	4	4																										
Bank structure and stability	0	4																										
Bank vegetation	1	3																										
Riparian land cover	1	1																										
Floodplain connectivity	0	0																										
Total Score: 36	Spot-Check Class: Moderate																											
Comments: <p>The upstream section has been extensively modified. The bank has been straightened and rock armature is present on the right hand side. Channel is infilled with Reed Canary Grass (<i>Phalaris arundinacea</i>). The downstream section appears relatively unmodified, with gravel areas present at side and Beech treeline. Channel width up to 5m downstream, but only 2m upstream.</p>

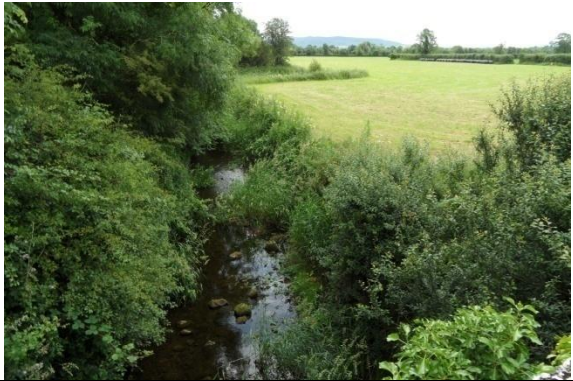
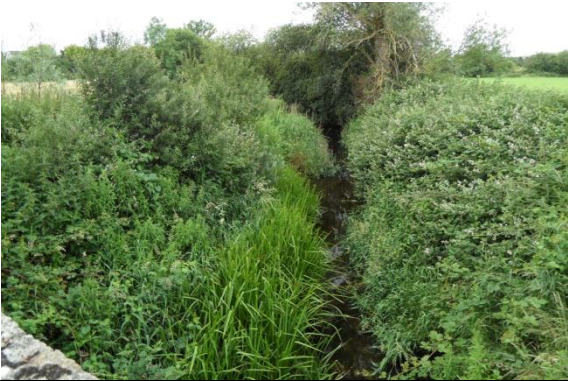
River: Camoge	Site Code: CM06																											
Survey Date: 11/07/2019	Surveyors: PF and MCG																											
Photo U/S

U/S	D/S	Channel from and flow	1	1	Channel vegetation	4	4	Substrate condition	3	3	Barriers to continuity	4	4	Bank structure and stability	3	3	Bank vegetation	1	1	Riparian land cover	0	0	Floodplain connectivity	0	0
	U/S	D/S																										
Channel from and flow	1	1																										
Channel vegetation	4	4																										
Substrate condition	3	3																										
Barriers to continuity	4	4																										
Bank structure and stability	3	3																										
Bank vegetation	1	1																										
Riparian land cover	0	0																										
Floodplain connectivity	0	0																										
Total Score: 32	Spot-Check Class: Moderate																											
Comments: This section of river has been straightened and deepened, channel 3m wide.

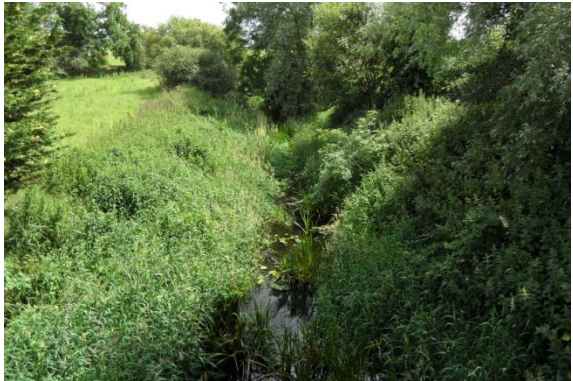
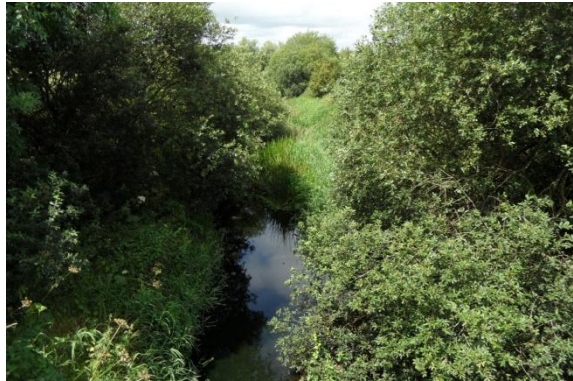
River: Camoge	Site Code: CM07																											
Survey Date: 11/07/2019	Surveyors: PF and MCG																											
Photo U/S

U/S	D/S	Channel from and flow	4	4	Channel vegetation	4	4	Substrate condition	2	2	Barriers to continuity	4	4	Bank structure and stability	4	4	Bank vegetation	3	3	Riparian land cover	0	0	Floodplain connectivity	0	0
	U/S	D/S																										
Channel from and flow	4	4																										
Channel vegetation	4	4																										
Substrate condition	2	2																										
Barriers to continuity	4	4																										
Bank structure and stability	4	4																										
Bank vegetation	3	3																										
Riparian land cover	0	0																										
Floodplain connectivity	0	0																										
Total Score: 42	Spot-Check Class: Good																											
Comments: Channel width 4-5m, with Branched Bur-reed (<i>Sparganium erectum</i>), Reed Canary Grass (<i>Phalaris arundinacea</i>), Yellow Water-lily (<i>Nuphar lutea</i>), and Common Club-rush (<i>Schoenoplectus lacustris</i>). Duckweed (<i>Lemna</i> sp.) is present in some open areas of channel. Riparian vegetation is beginning to become more diverse here, with multiple layers present in some parts.

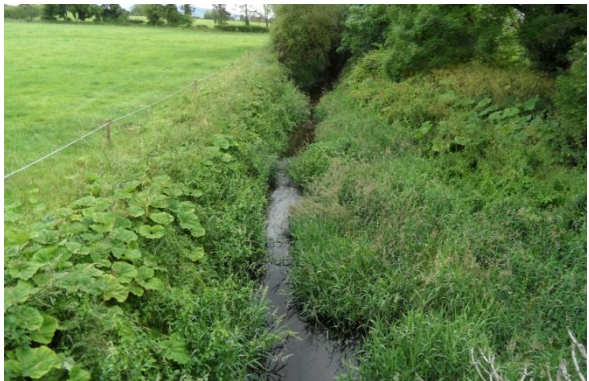
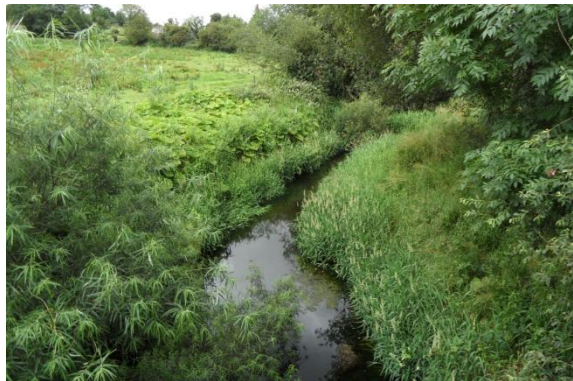
River: Camoge	Site Code: CM08																											
Survey Date: 11/07/2019	Surveyors: PF and MCG																											
Photo U/S

U/S	D/S	Channel from and flow	1	1	Channel vegetation	4	4	Substrate condition	1	1	Barriers to continuity	4	4	Bank structure and stability	4	4	Bank vegetation	1	1	Riparian land cover	0	0	Floodplain connectivity	0	0
	U/S	D/S																										
Channel from and flow	1	1																										
Channel vegetation	4	4																										
Substrate condition	1	1																										
Barriers to continuity	4	4																										
Bank structure and stability	4	4																										
Bank vegetation	1	1																										
Riparian land cover	0	0																										
Floodplain connectivity	0	0																										
Total Score: 30	Spot-Check Class: Moderate																											
Comments: Channel 4-5m wide. Extensive areas of banks are colonised by Butterbur (<i>Petasites hybridus</i>).

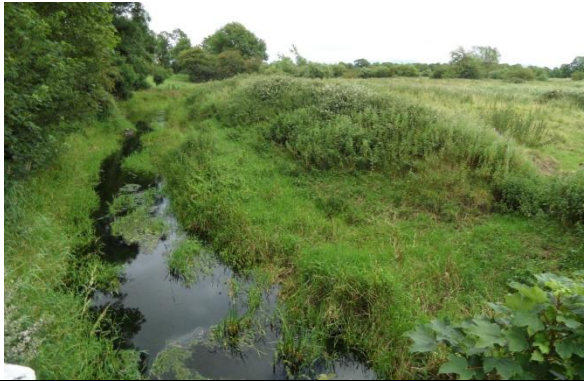
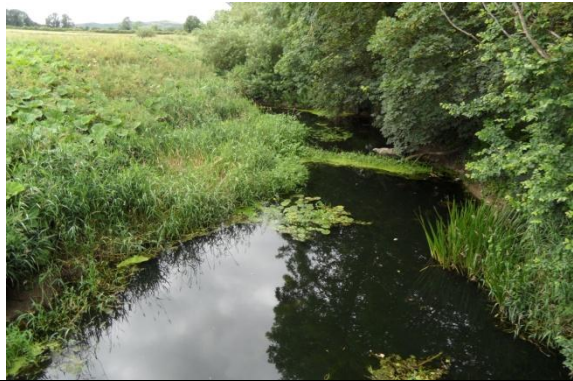
River: Camoge	Site Code: CM09																											
Survey Date: 11/07/2019	Surveyors: PF and MCG																											
Photo U/S

U/S	D/S	Channel form and flow	0	1	Channel vegetation	3	4	Substrate condition	2	2	Barriers to continuity	4	4	Bank structure and stability	2	2	Bank vegetation	1	1	Riparian land cover	0	0	Floodplain connectivity	0	0
	U/S	D/S																										
Channel form and flow	0	1																										
Channel vegetation	3	4																										
Substrate condition	2	2																										
Barriers to continuity	4	4																										
Bank structure and stability	2	2																										
Bank vegetation	1	1																										
Riparian land cover	0	0																										
Floodplain connectivity	0	0																										
Total Score: 26	Spot-Check Class: Poor																											
Comments: Channel width 4-8m. River is slow flowing and there are extensive areas without channel vegetation. Some areas of bare soil at base of river banks which are eroding. Earth bund associated with arterial drainage visible on upstream side of bridge. Trout present in pool.

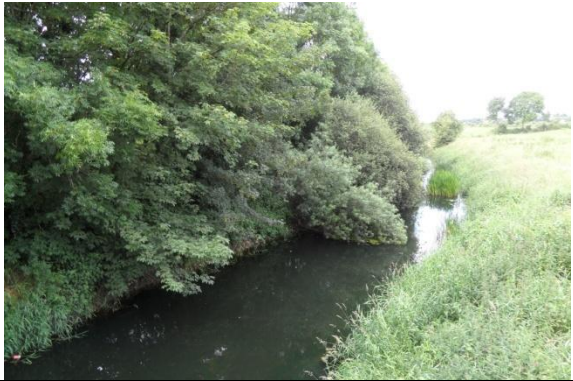
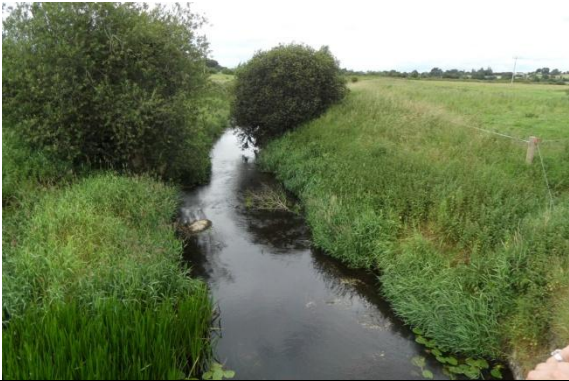
River: Camoge	Site Code: CM10																											
Survey Date: 11/07/2019	Surveyors: PF and MCG																											
Photo U/S

U/S	D/S	Channel form and flow	0	0	Channel vegetation	3	3	Substrate condition	2	2	Barriers to continuity	4	4	Bank structure and stability	0	0	Bank vegetation	0	0	Riparian land cover	0	0	Floodplain connectivity	0	0
	U/S	D/S																										
Channel form and flow	0	0																										
Channel vegetation	3	3																										
Substrate condition	2	2																										
Barriers to continuity	4	4																										
Bank structure and stability	0	0																										
Bank vegetation	0	0																										
Riparian land cover	0	0																										
Floodplain connectivity	0	0																										
Total Score: 18	Spot-Check Class: Poor																											
Comments: Extensively altered stretch of river. Channel has been deepened and straightened. Channel width 4-5m. Emergent vegetation includes Branched Bur-reed (<i>Sparganium erectum</i>), Reed Canary Grass (<i>Phalaris arundinacea</i>), and patches of Yellow Water-lily (<i>Nuphar lutea</i>).

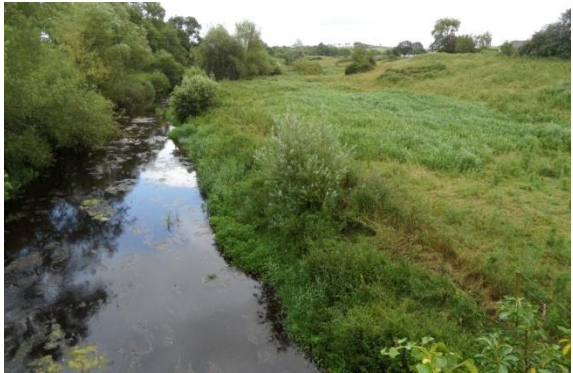
River: Camoge	Site Code: CM11																											
Survey Date: 17/07/2019	Surveyors: PF and MCG																											
Photo U/S

U/S	D/S	Channel form and flow	1	1	Channel vegetation	2	1	Substrate condition	2	2	Barriers to continuity	4	4	Bank structure and stability	2	2	Bank vegetation	2	1	Riparian land cover	0	0	Floodplain connectivity	0	0
	U/S	D/S																										
Channel form and flow	1	1																										
Channel vegetation	2	1																										
Substrate condition	2	2																										
Barriers to continuity	4	4																										
Bank structure and stability	2	2																										
Bank vegetation	2	1																										
Riparian land cover	0	0																										
Floodplain connectivity	0	0																										
Total Score: 24	Spot-Check Class: Poor																											
Comments: Channel 6m wide. Excess algae present on surface, in particular downstream. Absence of treeline downstream, but limited trees present along upstream banks. Cattle access river from downstream left bank. Wet grassland present on left bank up and down stream.

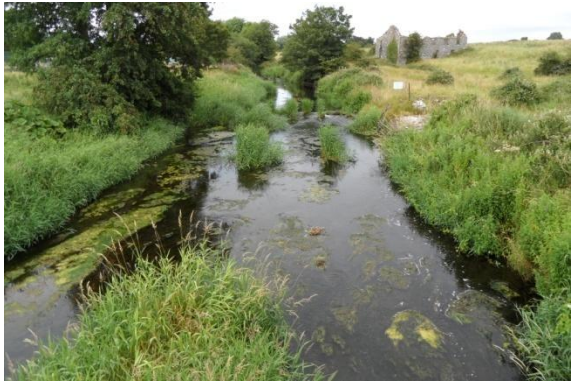
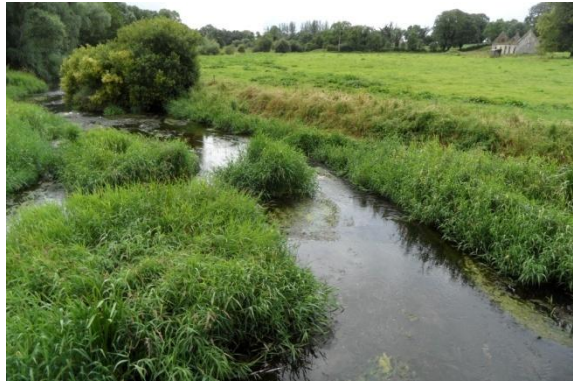
River: Camoge	Site Code: CM12																											
Survey Date: 17/07/2019	Surveyors: PF and MCG																											
Photo U/S

U/S	D/S	Channel form and flow	2	3	Channel vegetation	3	2	Substrate condition	2	2	Barriers to continuity	4	4	Bank structure and stability	1	2	Bank vegetation	1	3	Riparian land cover	0	0	Floodplain connectivity	0	0
	U/S	D/S																										
Channel form and flow	2	3																										
Channel vegetation	3	2																										
Substrate condition	2	2																										
Barriers to continuity	4	4																										
Bank structure and stability	1	2																										
Bank vegetation	1	3																										
Riparian land cover	0	0																										
Floodplain connectivity	0	0																										
Total Score: 29	Spot-Check Class: Moderate																											
Comments: Channel up to 10 m wide. Cattle access and erosion visible upstream. No treeline present along upstream banks. Section of bank reinforcement on right upstream, likely to do with adjacent ruined building. Green algae visible on surface and in water column.

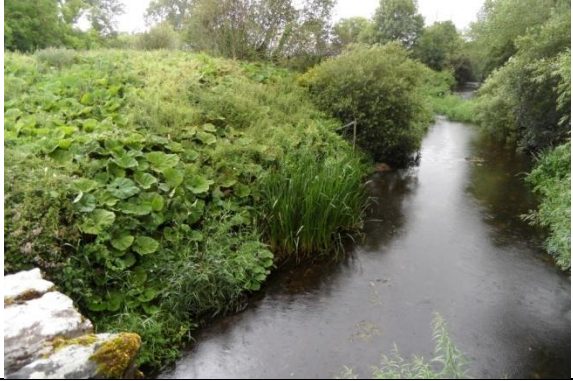
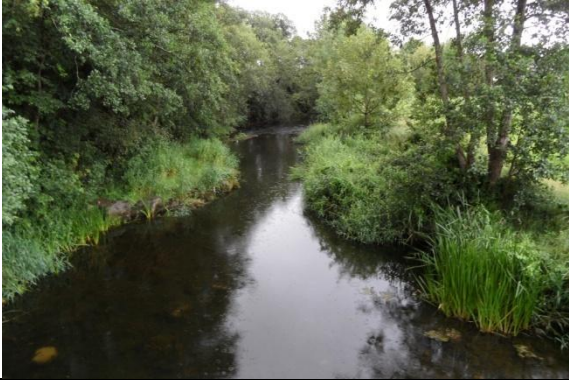
River: Camoge	Site Code: CM13																											
Survey Date: 17/07/2019	Surveyors: PF and MCG																											
Photo U/S

U/S	D/S	Channel form and flow	4	3	Channel vegetation	2	2	Substrate condition	2	2	Barriers to continuity	4	4	Bank structure and stability	2	1	Bank vegetation	2	3	Riparian land cover	0	0	Floodplain connectivity	0	0
	U/S	D/S																										
Channel form and flow	4	3																										
Channel vegetation	2	2																										
Substrate condition	2	2																										
Barriers to continuity	4	4																										
Bank structure and stability	2	1																										
Bank vegetation	2	3																										
Riparian land cover	0	0																										
Floodplain connectivity	0	0																										
Total Score: 31	Spot-Check Class: Moderate																											
Comments: Channel up to 10m wide. Area of reclaimed land surrounded by boulders, present downstream, likely a fishing location. Riparian vegetation limited, treeline present on left hand bank, limited on right bank. Relatively high cover of algae on the substrate, but no surface algae.

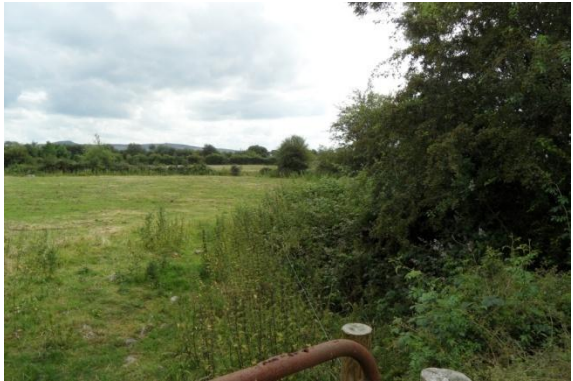
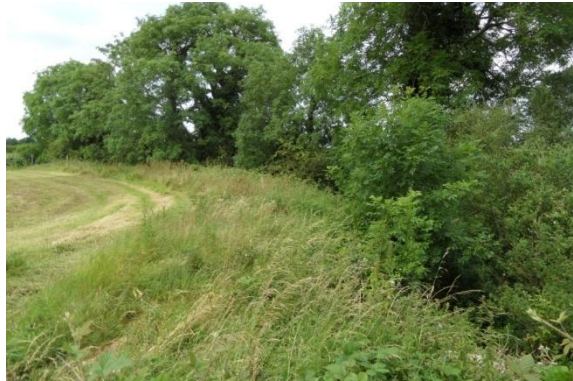
River: Clonshire	Site Code: CS01																												
Survey Date: 16/07/2019	Surveyors: PF and MCG																												
Photo U/S

U/S	D/S	Channel form and flow	0	0	Channel vegetation	2	2	Substrate condition	2	2	Barriers to continuity	4	4	Bank structure and stability	0	0	Bank vegetation	0	0	Riparian land cover	0	0	Floodplain connectivity	0	0
	U/S	D/S																											
Channel form and flow	0	0																											
Channel vegetation	2	2																											
Substrate condition	2	2																											
Barriers to continuity	4	4																											
Bank structure and stability	0	0																											
Bank vegetation	0	0																											
Riparian land cover	0	0																											
Floodplain connectivity	0	0																											
Total Score: 16	Spot-Check Class: Poor																												
Comments: Very narrow section of channel, 1-2m wide. There has been significant alteration to channel, and it is shaded and overhung by scrub and treelines. No significant riparian vegetation present. Bank side vegetation is dominated by Bramble (<i>Rubus fruticosus</i> agg.), Ash (<i>Fraxinus excelsior</i>) and Hawthorn (<i>Crataegus monogyna</i>) dominated. The majority of the treeline present is comprised of Ash. GA1 adjoins river channel with only a narrow strip of bankside vegetation present.

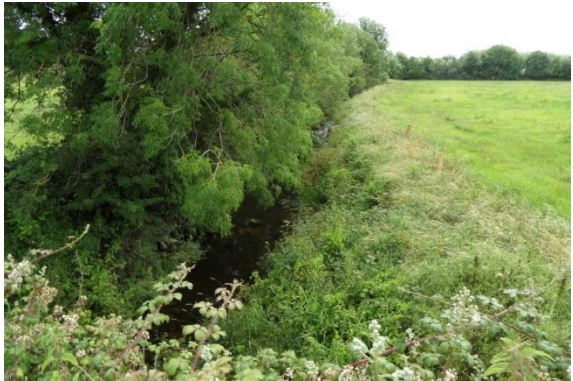
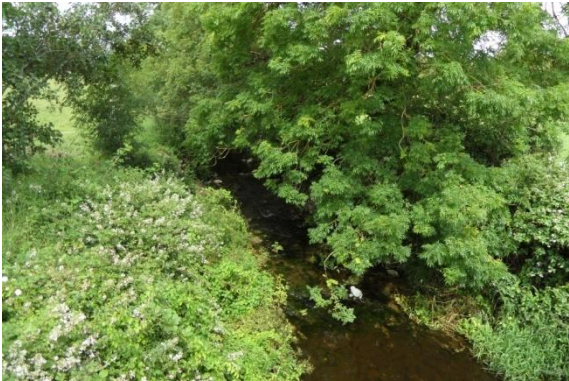
River: Clonshire	Site Code: CS02																												
Survey Date: 16/07/2019	Surveyors: PF and MCG																												
Photo U/S

U/S	D/S	Channel form and flow	0	0	Channel vegetation	3	2	Substrate condition	3	2	Barriers to continuity	4	4	Bank structure and stability	2	1	Bank vegetation	1	0	Riparian land cover	0	0	Floodplain connectivity	0	0
	U/S	D/S																											
Channel form and flow	0	0																											
Channel vegetation	3	2																											
Substrate condition	3	2																											
Barriers to continuity	4	4																											
Bank structure and stability	2	1																											
Bank vegetation	1	0																											
Riparian land cover	0	0																											
Floodplain connectivity	0	0																											
Total Score: 22	Spot-Check Class: Poor																												
Comments: Channel approx 3m wide. Riparian vegetation completely absent from the left bank upstream and downstream. Overhanging trees on the right bank are beginning to shade out the channel in places. Intensive GA1 fields are almost directly adjoining steep bank. Previous channel clearance has been carried out. Cattle access on downstream stretch, resulting in erosion and sedimentation. Brown trout in river.

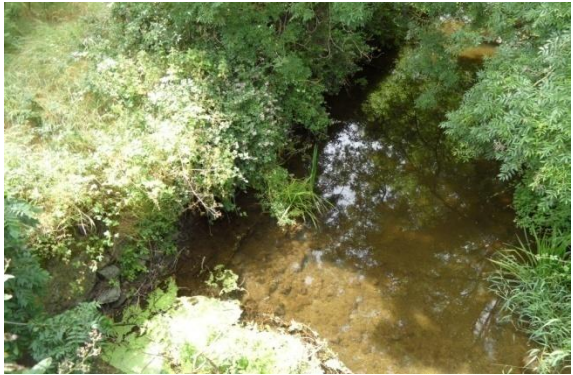
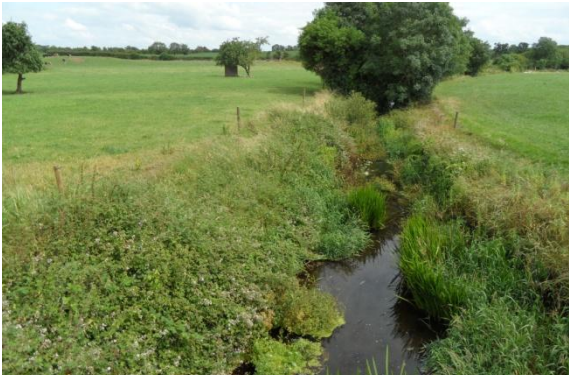
River: Clonshire	Site Code: CS03																												
Survey Date: 16/07/2019	Surveyors: PF and MCG																												
Photo U/S

U/S	D/S	Channel form and flow	3	3	Channel vegetation	3	2	Substrate condition	2	2	Barriers to continuity	4	4	Bank structure and stability	2	3	Bank vegetation	1	2	Riparian land cover	0	0	Floodplain connectivity	0	0
	U/S	D/S																											
Channel form and flow	3	3																											
Channel vegetation	3	2																											
Substrate condition	2	2																											
Barriers to continuity	4	4																											
Bank structure and stability	2	3																											
Bank vegetation	1	2																											
Riparian land cover	0	0																											
Floodplain connectivity	0	0																											
Total Score: 31	Spot-Check Class: Moderate																												
Comments: Channel 5-6m wide. The upstream section is shaded by an overhanging Ash (<i>Fraxinus excelsior</i>) treeline. Limited riparian zone present, GA1 present to bank edge. Some straightening and deepening was previously carried out.

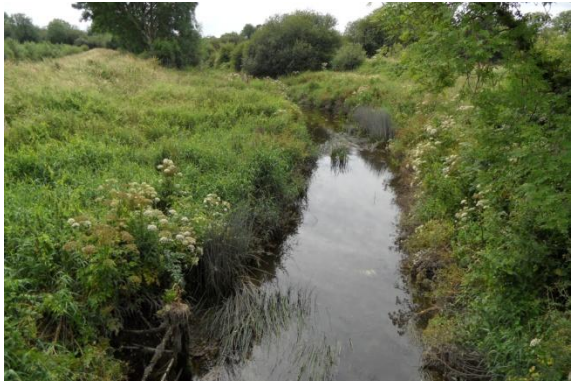
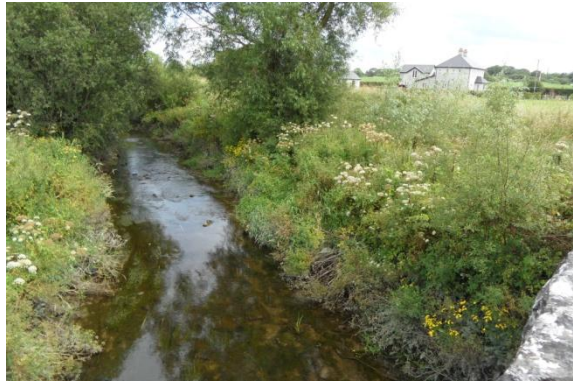
River: Clonshire	Site Code: CS04																											
Survey Date: 16/07/2019	Surveyors: PF and MCG																											
Photo U/S

U/S	D/S	Channel form and flow	1	1	Channel vegetation	3	3	Substrate condition	3	3	Barriers to continuity	4	4	Bank structure and stability	2	1	Bank vegetation	2	2	Riparian land cover	0	0	Floodplain connectivity	0	0
	U/S	D/S																										
Channel form and flow	1	1																										
Channel vegetation	3	3																										
Substrate condition	3	3																										
Barriers to continuity	4	4																										
Bank structure and stability	2	1																										
Bank vegetation	2	2																										
Riparian land cover	0	0																										
Floodplain connectivity	0	0																										
Total Score: 29	Spot-Check Class: Moderate																											
Comments: Channel 4-5m wide. Has been deepened and straightened, Earth banks present. In general treelines are absent.

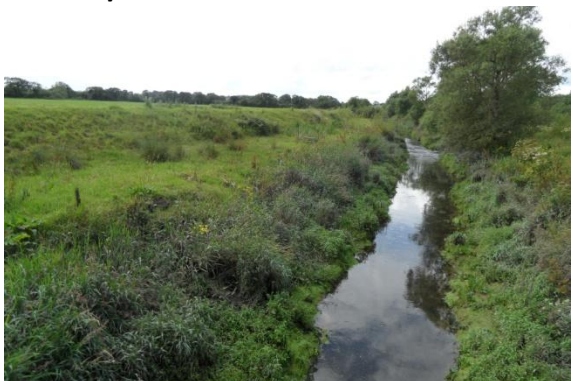
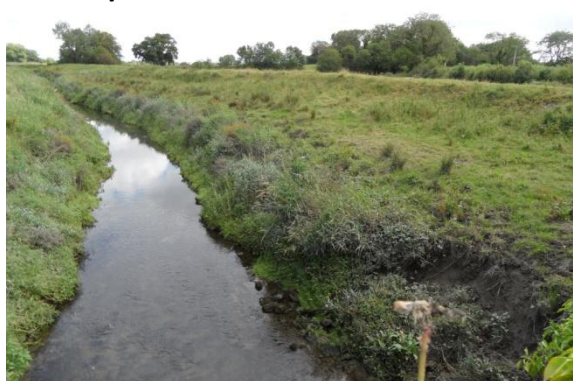
River: Clonshire	Site Code: CS05																											
Survey Date: 16/07/2019	Surveyors: PF and MCG																											
Photo U/S

U/S	D/S	Channel form and flow	0	0	Channel vegetation	2	2	Substrate condition	1	1	Barriers to continuity	4	4	Bank structure and stability	1	1	Bank vegetation	0	1	Riparian land cover	0	0	Floodplain connectivity	0	0
	U/S	D/S																										
Channel form and flow	0	0																										
Channel vegetation	2	2																										
Substrate condition	1	1																										
Barriers to continuity	4	4																										
Bank structure and stability	1	1																										
Bank vegetation	0	1																										
Riparian land cover	0	0																										
Floodplain connectivity	0	0																										
Total Score: 17	Spot-Check Class: Poor																											
Comments: Channel 4-5m wide. The upstream right bank has been recently cleared (tree removal etc.). Large earth bank present 5m in from channel as a result of previous arterial drainage works. Erosion evident on upstream stretch.

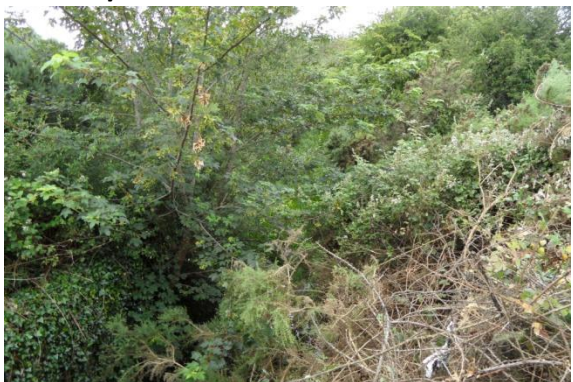
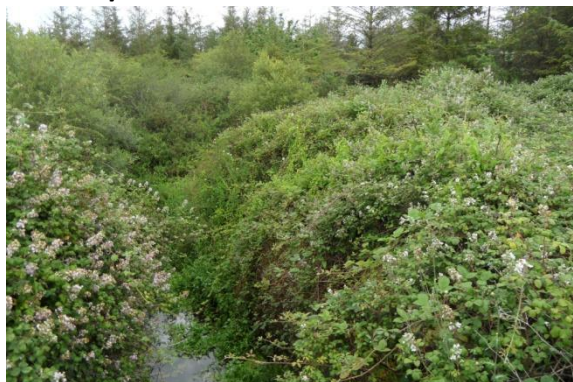
River: Curraghchase North	Site Code: CN01																											
Survey Date: 16/07/2019	Surveyors: PF and MCG																											
Photo U/S

U/S	D/S	Channel from and flow	0	0	Channel vegetation	1	1	Substrate condition	0	0	Barriers to continuity	4	4	Bank structure and stability	0	0	Bank vegetation	0	0	Riparian land cover	0	0	Floodplain connectivity	0	0
	U/S	D/S																										
Channel from and flow	0	0																										
Channel vegetation	1	1																										
Substrate condition	0	0																										
Barriers to continuity	4	4																										
Bank structure and stability	0	0																										
Bank vegetation	0	0																										
Riparian land cover	0	0																										
Floodplain connectivity	0	0																										
Total Score: 10	Spot-Check Class: Bad																											
Comments: Very narrow upstream stretch of channel, approx. 1m wide. Extremely low flow. Walls present along both sides of river bank for approx 4-5m after bridge. Vegetation beginning to decompose in river. Scrub present on both banks. Influenced by adjacent conifer forestry.

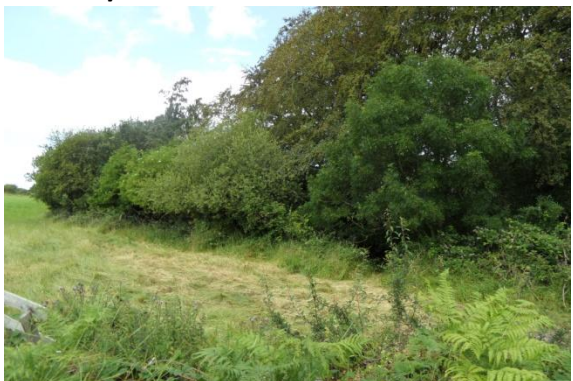
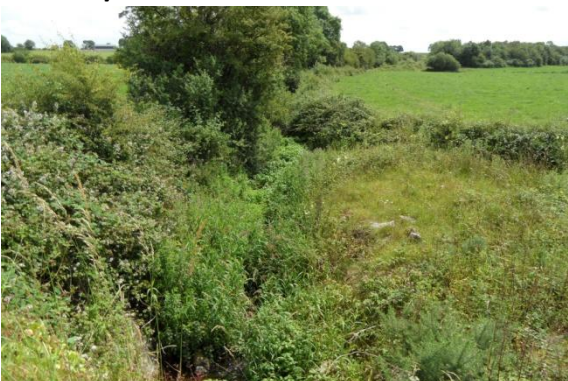
River: Curraghchase North	Site Code: CN02																												
Survey Date: 16/07/2019	Surveyors: PF and MCG																												
Photo U/S

U/S	D/S	Channel from and flow	0	0	Channel vegetation	0	3	Substrate condition	3	3	Barriers to continuity	4	4	Bank structure and stability	0	0	Bank vegetation	0	2	Riparian land cover	0	0	Floodplain connectivity	0	0
	U/S	D/S																											
Channel from and flow	0	0																											
Channel vegetation	0	3																											
Substrate condition	3	3																											
Barriers to continuity	4	4																											
Bank structure and stability	0	0																											
Bank vegetation	0	2																											
Riparian land cover	0	0																											
Floodplain connectivity	0	0																											
Total Score: 19	Spot-Check Class: Poor																												
Comments: Narrow channel, approx 2m wide. Upstream section is totally shaded by overhanging Beech (<i>Fagus sylvatica</i>) treeline, which also makes it difficult to see channel. Riparian vegetation present downstream with a gappy hedgerow with Ash (<i>Fraxinus excelsior</i>) standards on the left bank and scrub grading into GA1 on right bank. Earth bank present on right bank downstream, due to channel deepening. Small island area present downstream with GS1/GS2.

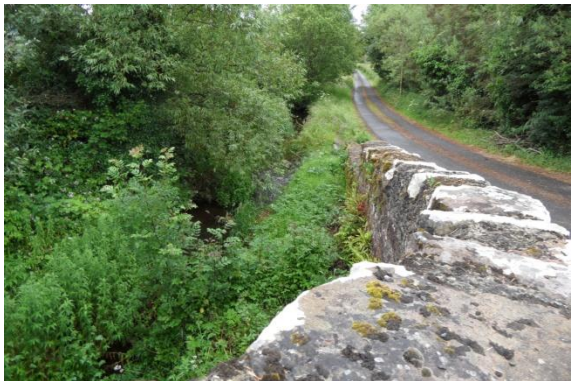
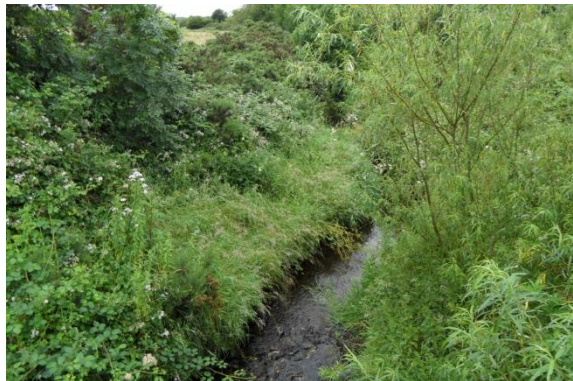
River: Loobagh	Site Code: LB01																											
Survey Date: 10/07/2019	Surveyors: PF and PC																											
Photo U/S

U/S	D/S	Channel form and flow	1	1	Channel vegetation	3	3	Substrate condition	3	3	Barriers to continuity	4	4	Bank structure and stability	3	3	Bank vegetation	3	2	Riparian land cover	0	1	Floodplain connectivity	0	0
	U/S	D/S																										
Channel form and flow	1	1																										
Channel vegetation	3	3																										
Substrate condition	3	3																										
Barriers to continuity	4	4																										
Bank structure and stability	3	3																										
Bank vegetation	3	2																										
Riparian land cover	0	1																										
Floodplain connectivity	0	0																										
Total Score: 34	Spot-Check Class: Moderate																											
Comments: N/A

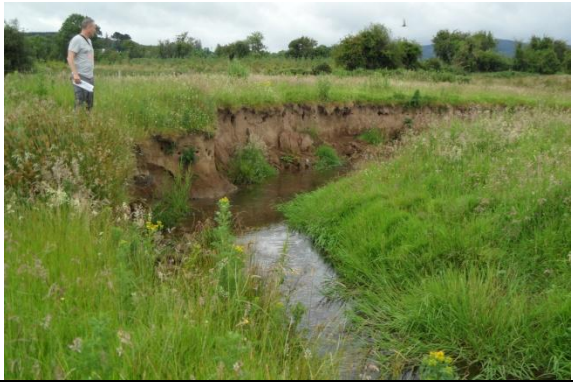
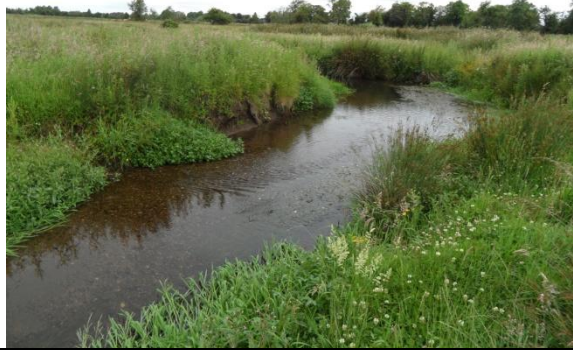
River: Loobagh	Site Code: LB02																											
Survey Date: 10/07/2019	Surveyors: PF and PC																											
Photo U/S

U/S	D/S	Channel from and flow	4	4	Channel vegetation	4	4	Substrate condition	3	3	Barriers to continuity	4	4	Bank structure and stability	4	4	Bank vegetation	2	2	Riparian land cover	2	2	Floodplain connectivity	4	4
	U/S	D/S																										
Channel from and flow	4	4																										
Channel vegetation	4	4																										
Substrate condition	3	3																										
Barriers to continuity	4	4																										
Bank structure and stability	4	4																										
Bank vegetation	2	2																										
Riparian land cover	2	2																										
Floodplain connectivity	4	4																										
Total Score: 54	Spot-Check Class: Good																											
Comments: Semi natural river section with extensive meanders. Possibly not affected by past drainage works. Sandmartins nesting in exposed sandy river banks. No woodland margins along this river section.

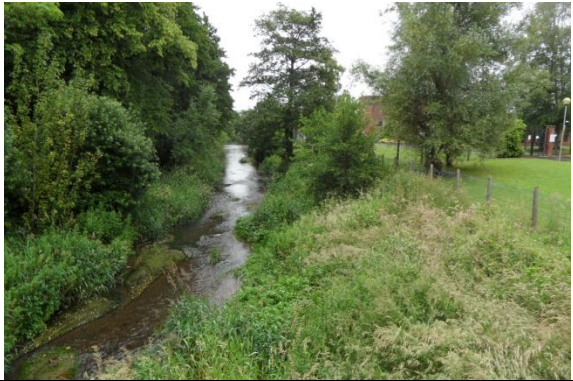
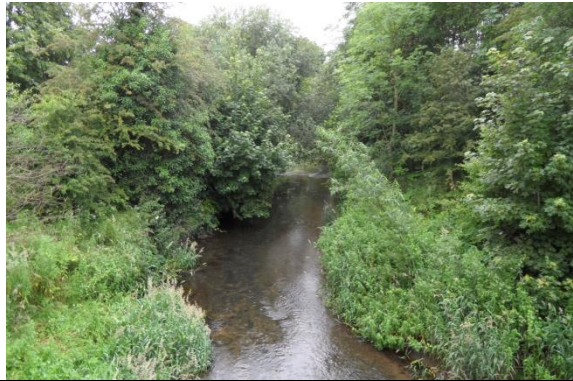
River: Loobagh	Site Code: LB03																											
Survey Date: 10/07/2019	Surveyors: PF and PC																											
Photo U/S

U/S	D/S	Channel from and flow	2	3	Channel vegetation	4	4	Substrate condition	4	4	Barriers to continuity	0	4	Bank structure and stability	3	3	Bank vegetation	3	3	Riparian land cover	1	2	Floodplain connectivity	0	0
	U/S	D/S																										
Channel from and flow	2	3																										
Channel vegetation	4	4																										
Substrate condition	4	4																										
Barriers to continuity	0	4																										
Bank structure and stability	3	3																										
Bank vegetation	3	3																										
Riparian land cover	1	2																										
Floodplain connectivity	0	0																										
Total Score: 40	Spot-Check Class: Moderate																											
Comments: Weir present 150m upstream, likely water abstraction point. Downstream rivers runs through demesne woodland planting.

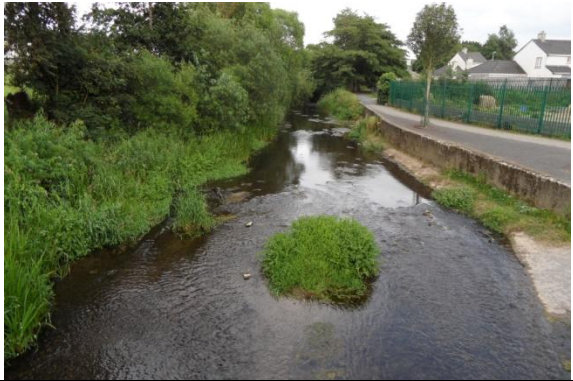
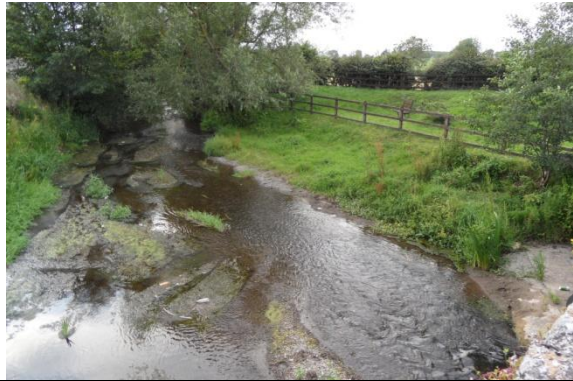
River: Loobagh	Site Code: LB04																											
Survey Date: 15/07/2019	Surveyors: PF and MCG																											
Photo U/S

U/S	D/S	Channel form and flow	0	0	Channel vegetation	0	0	Substrate condition	0	0	Barriers to continuity	4	4	Bank structure and stability	0	0	Bank vegetation	1	0	Riparian land cover	0	0	Floodplain connectivity	0	0
	U/S	D/S																										
Channel form and flow	0	0																										
Channel vegetation	0	0																										
Substrate condition	0	0																										
Barriers to continuity	4	4																										
Bank structure and stability	0	0																										
Bank vegetation	1	0																										
Riparian land cover	0	0																										
Floodplain connectivity	0	0																										
Total Score: 9	Spot-Check Class: Bad																											
Comments: Highly altered river section with armature in Kilmallock town. Adjacent area built land and amenity park.

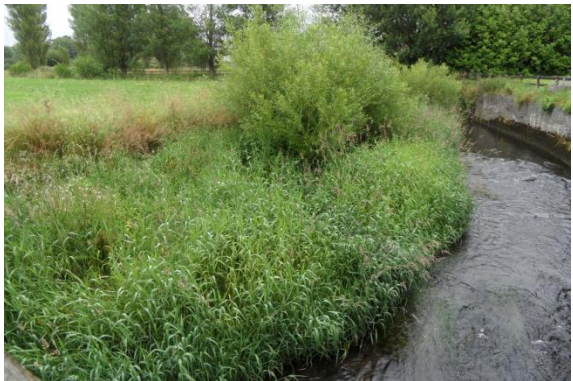
River: Loobagh	Site Code: LB05																											
Survey Date: 10/07/2019	Surveyors: PF and PC																											
Photo U/S

U/S	D/S	Channel from and flow	0	0	Channel vegetation	3	3	Substrate condition	3	3	Barriers to continuity	4	4	Bank structure and stability	1	1	Bank vegetation	1	1	Riparian land cover	1	1	Floodplain connectivity	0	0
	U/S	D/S																										
Channel from and flow	0	0																										
Channel vegetation	3	3																										
Substrate condition	3	3																										
Barriers to continuity	4	4																										
Bank structure and stability	1	1																										
Bank vegetation	1	1																										
Riparian land cover	1	1																										
Floodplain connectivity	0	0																										
Total Score: 26	Spot-Check Class: Poor																											
Comments: Concrete wall forms left hand bank adjacent to industrial buildings.

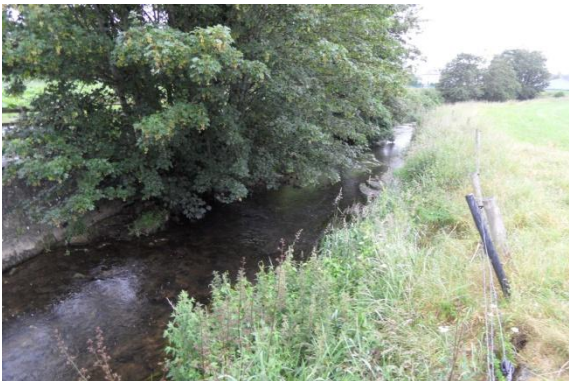
Photo D/S

Channel Type U/S: Pool-riffle-glide	Channel Type D/S: Pool-riffle-glide																											
Bank Vegetation U/S (L): BL3	Bank Vegetation D/S (L): WL2																											
Bank Vegetation U/S (R): FS1 / GS2 / WL2	Bank Vegetation D/S (R): GS2																											
Land Cover U/S (L): GA2	Land Cover D/S (L): GA2 / BL3																											
Land Cover U/S (R): GA1	Land Cover D/S (R): GA1																											
Artificial Features U/S: Reinforced	Artificial Features D/S: Reinforced																											
Scoring Matrix

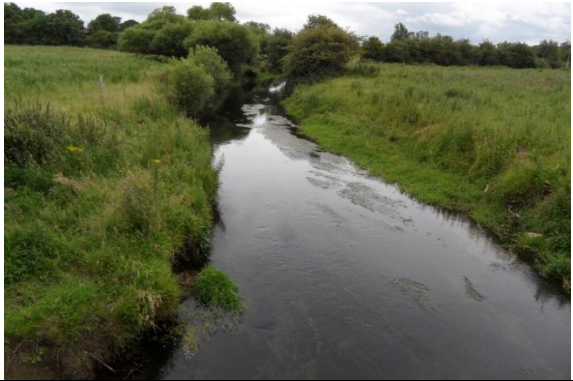
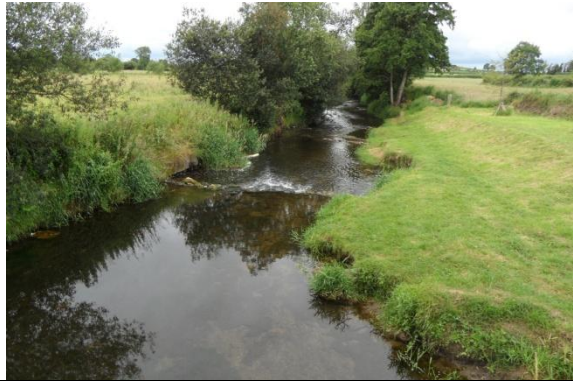
River: Loobagh	Site Code: LB06																											
Survey Date: 10/07/2019	Surveyors: PF and PC																											
Photo U/S

Channel Type U/S: Lowland meandering	Channel Type D/S: Pool-riffle-glide																											
Bank Vegetation U/S (L): GS2	Bank Vegetation D/S (L): GS2 / WL2																											
Bank Vegetation U/S (R): GS2	Bank Vegetation D/S (R): GA2 / WL2																											
Land Cover U/S (L): GA1 / WL1	Land Cover D/S (L): GA1																											
Land Cover U/S (R): GS4	Land Cover D/S (R): GA1 / WL1																											
Artificial Features U/S: Over-deepened	Artificial Features D/S: Over-deepened																											
Scoring Matrix

U/S	D/S	Channel form and flow	2	1	Channel vegetation	2	2	Substrate condition	2	4	Barriers to continuity	4	2	Bank structure and stability	1	1	Bank vegetation	1	1	Riparian land cover	1	1	Floodplain connectivity	1	0
	U/S	D/S																										
Channel form and flow	2	1																										
Channel vegetation	2	2																										
Substrate condition	2	4																										
Barriers to continuity	4	2																										
Bank structure and stability	1	1																										
Bank vegetation	1	1																										
Riparian land cover	1	1																										
Floodplain connectivity	1	0																										
Total Score: 26	Spot-Check Class: Poor																											
Comments: Small artificial weirs present downstream. Limited woodland vegetation along river banks. Small managed amenity grassland area with picnic bench on downstream bank.
