River Maigue Catchment Riparian Habitat Study

RIVER MAIGUE RIPARIAN HABITAT SURVEYS

FINAL REPORT

Prepared by Wetland Surveys

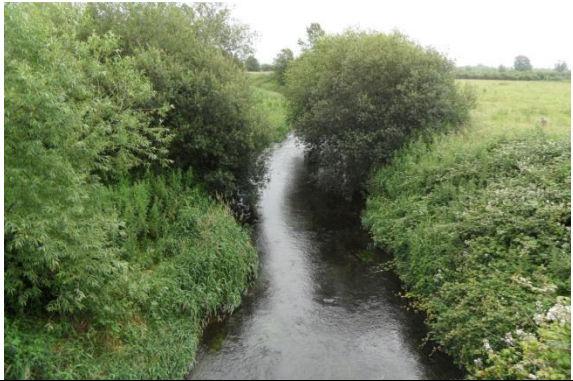
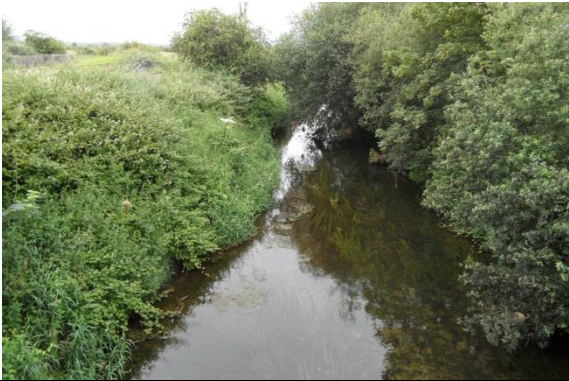
River: Loobagh	Site Code: LB07																											
Survey Date: 10/07/2019	Surveyors: PF and PC																											
Photo U/S

Channel Type U/S: Pool-riffle-glide	Channel Type D/S: Lowland meandering																											
Bank Vegetation U/S (L): WS1	Bank Vegetation D/S (L): WS1																											
Bank Vegetation U/S (R): WL2	Bank Vegetation D/S (R): WL2																											
Land Cover U/S (L): GA1	Land Cover D/S (L): BL3 / GA1																											
Land Cover U/S (R): GA1	Land Cover D/S (R): GA1																											
Artificial Features U/S: Over-deepened	Artificial Features D/S: Over-deepened																											
Scoring Matrix

U/S	D/S	Channel form and flow	3	3	Channel vegetation	3	3	Substrate condition	2	2	Barriers to continuity	4	4	Bank structure and stability	1	1	Bank vegetation	1	1	Riparian land cover	1	1	Floodplain connectivity	0	0
	U/S	D/S																										
Channel form and flow	3	3																										
Channel vegetation	3	3																										
Substrate condition	2	2																										
Barriers to continuity	4	4																										
Bank structure and stability	1	1																										
Bank vegetation	1	1																										
Riparian land cover	1	1																										
Floodplain connectivity	0	0																										
Total Score: 30	Spot-Check Class: Moderate																											
Comments: N/A

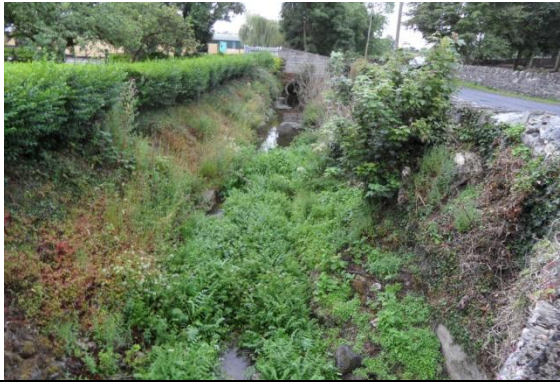
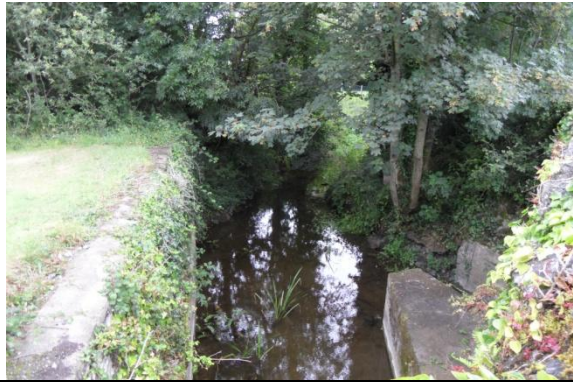
River: Mondellihy	Site Code: MD01																											
Survey Date: 17/07/2019	Surveyors: PF and MCG																											
Photo U/S

Channel Type U/S: Other	Channel Type D/S: Other																											
Bank Vegetation U/S (L): WS1	Bank Vegetation D/S (L): WS1 / WL2																											
Bank Vegetation U/S (R): WL1	Bank Vegetation D/S (R): WS1																											
Land Cover U/S (L): BL3	Land Cover D/S (L): GA2																											
Land Cover U/S (R): GA2 / BL3	Land Cover D/S (R): GA2																											
Artificial Features U/S: None	Artificial Features D/S: None																											
Scoring Matrix

U/S	D/S	Channel from and flow	0	0	Channel vegetation	0	1	Substrate condition	1	1	Barriers to continuity	4	4	Bank structure and stability	0	0	Bank vegetation	0	0	Riparian land cover	0	0	Floodplain connectivity	0	0
	U/S	D/S																										
Channel from and flow	0	0																										
Channel vegetation	0	1																										
Substrate condition	1	1																										
Barriers to continuity	4	4																										
Bank structure and stability	0	0																										
Bank vegetation	0	0																										
Riparian land cover	0	0																										
Floodplain connectivity	0	0																										
Total Score: 11	Spot-Check Class: Bad																											
Comments: Extremely altered section of river running under road through pipe. Banks have been reinforced close to bridge. Downstream treeline shades the channel, resulting in little channel vegetation. No riparian vegetation present upstream.

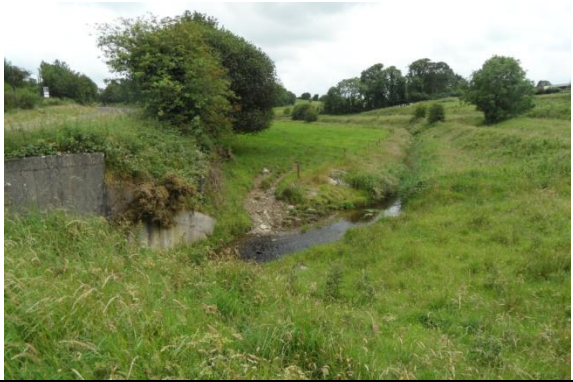
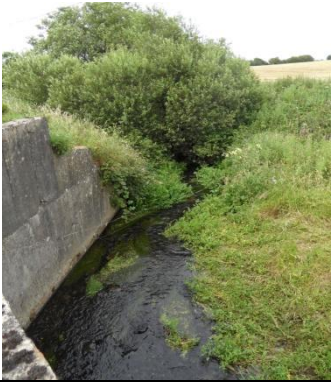
River: Morningstar	Site Code: MS01																											
Survey Date: 15/07/2019	Surveyors: PF and MCG																											
Photo U/S

Channel Type U/S: Other	Channel Type D/S: Other																											
Bank Vegetation U/S (L): GS2 / FS1	Bank Vegetation D/S (L): GS2																											
Bank Vegetation U/S (R): GS2	Bank Vegetation D/S (R): WL1																											
Land Cover U/S (L): BL3	Land Cover D/S (L): GA2 / BL3																											
Land Cover U/S (R): GA1	Land Cover D/S (R): WS1 / GA1																											
Artificial Features U/S: Poaching	Artificial Features D/S: Poaching																											
Scoring Matrix

U/S	D/S	Channel from and flow	1	0	Channel vegetation	3	2	Substrate condition	3	3	Barriers to continuity	4	4	Bank structure and stability	0	1	Bank vegetation	0	1	Riparian land cover	0	0	Floodplain connectivity	0	0
	U/S	D/S																										
Channel from and flow	1	0																										
Channel vegetation	3	2																										
Substrate condition	3	3																										
Barriers to continuity	4	4																										
Bank structure and stability	0	1																										
Bank vegetation	0	1																										
Riparian land cover	0	0																										
Floodplain connectivity	0	0																										
Total Score: 22	Spot-Check Class: Poor																											
Comments: Upper reach of river, flowing under main road. Channel 2-3m wide. Cattle are crossing through river underpass to get to fields. Significant bank erosion at crossing points. No treeline upstream and downstream stretch has been totally realigned due to road works.

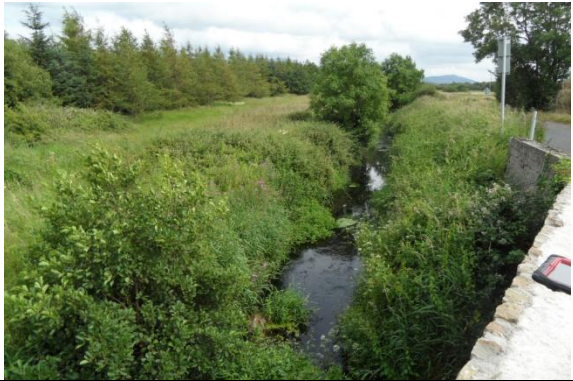
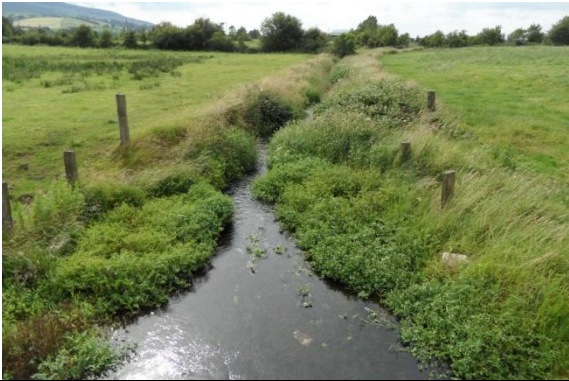
River: Morningstar	Site Code: MS02																											
Survey Date: 15/07/2019	Surveyors: PF and MCG																											
Photo U/S

Channel Type U/S: Other	Channel Type D/S: Other																											
Bank Vegetation U/S (L): GS2	Bank Vegetation D/S (L): GS2																											
Bank Vegetation U/S (R): GS2	Bank Vegetation D/S (R): GS2																											
Land Cover U/S (L): GS2 / BL3	Land Cover D/S (L): GA1 / GS4																											
Land Cover U/S (R): GA1 / WD4	Land Cover D/S (R): GA1																											
Artificial Features U/S: None	Artificial Features D/S: None																											
Scoring Matrix

U/S	D/S	Channel form and flow	0	0	Channel vegetation	3	3	Substrate condition	2	2	Barriers to continuity	4	4	Bank structure and stability	1	1	Bank vegetation	0	0	Riparian land cover	0	0	Floodplain connectivity	0	0
	U/S	D/S																										
Channel form and flow	0	0																										
Channel vegetation	3	3																										
Substrate condition	2	2																										
Barriers to continuity	4	4																										
Bank structure and stability	1	1																										
Bank vegetation	0	0																										
Riparian land cover	0	0																										
Floodplain connectivity	0	0																										
Total Score: 20	Spot-Check Class: Poor																											
Comments: Very altered upper reach of river. Channel 2-3m wide.

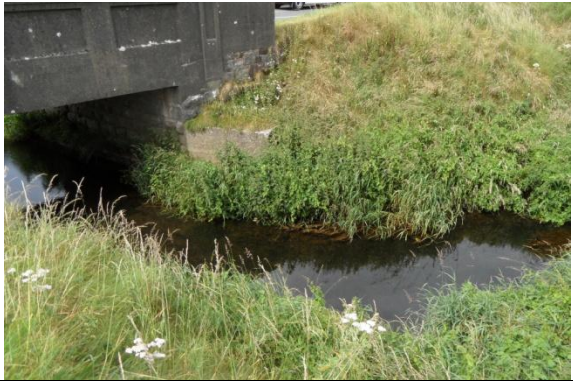
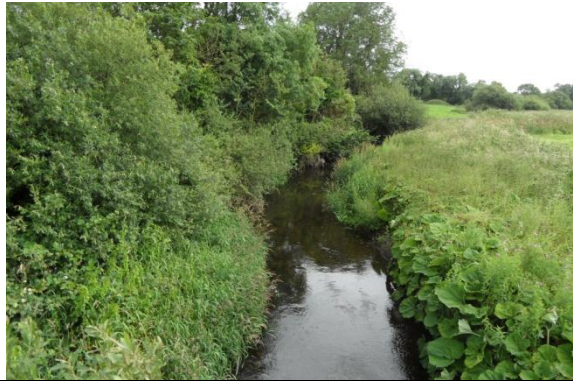
River: Morningstar	Site Code: MS03																												
Survey Date: 15/07/2019	Surveyors: PF and MCG																												
Photo U/S

Channel Type U/S: Lowland meandering	Channel Type D/S: Pool-riffle-glide																												
Bank Vegetation U/S (L): GS2	Bank Vegetation D/S (L): GS2																												
Bank Vegetation U/S (R): GS2	Bank Vegetation D/S (R): GS2																												
Land Cover U/S (L): BL3	Land Cover D/S (L): GS4 / GA1																												
Land Cover U/S (R): GA1	Land Cover D/S (R): GS2																												
Artificial Features U/S: None	Artificial Features D/S: None																												
Scoring Matrix

U/S	D/S	Channel form and flow	0	0	Channel vegetation	4	4	Substrate condition	2	2	Barriers to continuity	4	4	Bank structure and stability	1	1	Bank vegetation	0	0	Riparian land cover	0	0	Floodplain connectivity	0	0
	U/S	D/S																											
Channel form and flow	0	0																											
Channel vegetation	4	4																											
Substrate condition	2	2																											
Barriers to continuity	4	4																											
Bank structure and stability	1	1																											
Bank vegetation	0	0																											
Riparian land cover	0	0																											
Floodplain connectivity	0	0																											
Total Score: 22	Spot-Check Class: Poor																												
Comments: Channel approx 4m wide. Himalayan Balsam (<i>Impatiens glandulifera</i>) present both upstream and downstream, but not yet extensive. Four plants observed from bridge. Removal recommended as soon as possible to avoid the spread of this invasive species. Natural riparian vegetation absent, treeline totally removed.

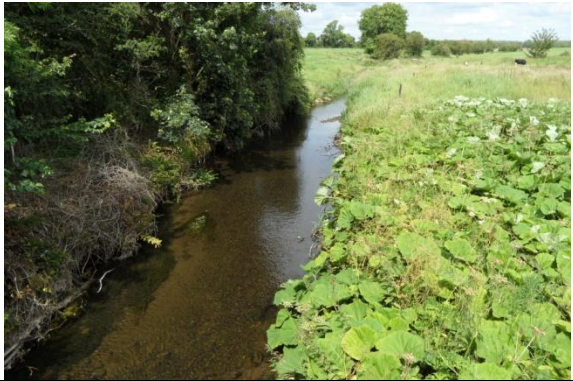
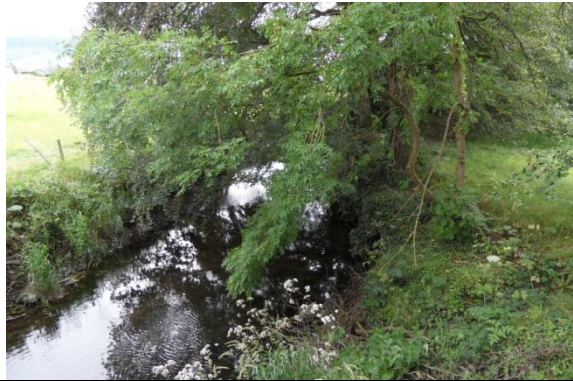
River: Morningstar	Site Code: MS04																												
Survey Date: 15/07/2019	Surveyors: PF and MCG																												
Photo U/S

Channel Type U/S: Pool-riffle-glide	Channel Type D/S: Pool-riffle-glide																												
Bank Vegetation U/S (L): GS2	Bank Vegetation D/S (L): GS2																												
Bank Vegetation U/S (R): WS1	Bank Vegetation D/S (R): WL2																												
Land Cover U/S (L): GS4	Land Cover D/S (L): GA1 / GS4																												
Land Cover U/S (R): GA1	Land Cover D/S (R): GA2 / BL3																												
Artificial Features U/S: None	Artificial Features D/S: None																												
Scoring Matrix

U/S	D/S	Channel from and flow	2	2	Channel vegetation	2	2	Substrate condition	2	2	Barriers to continuity	4	4	Bank structure and stability	1	1	Bank vegetation	1	1	Riparian land cover	0	0	Floodplain connectivity	0	0
	U/S	D/S																											
Channel from and flow	2	2																											
Channel vegetation	2	2																											
Substrate condition	2	2																											
Barriers to continuity	4	4																											
Bank structure and stability	1	1																											
Bank vegetation	1	1																											
Riparian land cover	0	0																											
Floodplain connectivity	0	0																											
Total Score: 24	Spot-Check Class: Poor																												
Comments: Channel 5m wide. Erosion visible on upstream right bank. Complete lack of tree/ shrub layer. Plaque on bridge states drainage work has been ongoing since 1886. Downstream right bank has mature Beech (<i>Fagus sylvatica</i>) treeline, left hand side complete lack of shrubs / trees. Erosion also occurring downstream, beneath Beech treeline, which is overhanging and shading channel.

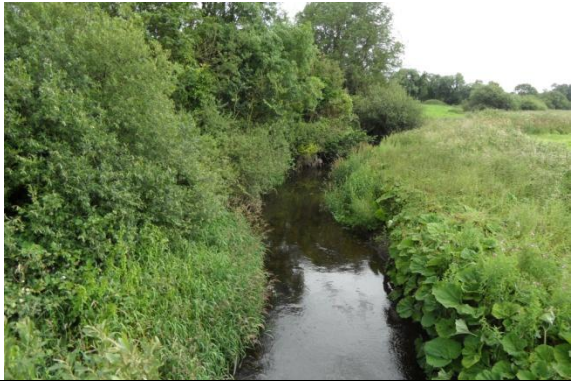
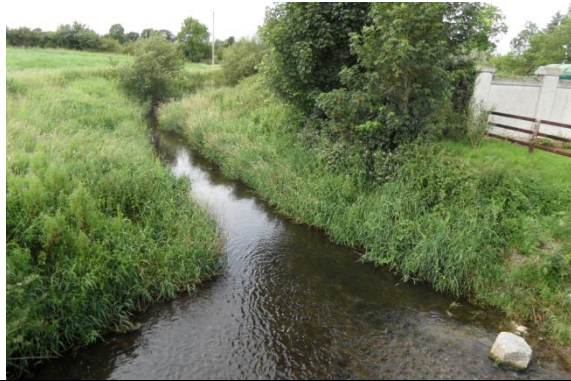
River: Morningstar	Site Code: MS05																											
Survey Date: 15/07/2019	Surveyors: PF and MCG																											
Photo U/S

Channel Type U/S: Lowland meandering	Channel Type D/S: Lowland meandering																											
Bank Vegetation U/S (L): GS2	Bank Vegetation D/S (L): GS2 / WS1																											
Bank Vegetation U/S (R): WL1 / WL2	Bank Vegetation D/S (R): WS1																											
Land Cover U/S (L): GA1	Land Cover D/S (L): GA1 / GS4																											
Land Cover U/S (R): BL3	Land Cover D/S (R): BL3																											
Artificial Features U/S: None	Artificial Features D/S: None																											
Scoring Matrix

U/S	D/S	Channel form and flow	1	1	Channel vegetation	3	3	Substrate condition	2	3	Barriers to continuity	4	4	Bank structure and stability	1	1	Bank vegetation	2	2	Riparian land cover	0	0	Floodplain connectivity	0	0
	U/S	D/S																										
Channel form and flow	1	1																										
Channel vegetation	3	3																										
Substrate condition	2	3																										
Barriers to continuity	4	4																										
Bank structure and stability	1	1																										
Bank vegetation	2	2																										
Riparian land cover	0	0																										
Floodplain connectivity	0	0																										
Total Score: 27	Spot-Check Class: Poor																											
Comments: Channel 4-5m wide. This stretch has been deepened in the past and tree layer removal has also taken place.

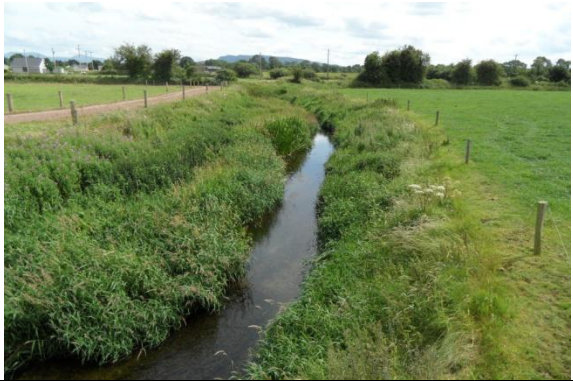
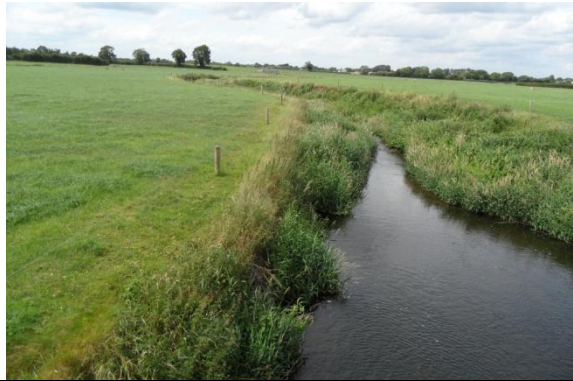
River: Morningstar	Site Code: MS06																											
Survey Date: 15/07/2019	Surveyors: PF and MCG																											
Photo U/S

Channel Type U/S: Pool-riffle-glide	Channel Type D/S: Pool-riffle-glide																											
Bank Vegetation U/S (L): GS2 / FS1	Bank Vegetation D/S (L): FS1 / GS2																											
Bank Vegetation U/S (R): GS2 / FS1	Bank Vegetation D/S (R): FS1 / GS2																											
Land Cover U/S (L): GA1	Land Cover D/S (L): GA1																											
Land Cover U/S (R): GA1	Land Cover D/S (R): GA1																											
Artificial Features U/S: None	Artificial Features D/S: None																											
Scoring Matrix

U/S	D/S	Channel from and flow	0	0	Channel vegetation	4	4	Substrate condition	4	4	Barriers to continuity	4	4	Bank structure and stability	1	0	Bank vegetation	0	0	Riparian land cover	0	0	Floodplain connectivity	0	0
	U/S	D/S																										
Channel from and flow	0	0																										
Channel vegetation	4	4																										
Substrate condition	4	4																										
Barriers to continuity	4	4																										
Bank structure and stability	1	0																										
Bank vegetation	0	0																										
Riparian land cover	0	0																										
Floodplain connectivity	0	0																										
Total Score: 25	Spot-Check Class: Poor																											
Comments: Channel approx. 5m wide. Intensively managed agricultural area. Channel has been deepened. Narrow band of FS1/GS2 on banks which is directly adjoined by GA1 fields and farm tracks. Complete absence of treeline. Some evidence of bankside erosion on downstream right bank. All banks fenced from livestock.

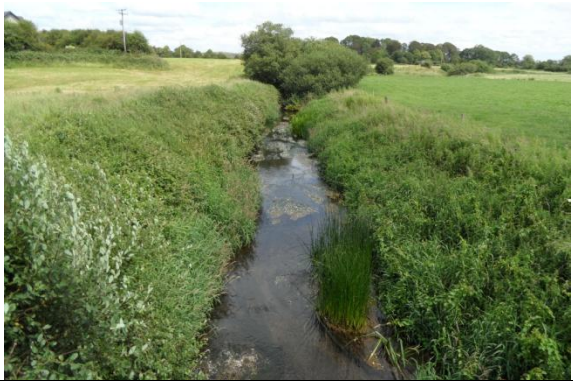
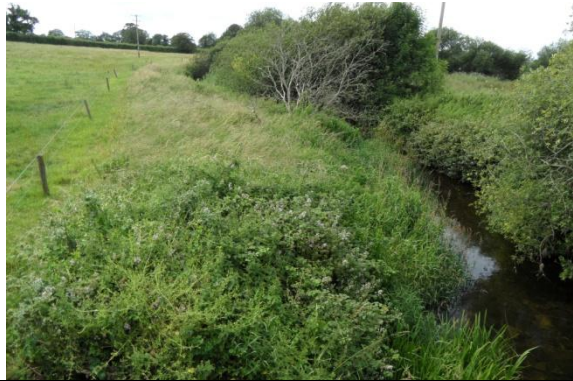
River: Morningstar	Site Code: MS07																											
Survey Date: 15/07/2019	Surveyors: PF and MCG																											
Photo U/S

Channel Type U/S: Pool-riffle-glide	Channel Type D/S: Lowland meandering																											
Bank Vegetation U/S (L): GS2	Bank Vegetation D/S (L): GS2 / WS1																											
Bank Vegetation U/S (R): GS2	Bank Vegetation D/S (R): WS1 / WL1																											
Land Cover U/S (L): GA1	Land Cover D/S (L): GA1																											
Land Cover U/S (R): GA1	Land Cover D/S (R): GS4																											
Artificial Features U/S: Over-deepened	Artificial Features D/S: None																											
Scoring Matrix

U/S	D/S	Channel form and flow	0	1	Channel vegetation	4	4	Substrate condition	4	4	Barriers to continuity	4	4	Bank structure and stability	2	2	Bank vegetation	2	2	Riparian land cover	0	0	Floodplain connectivity	0	0
	U/S	D/S																										
Channel form and flow	0	1																										
Channel vegetation	4	4																										
Substrate condition	4	4																										
Barriers to continuity	4	4																										
Bank structure and stability	2	2																										
Bank vegetation	2	2																										
Riparian land cover	0	0																										
Floodplain connectivity	0	0																										
Total Score: 33	Spot-Check Class: Moderate																											
Comments: Channel approx. 5m wide. Upstream section in particular, has clearly been deepened in the past. Steep banks now colonised by Bramble (<i>Rubus fruticosus</i> agg.), Bindweed (<i>Calystegia sepium</i>), Greater Willowherb (<i>Epilobium hirsutum</i>) and limited Willow (<i>Salix</i> sp.) scrub. <i>Ranunculus</i> present in channel. Downstream stretch lacks riffles and glides as seen upstream. Bank adjoining wet grassland still has Willow/Ash (<i>Fraxinus excelsior</i>) treeline mostly intact. Opposite bank has had all riparian vegetation removed.

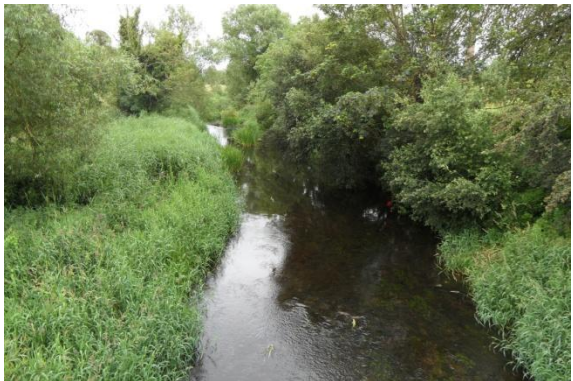
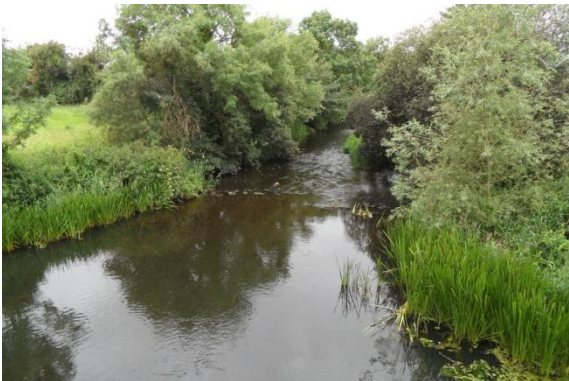
River: Morningstar	Site Code: MS08																											
Survey Date: 12/07/2019	Surveyors: PF and MCG																											
Photo U/S

Channel Type U/S: Pool-riffle-glide	Channel Type D/S: Pool-riffle-glide																											
Bank Vegetation U/S (L): WL2	Bank Vegetation D/S (L): WL2																											
Bank Vegetation U/S (R): FS1 / WS1	Bank Vegetation D/S (R): WL2																											
Land Cover U/S (L): GA1	Land Cover D/S (L): GA1																											
Land Cover U/S (R): BL3	Land Cover D/S (R): BL3																											
Artificial Features U/S: None	Artificial Features D/S: None																											
Scoring Matrix

U/S	D/S	Channel from and flow	4	4	Channel vegetation	4	4	Substrate condition	3	3	Barriers to continuity	4	4	Bank structure and stability	4	4	Bank vegetation	3	3	Riparian land cover	0	0	Floodplain connectivity	0	0
	U/S	D/S																										
Channel from and flow	4	4																										
Channel vegetation	4	4																										
Substrate condition	3	3																										
Barriers to continuity	4	4																										
Bank structure and stability	4	4																										
Bank vegetation	3	3																										
Riparian land cover	0	0																										
Floodplain connectivity	0	0																										
Total Score: 44	Spot-Check Class: Good																											
Comments: Channel 8-10m wide. There appears to have been little alteration to this section of river. Some narrow reed areas in braided channel.

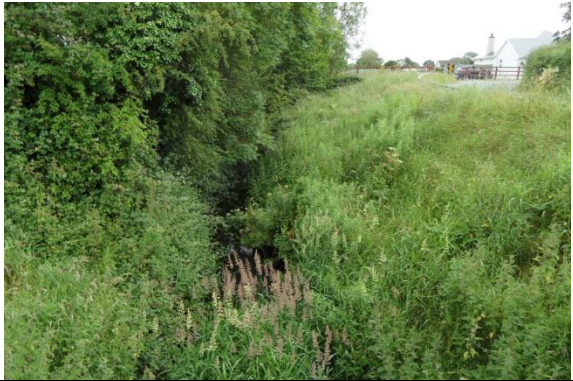
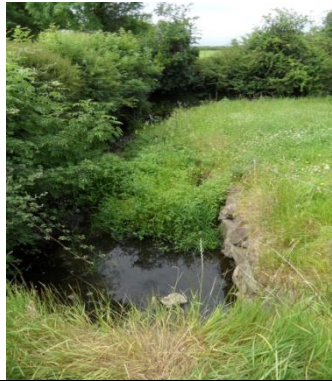
River: Maigue	Site Code: MG01																												
Survey Date: 08/07/2019	Surveyors: PF and MCG																												
Photo U/S

Channel Type U/S: Other	Channel Type D/S: Other																												
Bank Vegetation U/S (L): GS2	Bank Vegetation D/S (L): WL1																												
Bank Vegetation U/S (R): WS1	Bank Vegetation D/S (R): GA1																												
Land Cover U/S (L): BL3	Land Cover D/S (L): BL3 / GA1																												
Land Cover U/S (R): BL3	Land Cover D/S (R): GA1 / WL2																												
Artificial Features U/S: None	Artificial Features D/S: Reinforced																												
Scoring Matrix

U/S	D/S	Channel from and flow	2	1	Channel vegetation	3	4	Substrate condition	3	3	Barriers to continuity	4	4	Bank structure and stability	0	0	Bank vegetation	1	1	Riparian land cover	0	0	Floodplain connectivity	1	1
	U/S	D/S																											
Channel from and flow	2	1																											
Channel vegetation	3	4																											
Substrate condition	3	3																											
Barriers to continuity	4	4																											
Bank structure and stability	0	0																											
Bank vegetation	1	1																											
Riparian land cover	0	0																											
Floodplain connectivity	1	1																											
Total Score: 28	Spot-Check Class: Poor																												
Comments: Small upstream river section with low flow rate and few river features.

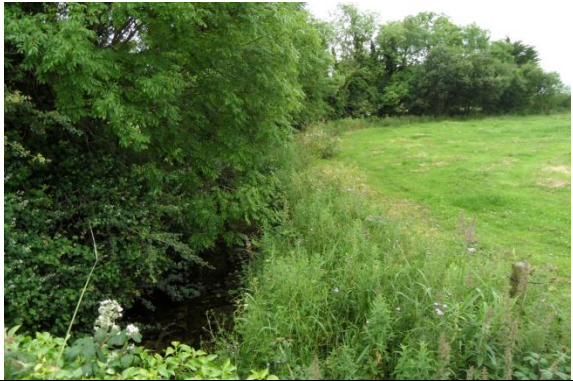
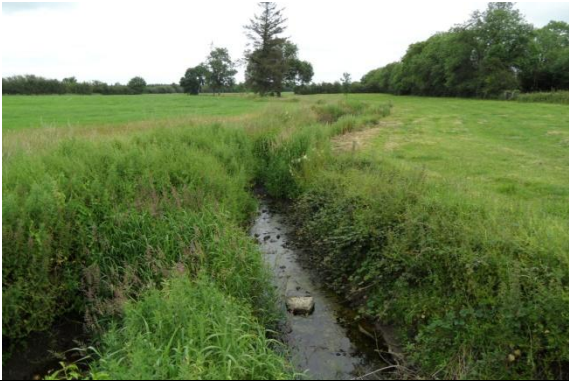
River: Maigue	Site Code: MG02																											
Survey Date: 08/07/2019	Surveyors: PF and MCG																											
Photo U/S

Channel Type U/S: Lowland meandering	Channel Type D/S: Lowland meandering																											
Bank Vegetation U/S (L): GA1	Bank Vegetation D/S (L): FS1 / GS2																											
Bank Vegetation U/S (R): WL2 / WL1	Bank Vegetation D/S (R): GS2																											
Land Cover U/S (L): GA1	Land Cover D/S (L): GA1																											
Land Cover U/S (R): BL1 / GA1	Land Cover D/S (R): GA1																											
Artificial Features U/S: None	Artificial Features D/S: None																											
Scoring Matrix

U/S	D/S	Channel from and flow	1	1	Channel vegetation	0	0	Substrate condition	2	2	Barriers to continuity	4	4	Bank structure and stability	2	2	Bank vegetation	2	2	Riparian land cover	0	0	Floodplain connectivity	1	1
	U/S	D/S																										
Channel from and flow	1	1																										
Channel vegetation	0	0																										
Substrate condition	2	2																										
Barriers to continuity	4	4																										
Bank structure and stability	2	2																										
Bank vegetation	2	2																										
Riparian land cover	0	0																										
Floodplain connectivity	1	1																										
Total Score: 22	Spot-Check Class: Poor																											
Comments: Area river is mostly surrounded by GA1. Well fenced off, no cattle access to river. There is a 1m wide band of GS2 bordering river, dominated by Greater Willowherb (<i>Epilobium hirsutum</i>), Nettles (<i>Urtica dioica</i>), Cleavers (<i>Gallium aparine</i>), Meadowsweet (<i>Fillipendula ulmaria</i>), Creeping Thistle (<i>Cirsium arvense</i>), Winter Heliotrope (<i>Petasites fragrans</i>), and tall grasses. Bank vegetation photo 5562. Brown algal/slime dominates channel vegetation. Water level in river is low with slow flow.

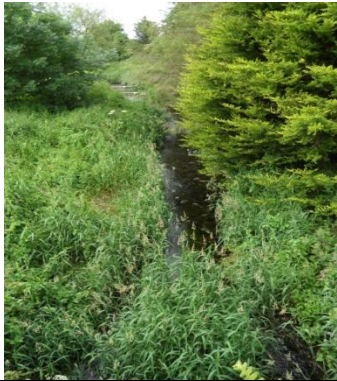
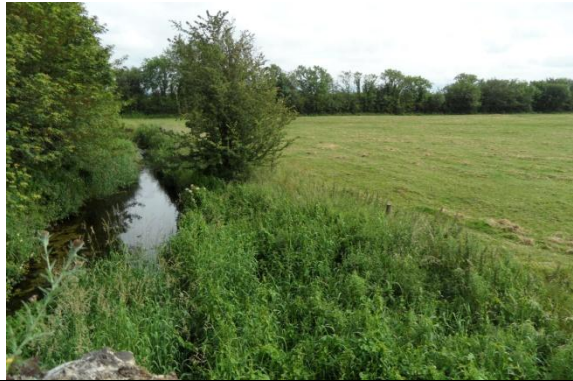
River: Maigue	Site Code: MG03																												
Survey Date: 08/07/2019	Surveyors: PF and MCG																												
Photo U/S

Channel Type U/S: Lowland meandering	Channel Type D/S: Lowland meandering																												
Bank Vegetation U/S (L): WL2 (Conifers)	Bank Vegetation D/S (L): GA1																												
Bank Vegetation U/S (R): GA1	Bank Vegetation D/S (R): WL2 (Sycamore)																												
Land Cover U/S (L): BL3	Land Cover D/S (L): GA1																												
Land Cover U/S (R): GA1	Land Cover D/S (R): GA1																												
Artificial Features U/S: None	Artificial Features D/S: None																												
Scoring Matrix

U/S	D/S	Channel form and flow	3	2	Channel vegetation	2	2	Substrate condition	3	2	Barriers to continuity	4	4	Bank structure and stability	2	1	Bank vegetation	1	1	Riparian land cover	1	0	Floodplain connectivity	1	0
	U/S	D/S																											
Channel form and flow	3	2																											
Channel vegetation	2	2																											
Substrate condition	3	2																											
Barriers to continuity	4	4																											
Bank structure and stability	2	1																											
Bank vegetation	1	1																											
Riparian land cover	1	0																											
Floodplain connectivity	1	0																											
Total Score: 29	Spot-Check Class: Moderate																												
Comments: <p>This section of river appears less modified than previous crossing point. Flow is faster. There has been some channel alteration in the past. Riparian zone remains narrow, with Reed Canary Grass (<i>Phalaris arundinacea</i>) and Bindweed (<i>Calystegia sepium</i>) dominant, but Nettles (<i>Urtica dioica</i>) still abundant.</p>

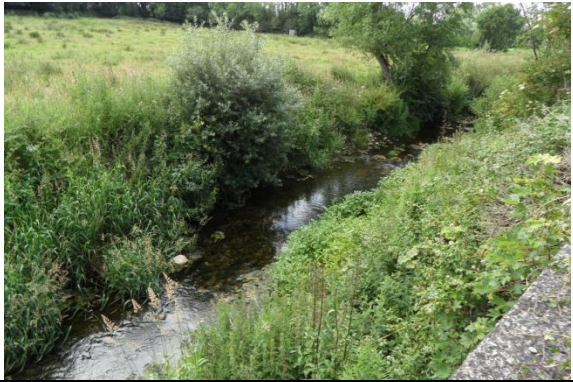
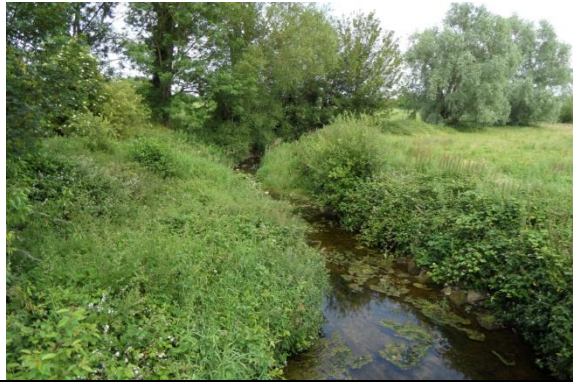
River: Maigue	Site Code: MG04																											
Survey Date: 08/07/2019	Surveyors: PF and MCG																											
Photo U/S

U/S	D/S	Channel from and flow	1	1	Channel vegetation	0	1	Substrate condition	2	1	Barriers to continuity	4	4	Bank structure and stability	0	0	Bank vegetation	0	0	Riparian land cover	0	0	Floodplain connectivity	0	0
	U/S	D/S																										
Channel from and flow	1	1																										
Channel vegetation	0	1																										
Substrate condition	2	1																										
Barriers to continuity	4	4																										
Bank structure and stability	0	0																										
Bank vegetation	0	0																										
Riparian land cover	0	0																										
Floodplain connectivity	0	0																										
Total Score: 14	Spot-Check Class: Bad																											
Comments: Banks have been altered. Reinforcements associated with bridge building, in addition to some stone reinforcement present. Abundance of green algae floating on surface and within water column (photos 5576-5577).

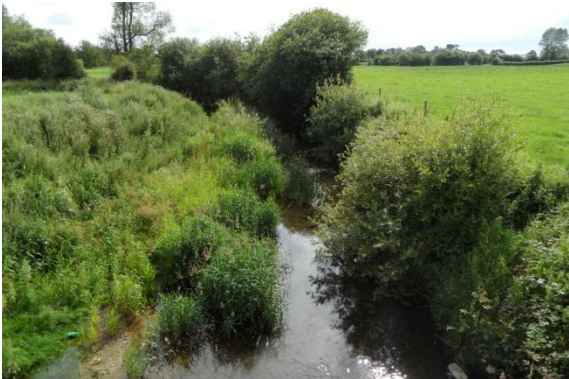
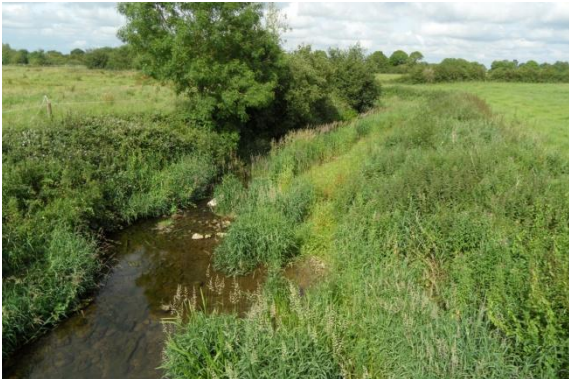
River: Maigue	Site Code: MG05																											
Survey Date: 08/07/2019	Surveyors: PF and MCG																											
Photo U/S

U/S	D/S	Channel form and flow	3	3	Channel vegetation	2	2	Substrate condition	2	3	Barriers to continuity	4	4	Bank structure and stability	0	0	Bank vegetation	0	0	Riparian land cover	0	0	Floodplain connectivity	0	0
	U/S	D/S																										
Channel form and flow	3	3																										
Channel vegetation	2	2																										
Substrate condition	2	3																										
Barriers to continuity	4	4																										
Bank structure and stability	0	0																										
Bank vegetation	0	0																										
Riparian land cover	0	0																										
Floodplain connectivity	0	0																										
Total Score: 23	Spot-Check Class: Poor																											
Comments: This is the first point on this tributary where Common Club-rush (<i>Schoenoplectus lacustris</i>), Branched Bur-reed (<i>Sparganium erectum</i>), and Reed Canary Grass (<i>Phalaris arundinacea</i>) form semi-natural vegetation stands within the channel. Also first riffle and pool present here. Some filamentous algal growth present in river. Channel has been significantly altered in the past. Still a very steep (3m) high embankment along river bank. Agricultural land runs almost to river bank. Good fencing present.

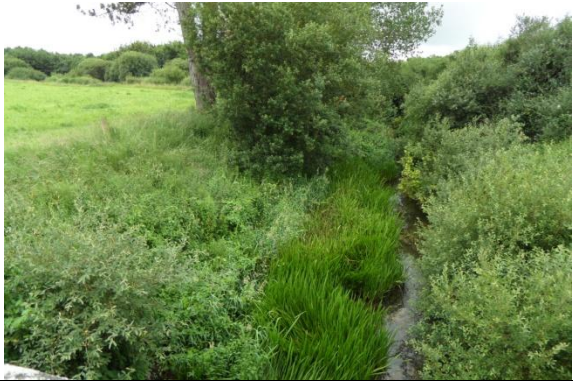
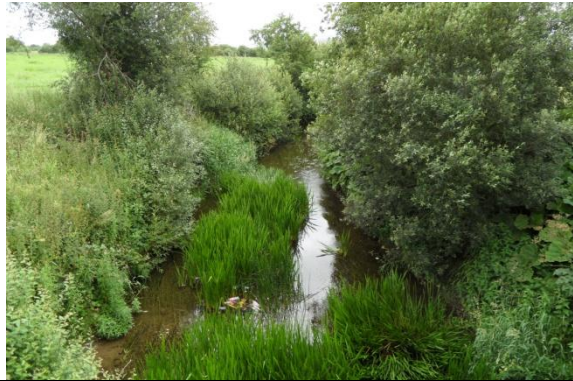
River: Maigue	Site Code: MG06																											
Survey Date: 12/07/2019	Surveyors: PF and MCG																											
Photo U/S

U/S	D/S	Channel form and flow	0	0	Channel vegetation	3	3	Substrate condition	2	2	Barriers to continuity	4	4	Bank structure and stability	1	1	Bank vegetation	2	2	Riparian land cover	0	0	Floodplain connectivity	0	0
	U/S	D/S																										
Channel form and flow	0	0																										
Channel vegetation	3	3																										
Substrate condition	2	2																										
Barriers to continuity	4	4																										
Bank structure and stability	1	1																										
Bank vegetation	2	2																										
Riparian land cover	0	0																										
Floodplain connectivity	0	0																										
Total Score: 24	Spot-Check Class: Poor																											
Comments: Bank 4-5m wide, with 3m high bank. This stretch has been extensively deepened and straightened. Channel vegetation includes Common Club-rush (<i>Schoenoplectus lacustris</i>), Branched Bur-reed (<i>Sparganium erectum</i>) with abundant Pondweed (<i>Potamogeton</i> sp.). High abundance of fine silt present on river bed. Trout and Mink present based on local land owner comments. Extensive dumping of household rubbish, with warning signs being ignored.

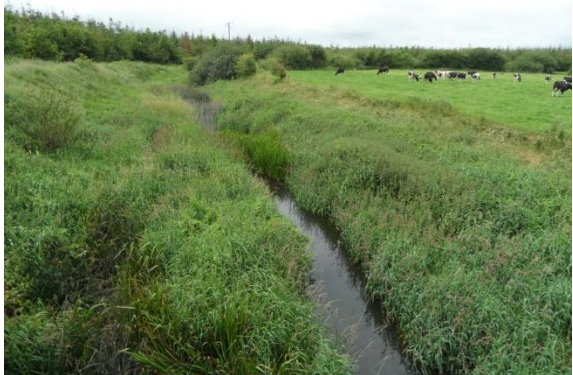
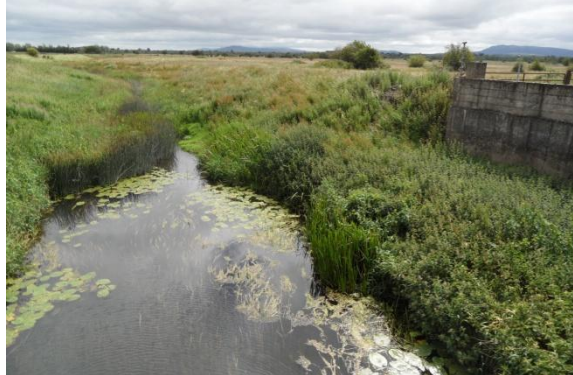
River: Maigue	Site Code: MG07																											
Survey Date: 12/07/2019	Surveyors: PF and MCG																											
Photo U/S

U/S	D/S	Channel from and flow	0	0	Channel vegetation	4	4	Substrate condition	2	2	Barriers to continuity	4	4	Bank structure and stability	0	0	Bank vegetation	0	0	Riparian land cover	0	0	Floodplain connectivity	0	0
	U/S	D/S																										
Channel from and flow	0	0																										
Channel vegetation	4	4																										
Substrate condition	2	2																										
Barriers to continuity	4	4																										
Bank structure and stability	0	0																										
Bank vegetation	0	0																										
Riparian land cover	0	0																										
Floodplain connectivity	0	0																										
Total Score: 20	Spot-Check Class: Poor																											
Comments: Highly altered stretch of river with no woodland scrub present in riparian zone. Channel infilled with FS1. Intensive agriculture and forestry adjoins river.

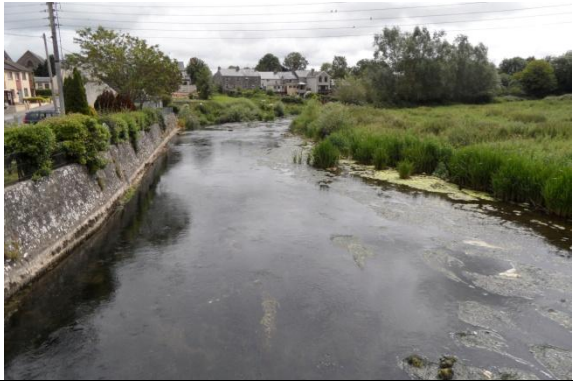
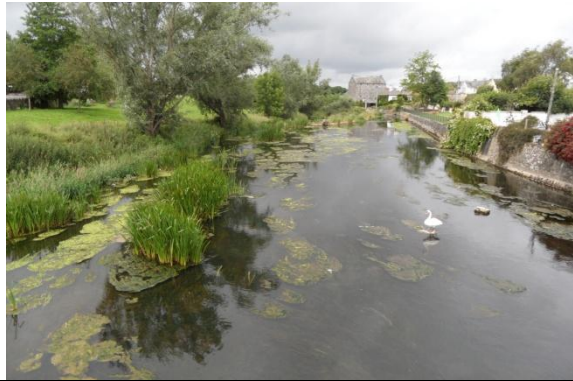
River: Maigue	Site Code: MG08																											
Survey Date: 10/07/2019	Surveyors: PF and PC																											
Photo U/S

U/S	D/S	Channel form and flow	1	1	Channel vegetation	1	1	Substrate condition	1	0	Barriers to continuity	4	0	Bank structure and stability	0	0	Bank vegetation	0	0	Riparian land cover	0	0	Floodplain connectivity	0	0
	U/S	D/S																										
Channel form and flow	1	1																										
Channel vegetation	1	1																										
Substrate condition	1	0																										
Barriers to continuity	4	0																										
Bank structure and stability	0	0																										
Bank vegetation	0	0																										
Riparian land cover	0	0																										
Floodplain connectivity	0	0																										
Total Score: 9	Spot-Check Class: Bad																											
Comments: River wall along river upstream and downstream. Weir and mill race approx 100m downstream.

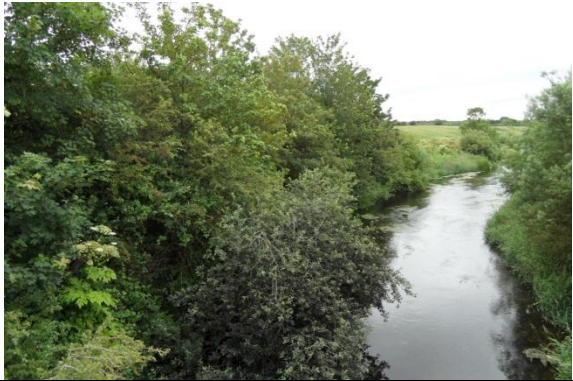
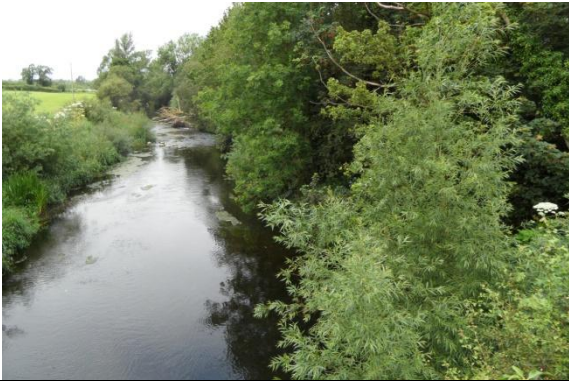
River: Maigue	Site Code: MG09																												
Survey Date: 12/07/2019	Surveyors: PF and MCG																												
Photo U/S

U/S	D/S	Channel form and flow	4	4	Channel vegetation	4	4	Substrate condition	3	3	Barriers to continuity	4	4	Bank structure and stability	3	3	Bank vegetation	4	4	Riparian land cover	1	1	Floodplain connectivity	0	0
	U/S	D/S																											
Channel form and flow	4	4																											
Channel vegetation	4	4																											
Substrate condition	3	3																											
Barriers to continuity	4	4																											
Bank structure and stability	3	3																											
Bank vegetation	4	4																											
Riparian land cover	1	1																											
Floodplain connectivity	0	0																											
Total Score: 46	Spot-Check Class: Good																												
Comments: This river stretch is approx 12m wide. Seems to be unaltered, though some straightening/deepening may have occurred in the past. Some algal mats present at the bank edges. Bank contains immature Osier Willow (<i>Salix viminalis</i>) scrub with extensive Giant Hogweed (<i>Heracleum mantegazzianum</i>).

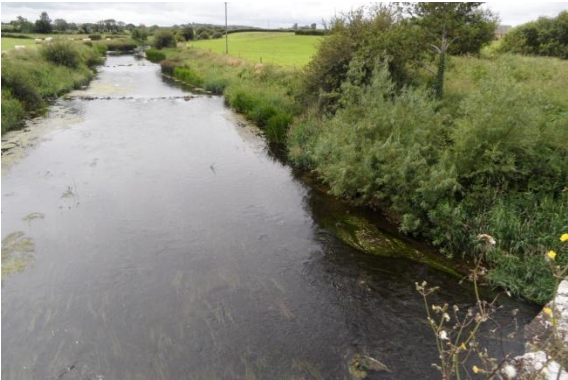
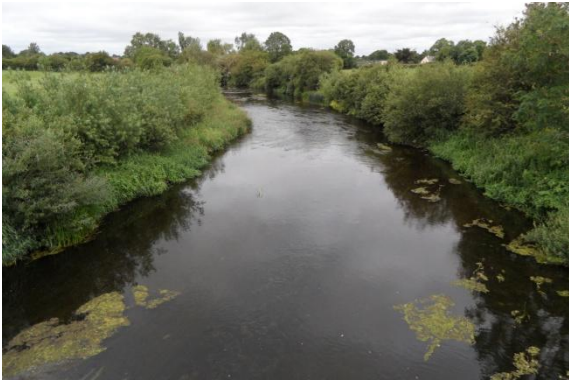
River: Maigue	Site Code: MG10																											
Survey Date: 12/07/2019	Surveyors: PF and MCG																											
Photo U/S

U/S	D/S	Channel form and flow	4	4	Channel vegetation	2	3	Substrate condition	3	3	Barriers to continuity	2	4	Bank structure and stability	3	3	Bank vegetation	2	3	Riparian land cover	0	0	Floodplain connectivity	0	0
	U/S	D/S																										
Channel form and flow	4	4																										
Channel vegetation	2	3																										
Substrate condition	3	3																										
Barriers to continuity	2	4																										
Bank structure and stability	3	3																										
Bank vegetation	2	3																										
Riparian land cover	0	0																										
Floodplain connectivity	0	0																										
Total Score: 36	Spot-Check Class: Moderate																											
Comments: This stretch of river appears relatively unaltered. The absence of trees along the banks is notable. Intermediate weirs in the upstream stretch do not impede water flow but may result in an increase in sediment.

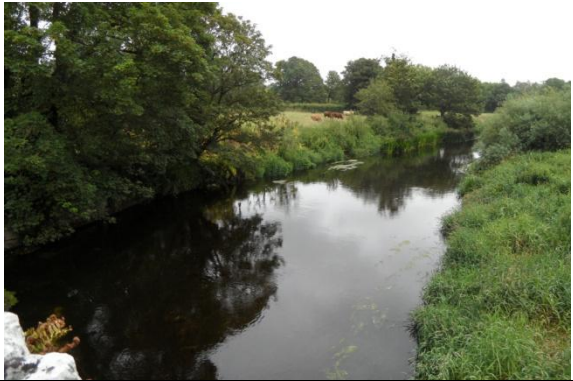
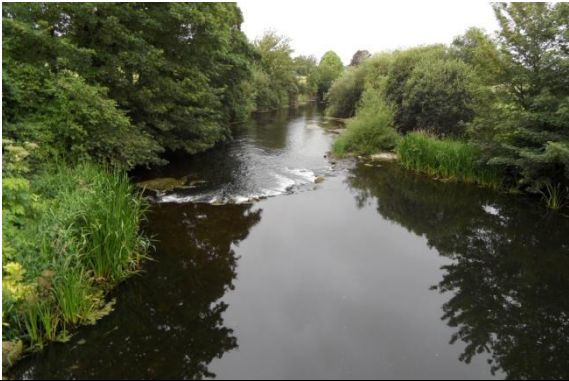
River: Maigue	Site Code: MG11																											
Survey Date: 17/07/2019	Surveyors: PF and MCG																											
Photo U/S

U/S	D/S	Channel form and flow	3	3	Channel vegetation	2	1	Substrate condition	2	2	Barriers to continuity	1	4	Bank structure and stability	3	2	Bank vegetation	3	2	Riparian land cover	0	0	Floodplain connectivity	0	0
	U/S	D/S																										
Channel form and flow	3	3																										
Channel vegetation	2	1																										
Substrate condition	2	2																										
Barriers to continuity	1	4																										
Bank structure and stability	3	2																										
Bank vegetation	3	2																										
Riparian land cover	0	0																										
Floodplain connectivity	0	0																										
Total Score: 28	Spot-Check Class: Poor																											
Comments: Channel 15-20m wide, with relatively good channel and bank side vegetation overall. Fishing occurs on this stretch of river. Giant Hogweed (<i>Heracleum mantegazzianum</i>) present.

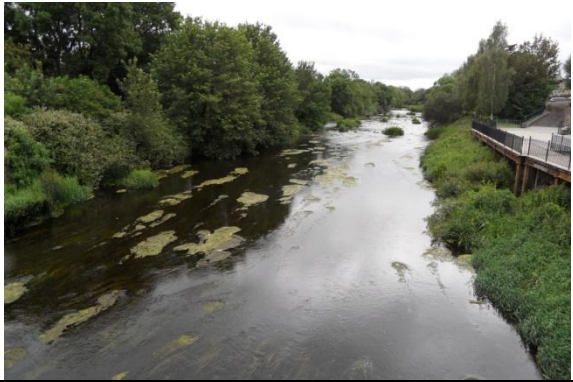
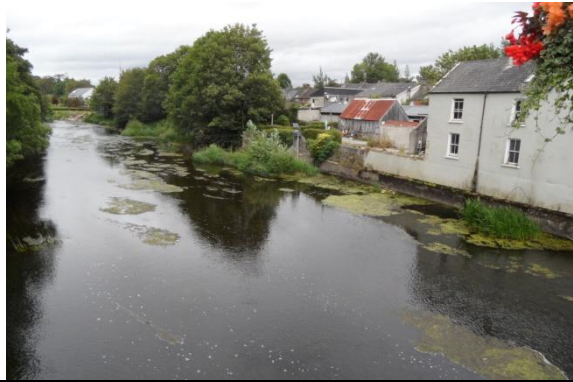
River: Maigue	Site Code: MG12																												
Survey Date: 17/07/2019	Surveyors: PF and MCG																												
Photo U/S

U/S	D/S	Channel from and flow	4	3	Channel vegetation	3	2	Substrate condition	4	3	Barriers to continuity	4	4	Bank structure and stability	4	2	Bank vegetation	3	2	Riparian land cover	0	0	Floodplain connectivity	0	0
	U/S	D/S																											
Channel from and flow	4	3																											
Channel vegetation	3	2																											
Substrate condition	4	3																											
Barriers to continuity	4	4																											
Bank structure and stability	4	2																											
Bank vegetation	3	2																											
Riparian land cover	0	0																											
Floodplain connectivity	0	0																											
Total Score: 38	Spot-Check Class: Moderate																												
Comments: Channel up to 20m wide. Upstream section appears to have minimal alteration/disturbance. Amenity park present on upstream left bank. Downstream section has been more altered, with reinforced walls present along banks. Green algae present on surface.

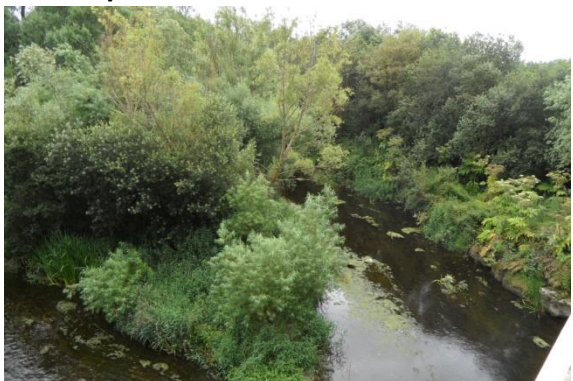
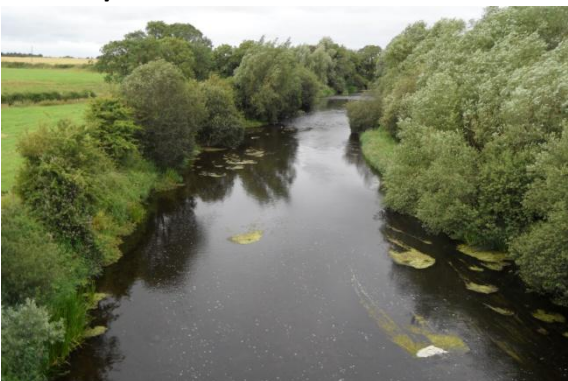
River: Maigue	Site Code: MG13																												
Survey Date: 17/07/2019	Surveyors: PF and MCG																												
Photo U/S

U/S	D/S	Channel from and flow	3	3	Channel vegetation	2	2	Substrate condition	2	2	Barriers to continuity	4	4	Bank structure and stability	3	2	Bank vegetation	3	3	Riparian land cover	0	0	Floodplain connectivity	0	0
	U/S	D/S																											
Channel from and flow	3	3																											
Channel vegetation	2	2																											
Substrate condition	2	2																											
Barriers to continuity	4	4																											
Bank structure and stability	3	2																											
Bank vegetation	3	3																											
Riparian land cover	0	0																											
Floodplain connectivity	0	0																											
Total Score: 33	Spot-Check Class: Moderate																												
Comments: Channel 15-20m wide. There has been some tree removal on the left downstream bank. Upstream there is a wooded island. Diversity of substrates present. Giant Hogweed (<i>Heracleum mantegazzianum</i>) present upstream and downstream. A lot of algae present in channel. Riparian woodland on island in river.

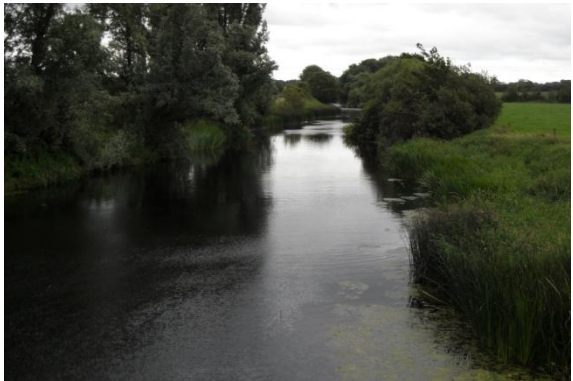
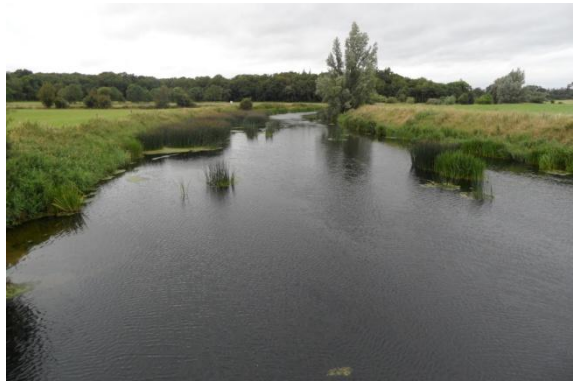
River: Maigue	Site Code: MG14																											
Survey Date: 17/07/2019	Surveyors: PF and MCG																											
Photo U/S

U/S	D/S	Channel form and flow	2	1	Channel vegetation	2	2	Substrate condition	2	2	Barriers to continuity	4	4	Bank structure and stability	1	1	Bank vegetation	2	1	Riparian land cover	0	0	Floodplain connectivity	0	0
	U/S	D/S																										
Channel form and flow	2	1																										
Channel vegetation	2	2																										
Substrate condition	2	2																										
Barriers to continuity	4	4																										
Bank structure and stability	1	1																										
Bank vegetation	2	1																										
Riparian land cover	0	0																										
Floodplain connectivity	0	0																										
Total Score: 24	Spot-Check Class: Poor																											
Comments: Channel up to 20m wide. Earth bank as a result of arterial drainage works visible. There has been extensive tree removal. GA1 fields run to edge of bank, cattle are accessing river resulting in significant bank erosion (photo 6242). Wooded island visible in upstream (photo 6243).

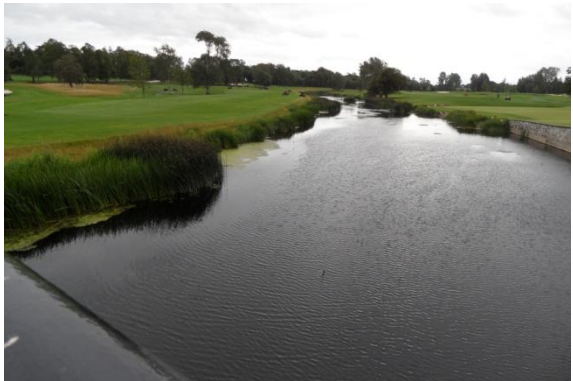
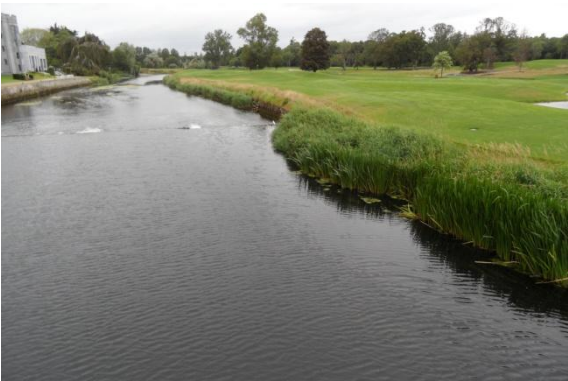
River: Maigue	Site Code: MG15																											
Survey Date: 17/07/2019	Surveyors: PF and MCG																											
Photo U/S

U/S	D/S	Channel form and flow	0	0	Channel vegetation	3	3	Substrate condition	2	2	Barriers to continuity	4	0	Bank structure and stability	0	0	Bank vegetation	0	0	Riparian land cover	0	0	Floodplain connectivity	0	0
	U/S	D/S																										
Channel form and flow	0	0																										
Channel vegetation	3	3																										
Substrate condition	2	2																										
Barriers to continuity	4	0																										
Bank structure and stability	0	0																										
Bank vegetation	0	0																										
Riparian land cover	0	0																										
Floodplain connectivity	0	0																										
Total Score: 14	Spot-Check Class: Bad																											
Comments: Channel up to 20m wide. Whole stretch has been extensively altered. Complete absence of riparian vegetation. Extensive reinforcement of both banks. Golf paths and green extend right up to bank top. Weir present downstream.

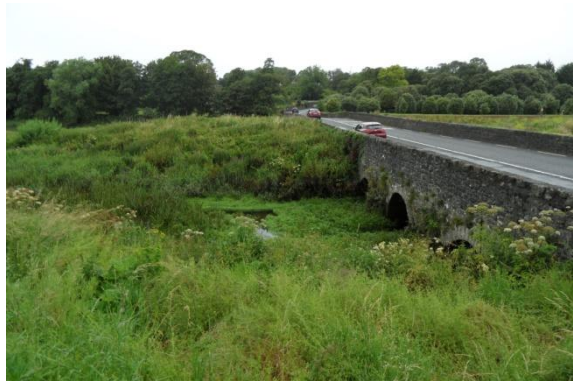
River: Maigue	Site Code: MG16																											
Survey Date: 17/07/2019	Surveyors: PF and MCG																											
Photo U/S Not possible to get photo due to busy road.	Photo D/S

U/S	D/S	Channel form and flow	4	4	Channel vegetation	4	4	Substrate condition	3	3	Barriers to continuity	4	4	Bank structure and stability	3	3	Bank vegetation	2	2	Riparian land cover	1	1	Floodplain connectivity	0	0
	U/S	D/S																										
Channel form and flow	4	4																										
Channel vegetation	4	4																										
Substrate condition	3	3																										
Barriers to continuity	4	4																										
Bank structure and stability	3	3																										
Bank vegetation	2	2																										
Riparian land cover	1	1																										
Floodplain connectivity	0	0																										
Total Score: 42	Spot-Check Class: Good																											
Comments: Survey done from Adare river walk path (downstream left bank) as very busy main road crosses river, not possible to do survey from road. Earth bank present along both banks as a result of previous arterial drainage. In channel vegetation is good, however, bankside vegetation is limited due to earth banks. Where trees are present, shading is occurring. Island present on downstream side of bridge.

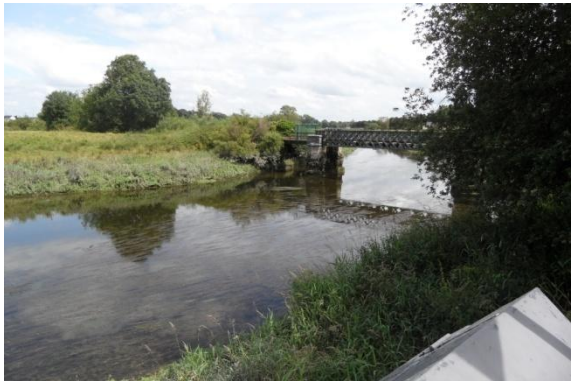
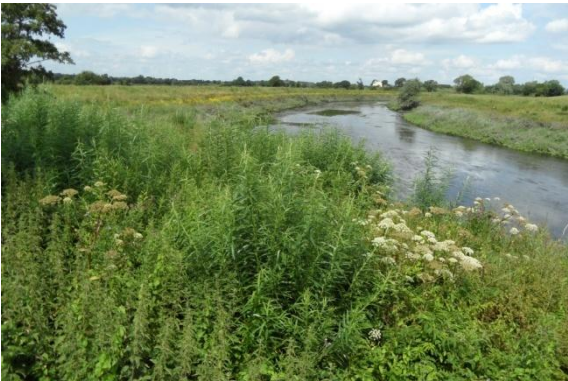
River: Maigue	Site Code: MG17																											
Survey Date: 16/07/2019	Surveyors: PF and MCG																											
Photo U/S

U/S	D/S	Channel form and flow	3	3	Channel vegetation	3	3	Substrate condition	3	3	Barriers to continuity	4	4	Bank structure and stability	0	0	Bank vegetation	0	0	Riparian land cover	0	0	Floodplain connectivity	0	0
	U/S	D/S																										
Channel form and flow	3	3																										
Channel vegetation	3	3																										
Substrate condition	3	3																										
Barriers to continuity	4	4																										
Bank structure and stability	0	0																										
Bank vegetation	0	0																										
Riparian land cover	0	0																										
Floodplain connectivity	0	0																										
Total Score: 26	Spot-Check Class: Poor																											
Comments: Channel 15-20m wide. Low water level with exposed mud banks in centre of channel. Riparian vegetation almost absent. Amenity park present upstream. Earth bank present after arterial drainage. Channel has been extensively altered.
