River Maigue Catchment Riparian Habitat Study

RIVER MAIGUE RIPARIAN HABITAT SURVEYS

FINAL REPORT

Prepared by Wetland Surveys

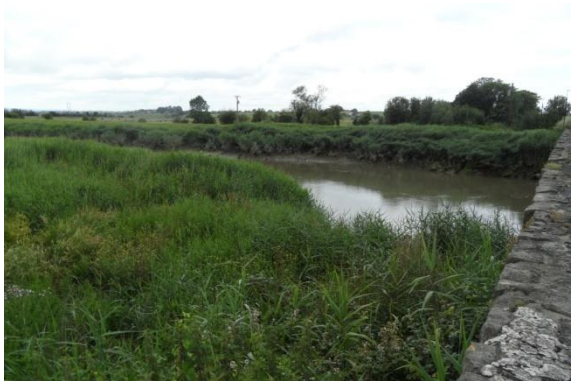
River: Maigue	Site Code: MG18																											
Survey Date: 16/07/2019	Surveyors: PF and MCG																											
Photo U/S

U/S	D/S	Channel form and flow	3	3	Channel vegetation	4	4	Substrate condition	4	4	Barriers to continuity	4	4	Bank structure and stability	1	1	Bank vegetation	4	4	Riparian land cover	3	3	Floodplain connectivity	0	0
	U/S	D/S																										
Channel form and flow	3	3																										
Channel vegetation	4	4																										
Substrate condition	4	4																										
Barriers to continuity	4	4																										
Bank structure and stability	1	1																										
Bank vegetation	4	4																										
Riparian land cover	3	3																										
Floodplain connectivity	0	0																										
Total Score: 46	Spot-Check Class: Good																											
Comments: Estuarine stretch with tidal influence. This stretch was previously straightened and deepened and there are earth banks present either side of the channel. This stretch of river has recovered relatively well, it follows the path of least resistance, and there are reed beds present at both sides of the channel.

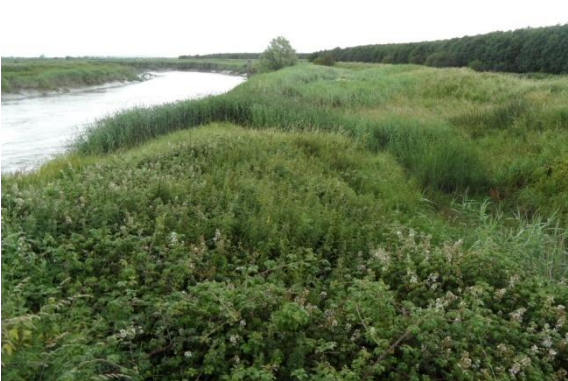
Photo D/S

Channel Type U/S: Lowland meandering	Channel Type D/S: Lowland meandering																											
Bank Vegetation U/S (L): FS1	Bank Vegetation D/S (L): FS1																											
Bank Vegetation U/S (R): FS1	Bank Vegetation D/S (R): FS1																											
Land Cover U/S (L): GA1	Land Cover D/S (L): FS1 / GS2																											
Land Cover U/S (R): FS1 / GS2	Land Cover D/S (R): GA2																											
Artificial Features U/S: None	Artificial Features D/S: None																											
Scoring Matrix
